## Profile/Photo Observation Report

Street:	<b>E RAND ST</b>	Flow Control:	<b>Not Controlled</b>
City:	<b>Hobart, IN</b>	Year Renewed:	
Location:	<b>Other</b>	Tape/Media #:	
Purpose:	<b>Not Known</b>	Dia/Height:	<b>12"</b>
Use:	<b>Sanitary</b>	Material:	<b>VCP</b>
Drain Area:	<b>NA</b>	Lining:	
Category:	<b>NA</b>		
Comment:

Location Details:		Direction of Survey:	<b>Downstream</b>
US MH:	<b>M-903-015</b>	DS MH:	<b>M-903-016</b>
		Total Length Surveyed (ft):	<b>13.7</b>

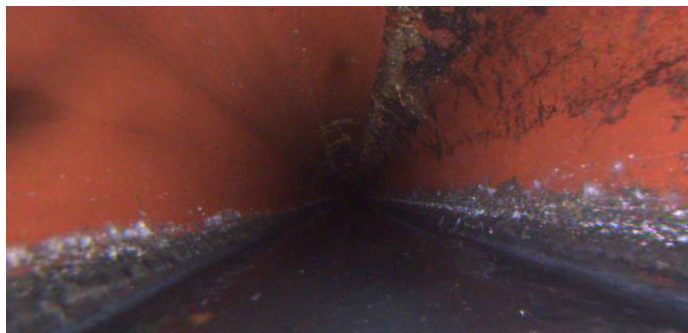
Code: **AMH**  
Description: **Manhole**

Distance (ft): **.0**  
Structural Grade: **0**  
O&M Grade: **0**  
Clock Start/From:  
Clock To:  
1st Value:  
2nd Value:  
Value Percent:  
Continuous Index:  
Within 8" of Joint: **NO**  
Remarks: **M-903-015**

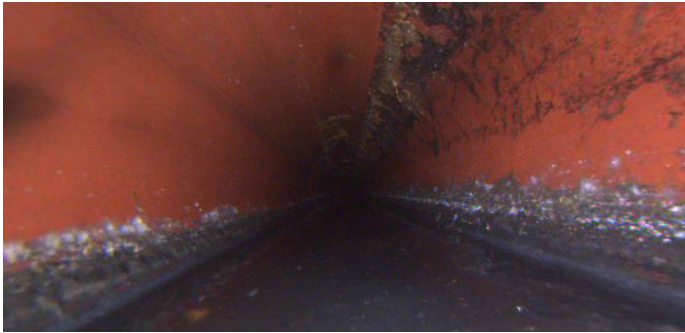
Code:	<b>MWL</b>
Description:	<b>Water Level</b>

Distance (ft):	<b>.0</b>
Structural Grade:	<b>0</b>
O&M Grade:	<b>0</b>
Clock Start/From:	
Clock To:	
1st Value:	
2nd Value:	
Value Percent:	<b>30.000</b>
Continuous Index:	
Within 8" of Joint:	<b>NO</b>
Remarks:

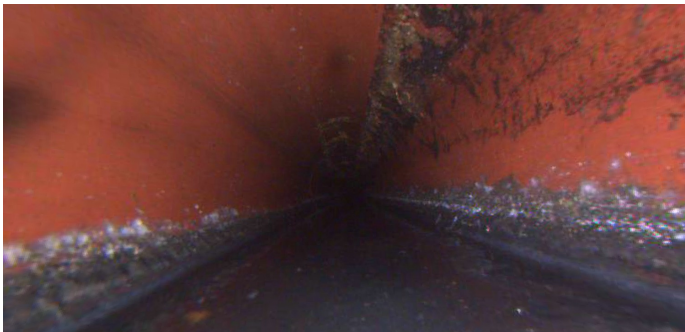
Code:	<b>DAGS</b>
Description:	<b>Deposits Attached Grease</b>

Distance (ft):	<b>.0</b>
Structural Grade:	<b>0</b>
O&M Grade:	<b>2</b>
Clock Start/From:	<b>8</b>
Clock To:	<b>4</b>
1st Value:	
2nd Value:	
Value Percent:	<b>5.000</b>
Continuous Index:	<b>S01</b>
Within 8" of Joint:	<b>NO</b>
Remarks:

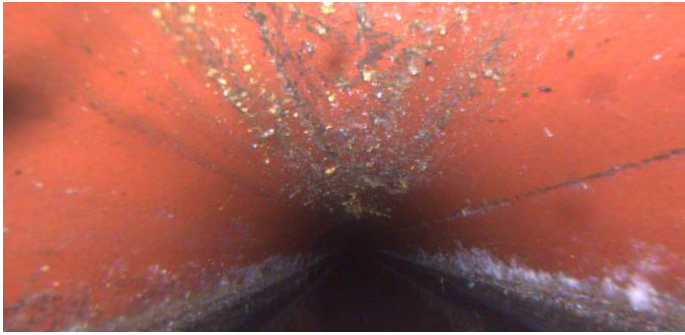
Code: **MSA**  
Description: **Abandoned Survey**

Distance (ft): **13.7**  
Structural Grade: **0**  
O&M Grade: **0**  
Clock Start/From:  
Clock To:  
1st Value:  
2nd Value:  
Value Percent:  
Continuous Index:  
Within 8" of Joint: **NO**  
Remarks: **DEBRIS UNDER WATER**

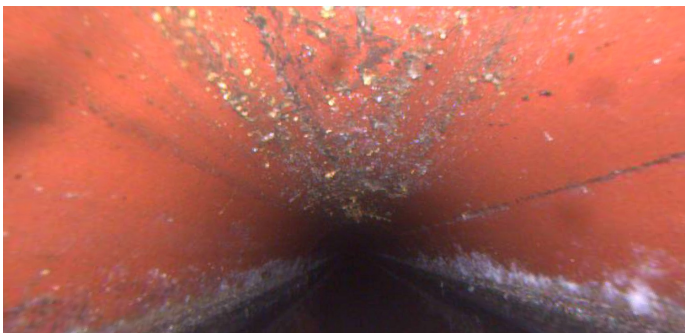
Code: **DAGS**  
Description: **Deposits Attached Grease**

Distance (ft): **13.7**  
Structural Grade: **0**  
O&M Grade: **2**  
Clock Start/From: **8**  
Clock To: **4**  
1st Value:  
2nd Value:  
Value Percent: **5.000**  
Continuous Index: **F01**  
Within 8" of Joint: **NO**  
Remarks:
