Profile/Photo Observation Report

Street:	Rand St.	Flow Control:	Not Controlled
City:	Hobart, IN	Year Renewed:	
Location:	Other	Tape/Media #:	
Purpose:	Not Known	Dia/Height:	12"
Use:	Sanitary	Material:	VCP
Drain Area:	NA	Lining:	
Category:	NA		
Comment:

Location Details:		Direction of Survey:	Downstream
US MH:	M-903-015	DS MH:	M-903-016
		Total Length Surveyed (ft):	13.7

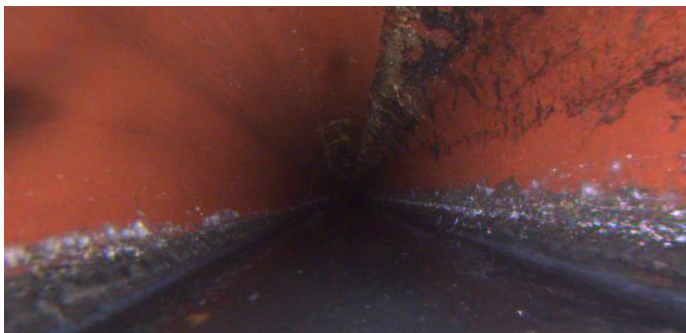
Code: **AMH**
Description: **Manhole**

Distance (ft): **.0**
Structural Grade: **0**
O&M Grade: **0**
Clock Start/From:
Clock To:
1st Value:
2nd Value:
Value Percent:
Continuous Index:
Within 8" of Joint: **NO**
Remarks: **M-903-015**

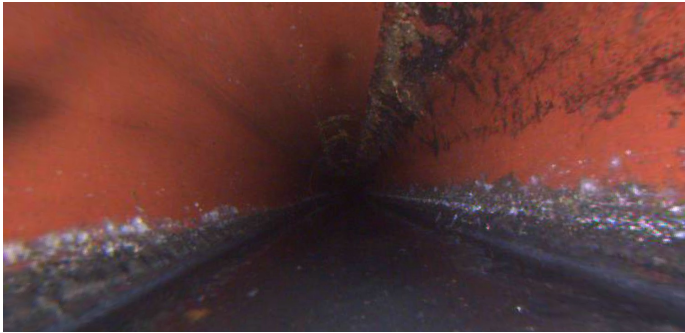
Code:	MWL
Description:	Water Level

Distance (ft):	.0
Structural Grade:	0
O&M Grade:	0
Clock Start/From:	
Clock To:	
1st Value:	
2nd Value:	
Value Percent:	30.000
Continuous Index:	
Within 8" of Joint:	NO
Remarks:

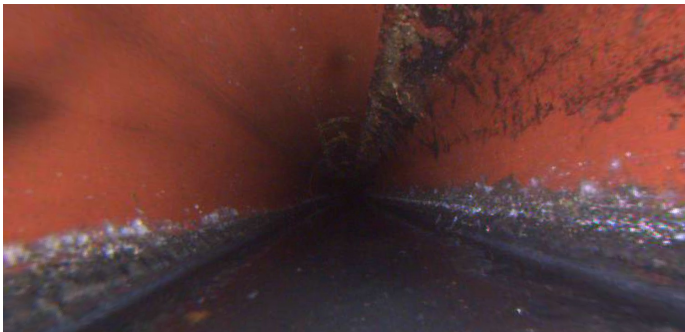
Code:	DAGS
Description:	Deposits Attached Grease

Distance (ft):	.0
Structural Grade:	0
O&M Grade:	2
Clock Start/From:	8
Clock To:	4
1st Value:	
2nd Value:	
Value Percent:	5.000
Continuous Index:	S01
Within 8" of Joint:	NO
Remarks:

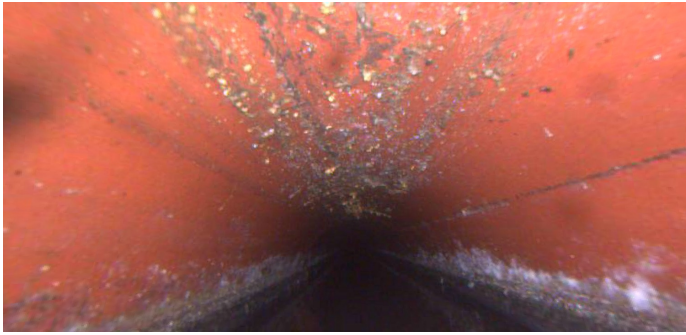
Code: **MSA**
Description: **Abandoned Survey**

Distance (ft): **13.7**
Structural Grade: **0**
O&M Grade: **0**
Clock Start/From:
Clock To:
1st Value:
2nd Value:
Value Percent:
Continuous Index:
Within 8" of Joint: **NO**
Remarks: **DEBRIS UNDER WATER**

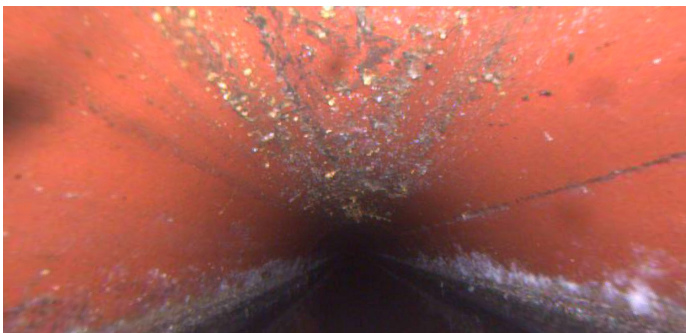
Code: **DAGS**
Description: **Deposits Attached Grease**

Distance (ft): **13.7**
Structural Grade: **0**
O&M Grade: **2**
Clock Start/From: **8**
Clock To: **4**
1st Value:
2nd Value:
Value Percent: **5.000**
Continuous Index: **F01**
Within 8" of Joint: **NO**
Remarks:
