Profile/Photo Observation Report

Street:	E RAND ST	Flow Control:	Not Controlled
City:	Hobart, IN	Year Renewed:	
Location:	Other	Tape/Media #:	
Purpose:	Not Known	Dia/Height:	12"
Use:	Sanitary	Material:	VCP
Drain Area:	NA	Lining:	
Category:	NA		
Comment:

Location Details:		Direction of Survey:	Upstream
US MH:	M-903-016	DS MH:	M-903-017
		Total Length Surveyed (ft):	47.0

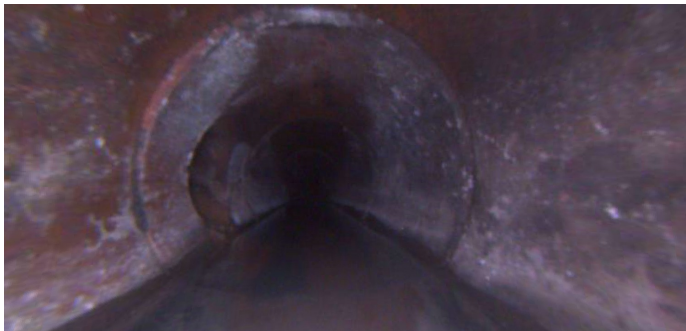
Code: **AMH**
Description: **Manhole**

Distance (ft): **.0**
Structural Grade: **0**
O&M Grade: **0**
Clock Start/From:
Clock To:
1st Value:
2nd Value:
Value Percent:
Continuous Index:
Within 8" of Joint: **NO**
Remarks: **M-903-017**

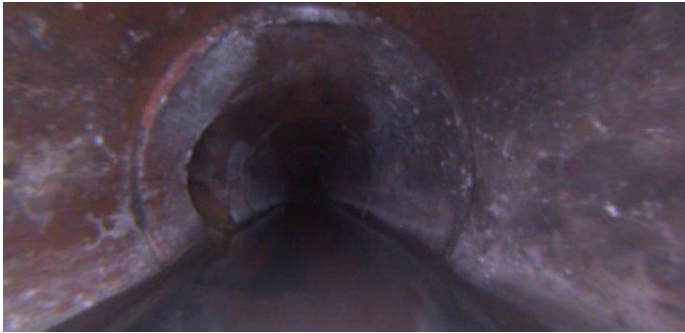
Code:	MWL
Description:	Water Level

Distance (ft):	.0
Structural Grade:	0
O&M Grade:	0
Clock Start/From:	
Clock To:	
1st Value:	
2nd Value:	
Value Percent:	20.000
Continuous Index:	
Within 8" of Joint:	NO
Remarks:

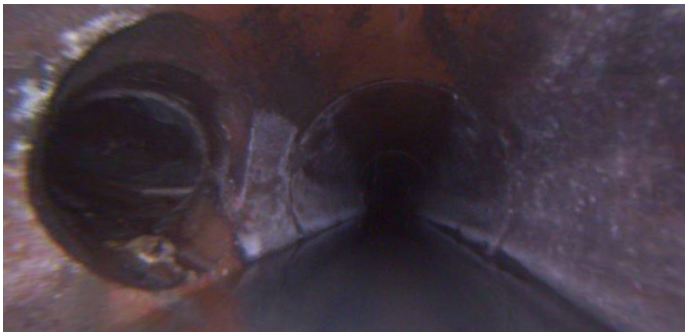
Code:	TF
Description:	Tap Factory

Distance (ft):	1.6
Structural Grade:	0
O&M Grade:	0
Clock Start/From:	9
Clock To:	
1st Value:	4.000
2nd Value:	
Value Percent:	
Continuous Index:	
Within 8" of Joint:	
Remarks:

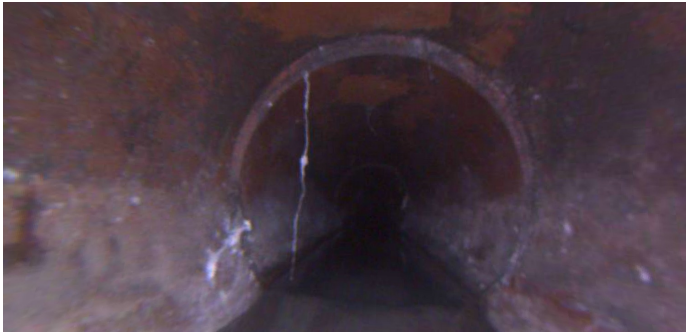
Code: **RFJ**
Description: **Roots Fine Joint**

Distance (ft): **5.1**
Structural Grade: **0**
O&M Grade: **1**
Clock Start/From: **11**
Clock To:
1st Value:
2nd Value:
Value Percent:
Continuous Index:
Within 8" of Joint: **YES**
Remarks:

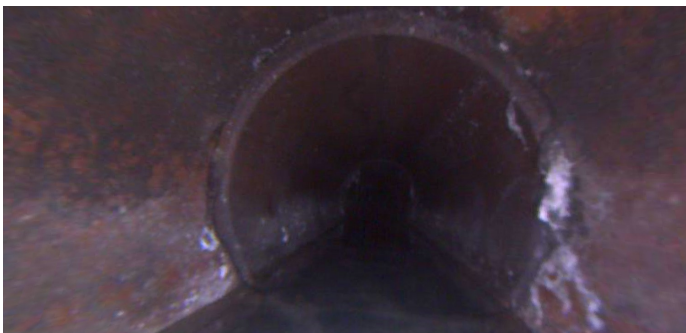
Code: **RFJ**
Description: **Roots Fine Joint**

Distance (ft): **8.3**
Structural Grade: **0**
O&M Grade: **1**
Clock Start/From: **2**
Clock To: **4**
1st Value:
2nd Value:
Value Percent:
Continuous Index:
Within 8" of Joint: **YES**
Remarks:

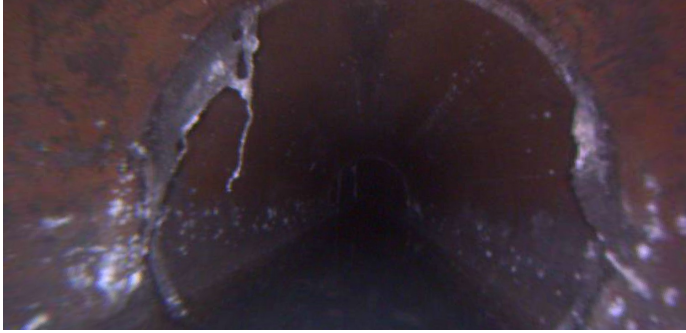
Code: **RFJ**
Description: **Roots Fine Joint**

Distance (ft): **11.5**
Structural Grade: **0**
O&M Grade: **1**
Clock Start/From: **8**
Clock To: **4**
1st Value:
2nd Value:
Value Percent:
Continuous Index: **S01**
Within 8" of Joint: **YES**
Remarks:

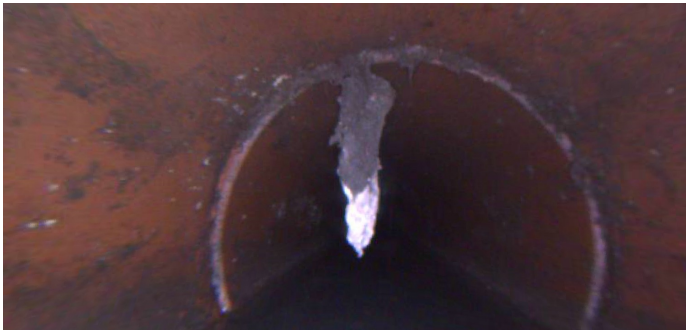
Code: **DAR**
Description: **Deposits Attached Ragging**

Distance (ft): **29.4**
Structural Grade: **0**
O&M Grade: **2**
Clock Start/From: **12**
Clock To:
1st Value:
2nd Value:
Value Percent: **10.000**
Continuous Index:
Within 8" of Joint: **YES**
Remarks:

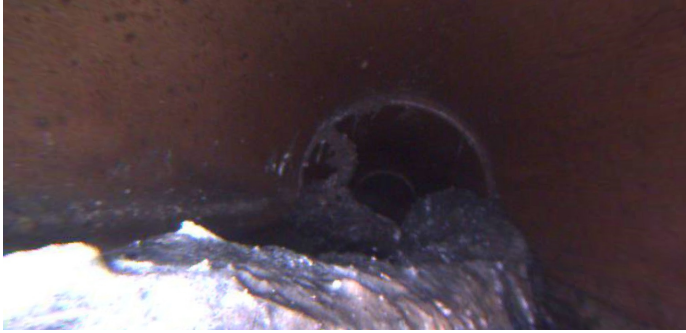
Code: **OBZ**
Description: **Obstacle Other**

Distance (ft): **47.0**
Structural Grade: **0**
O&M Grade: **5**
Clock Start/From: **3**
Clock To: **9**
1st Value:
2nd Value:
Value Percent: **40.000**
Continuous Index:
Within 8" of Joint: **NO**
Remarks: **MISC**

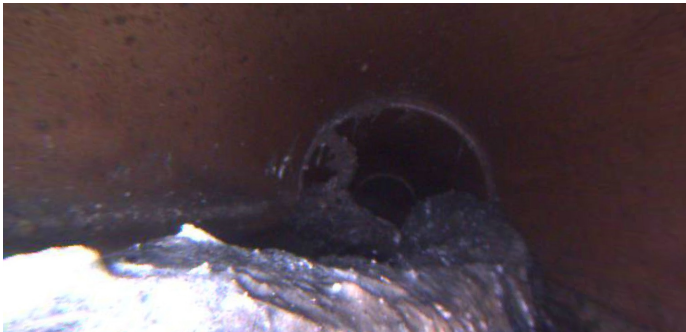
Code: **RFJ**
Description: **Roots Fine Joint**

Distance (ft): **47.0**
Structural Grade: **0**
O&M Grade: **1**
Clock Start/From: **8**
Clock To: **4**
1st Value:
2nd Value:
Value Percent:
Continuous Index: **F01**
Within 8" of Joint: **YES**
Remarks:

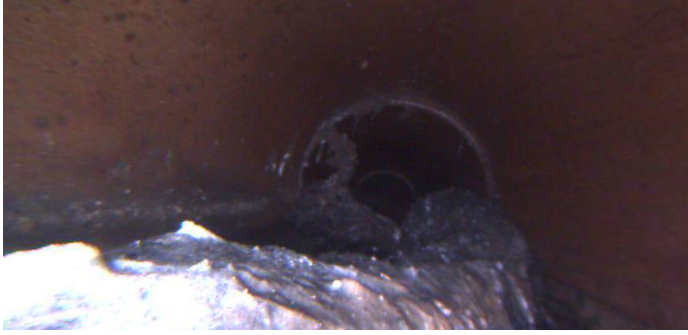
Code:	MSA
Description:	Abandoned Survey
Distance (ft):	47.0
Structural Grade:	0
O&M Grade:	0
Clock Start/From:	
Clock To:	
1st Value:	
2nd Value:	
Value Percent:	
Continuous Index:	
Within 8" of Joint:	NO
Remarks:	MISC
