Profile/Photo Observation Report

Street:	E RAND ST	Flow Control:	Not Controlled
City:	Hobart, IN	Year Renewed:	
Location:	Light Highway	Tape/Media #:	
Purpose:	Routine Assessment	Dia/Height:	12"
Use:	Sanitary	Material:	VCP
Drain Area:	NA	Lining:	
Category:	NA		
Comment:

Location Details:		Direction of Survey:	Downstream
US MH:	M-903-016	DS MH:	M-903-017
		Total Length Surveyed (ft):	140.6

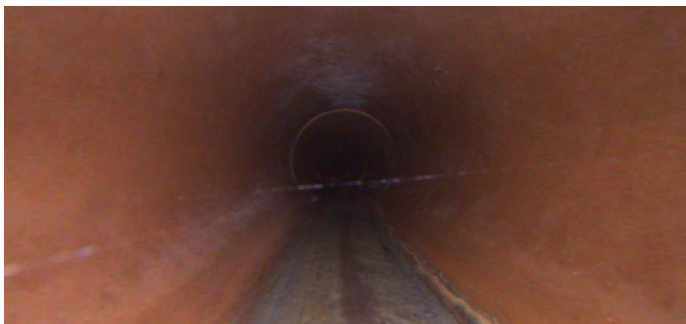
Code: **AMH**
Description: **Manhole**

Distance (ft): **.0**
Structural Grade: **0**
O&M Grade: **0**
Clock Start/From:
Clock To:
1st Value:
2nd Value:
Value Percent:
Continuous Index:
Within 8" of Joint: **NO**
Remarks: **M-903-016**

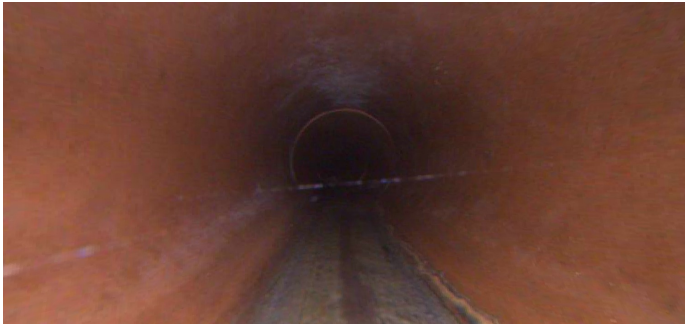
Code:	MWL
Description:	Water Level

Distance (ft):	.0
Structural Grade:	0
O&M Grade:	0
Clock Start/From:	
Clock To:	
1st Value:	
2nd Value:	
Value Percent:	5.000
Continuous Index:	
Within 8" of Joint:	NO
Remarks:

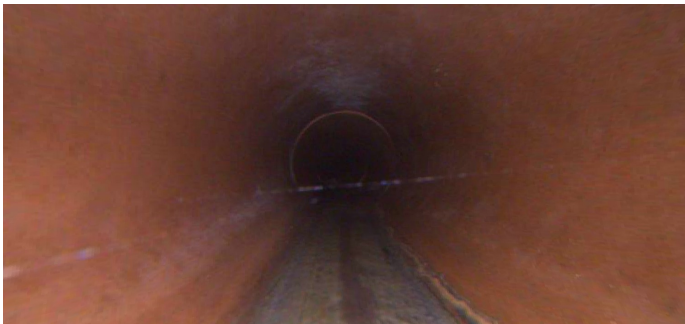
Code:	DAGS
Description:	Deposits Attached Grease

Distance (ft):	.0
Structural Grade:	0
O&M Grade:	2
Clock Start/From:	7
Clock To:	5
1st Value:	
2nd Value:	
Value Percent:	5.000
Continuous Index:	S01
Within 8" of Joint:	YES
Remarks:	WANDER

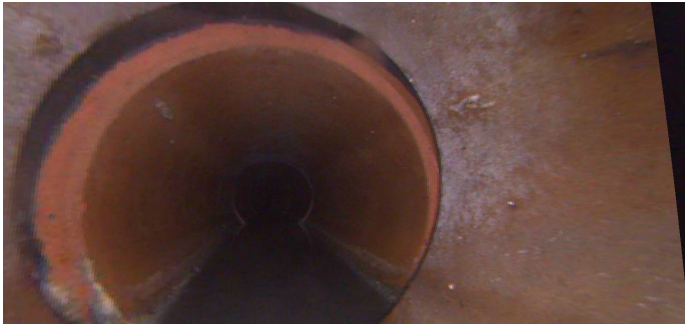
Code: **JOM**
Description: **Joint Offset Medium**

Distance (ft): **29.1**
Structural Grade: **1**
O&M Grade: **0**
Clock Start/From:
Clock To:
1st Value:
2nd Value:
Value Percent:
Continuous Index:
Within 8" of Joint: **NO**
Remarks:

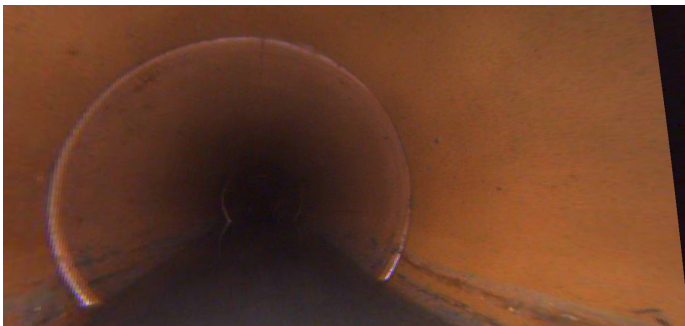
Code: **CL**
Description: **Crack Longitudinal**

Distance (ft): **74.6**
Structural Grade: **2**
O&M Grade: **0**
Clock Start/From: **12**
Clock To:
1st Value:
2nd Value:
Value Percent:
Continuous Index:
Within 8" of Joint: **YES**
Remarks:

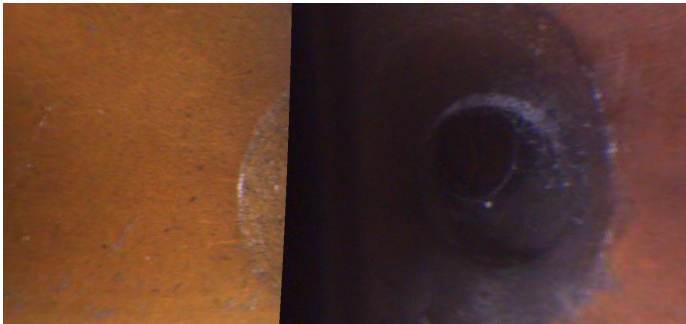
Code: **TF**
Description: **Tap Factory**

Distance (ft): **92.8**
Structural Grade: **0**
O&M Grade: **0**
Clock Start/From: **3**
Clock To:
1st Value: **4.000**
2nd Value:
Value Percent:
Continuous Index:
Within 8" of Joint:
Remarks:

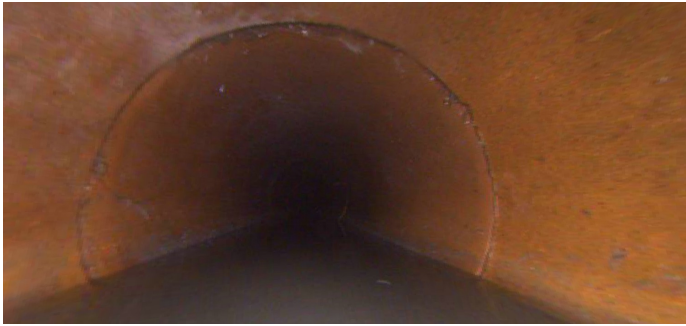
Code: **RFJ**
Description: **Roots Fine Joint**

Distance (ft): **93.3**
Structural Grade: **0**
O&M Grade: **1**
Clock Start/From: **8**
Clock To: **3**
1st Value:
2nd Value:
Value Percent:
Continuous Index:
Within 8" of Joint: **YES**
Remarks:

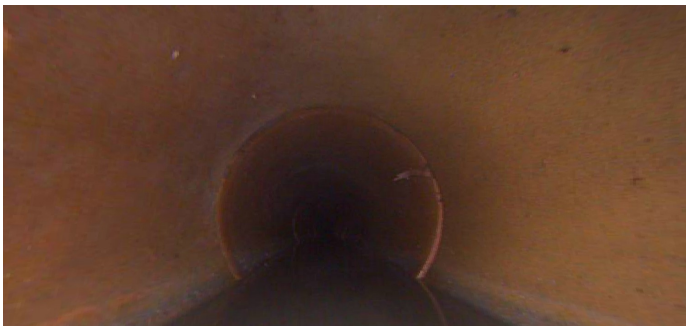
Code: **ISSR**
Description: **Intruding Sealing Ring**

Distance (ft): **95.6**
Structural Grade: **0**
O&M Grade: **2**
Clock Start/From: **2**
Clock To: **3**
1st Value:
2nd Value:
Value Percent: **5.000**
Continuous Index:
Within 8" of Joint: **NO**
Remarks:

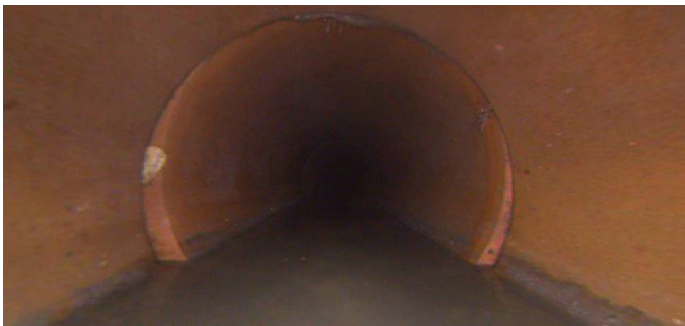
Code: **RFJ**
Description: **Roots Fine Joint**

Distance (ft): **106.7**
Structural Grade: **0**
O&M Grade: **1**
Clock Start/From: **12**
Clock To: **3**
1st Value:
2nd Value:
Value Percent:
Continuous Index:
Within 8" of Joint: **YES**
Remarks:

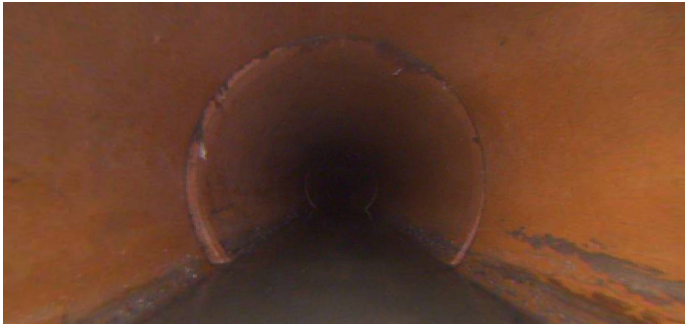
Code: **RFJ**
Description: **Roots Fine Joint**

Distance (ft): **112.0**
Structural Grade: **0**
O&M Grade: **1**
Clock Start/From: **9**
Clock To: **2**
1st Value:
2nd Value:
Value Percent:
Continuous Index:
Within 8" of Joint: **YES**
Remarks:

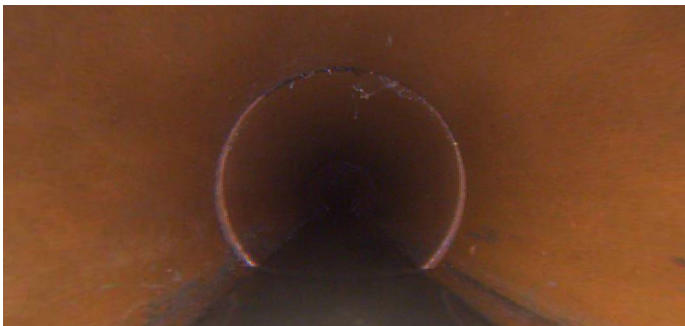
Code: **RFJ**
Description: **Roots Fine Joint**

Distance (ft): **114.6**
Structural Grade: **0**
O&M Grade: **1**
Clock Start/From: **11**
Clock To: **1**
1st Value:
2nd Value:
Value Percent:
Continuous Index:
Within 8" of Joint: **YES**
Remarks:

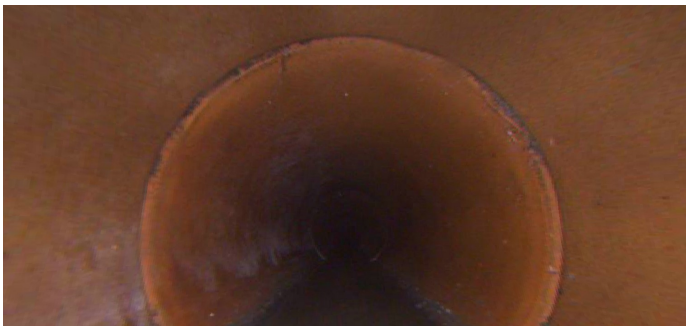
Code: **RFJ**
Description: **Roots Fine Joint**

Distance (ft): **127.8**
Structural Grade: **0**
O&M Grade: **1**
Clock Start/From: **10**
Clock To: **2**
1st Value:
2nd Value:
Value Percent:
Continuous Index:
Within 8" of Joint: **YES**
Remarks:

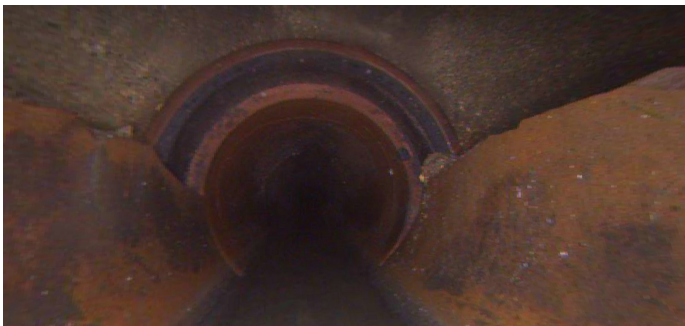
Code: **AMH**
Description: **Manhole**

Distance (ft): **140.6**
Structural Grade: **0**
O&M Grade: **0**
Clock Start/From:
Clock To:
1st Value:
2nd Value:
Value Percent:
Continuous Index:
Within 8" of Joint: **NO**
Remarks: **M-903-017**

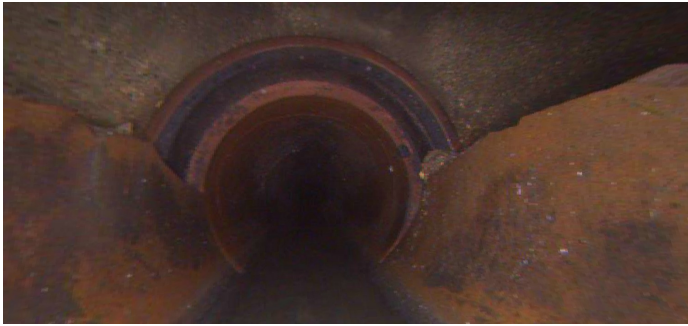
Code:	DAGS
Description:	Deposits Attached Grease
Distance (ft):	140.6
Structural Grade:	0
O&M Grade:	2
Clock Start/From:	7
Clock To:	5
1st Value:	
2nd Value:	
Value Percent:	5.000
Continuous Index:	F01
Within 8" of Joint:	YES
Remarks:	WANDER
