## Profile/Photo Observation Report

Street:	<b>Rand St.</b>	Flow Control:	<b>Not Controlled</b>
City:	<b>Hobart, IN</b>	Year Renewed:	
Location:	<b>Light Highway</b>	Tape/Media #:	
Purpose:	<b>Routine Assessment</b>	Dia/Height:	<b>12"</b>
Use:	<b>Sanitary</b>	Material:	<b>VCP</b>
Drain Area:	<b>NA</b>	Lining:	
Category:	<b>NA</b>		
Comment:

Location Details:		Direction of Survey:	<b>Downstream</b>
US MH:	<b>M-903-016</b>	DS MH:	<b>M-903-017</b>
		Total Length Surveyed (ft):	<b>140.6</b>

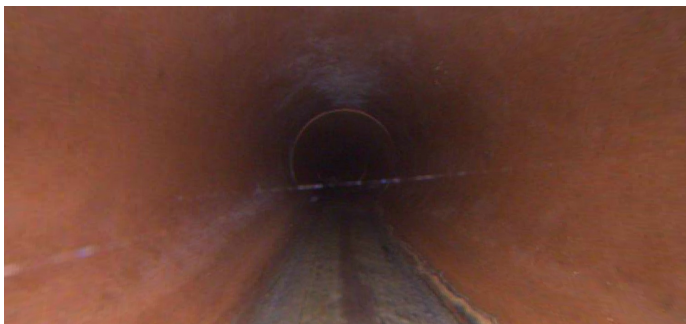
Code: **AMH**  
Description: **Manhole**

Distance (ft): **.0**  
Structural Grade: **0**  
O&M Grade: **0**  
Clock Start/From:  
Clock To:  
1st Value:  
2nd Value:  
Value Percent:  
Continuous Index:  
Within 8" of Joint: **NO**  
Remarks: **M-903-016**

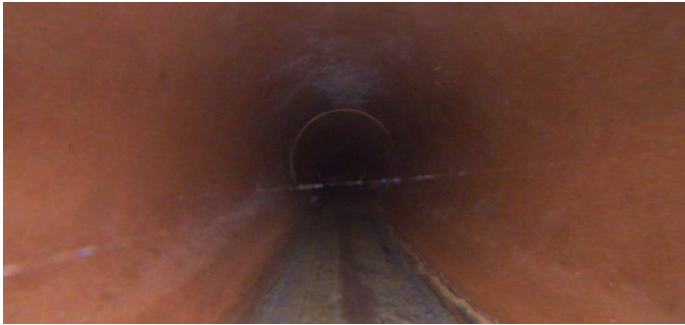
Code:	<b>MWL</b>
Description:	<b>Water Level</b>

Distance (ft):	<b>.0</b>
Structural Grade:	<b>0</b>
O&M Grade:	<b>0</b>
Clock Start/From:	
Clock To:	
1st Value:	
2nd Value:	
Value Percent:	<b>5.000</b>
Continuous Index:	
Within 8" of Joint:	<b>NO</b>
Remarks:

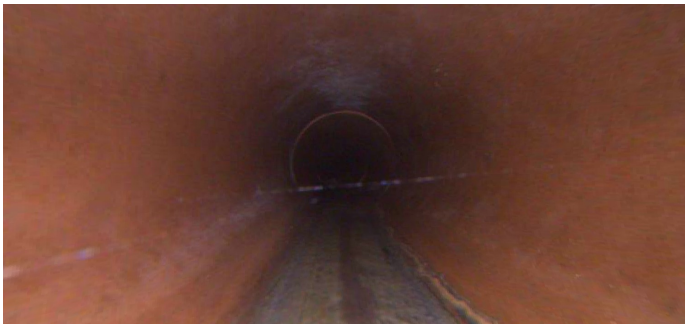
Code:	<b>DAGS</b>
Description:	<b>Deposits Attached Grease</b>

Distance (ft):	<b>.0</b>
Structural Grade:	<b>0</b>
O&M Grade:	<b>2</b>
Clock Start/From:	<b>7</b>
Clock To:	<b>5</b>
1st Value:	
2nd Value:	
Value Percent:	<b>5.000</b>
Continuous Index:	<b>S01</b>
Within 8" of Joint:	<b>YES</b>
Remarks:	<b>WANDER</b>

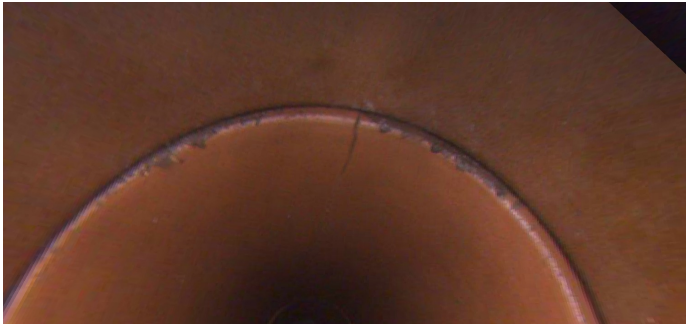
Code: **CL**  
Description: **Crack Longitudinal**

Distance (ft): **20.7**  
Structural Grade: **2**  
O&M Grade: **0**  
Clock Start/From: **12**  
Clock To:  
1st Value:  
2nd Value:  
Value Percent:  
Continuous Index:  
Within 8" of Joint: **YES**  
Remarks:

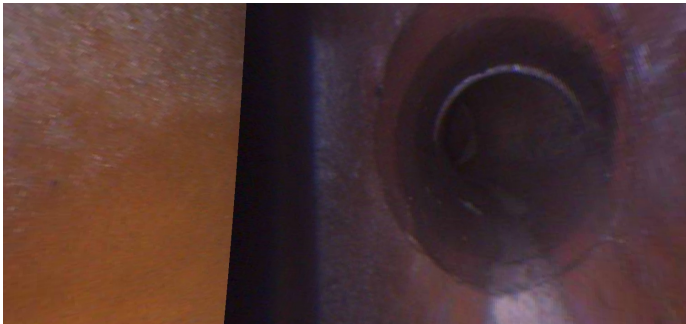
Code: **TF**  
Description: **Tap Factory**

Distance (ft): **27.9**  
Structural Grade: **0**  
O&M Grade: **0**  
Clock Start/From: **2**  
Clock To:  
1st Value: **4.000**  
2nd Value:  
Value Percent:  
Continuous Index:  
Within 8" of Joint:  
Remarks:

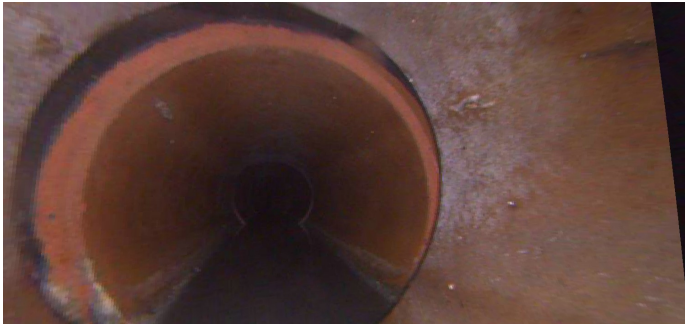
Code: **JOM**  
Description: **Joint Offset Medium**

Distance (ft): **29.1**  
Structural Grade: **1**  
O&M Grade: **0**  
Clock Start/From:  
Clock To:  
1st Value:  
2nd Value:  
Value Percent:  
Continuous Index:  
Within 8" of Joint: **NO**  
Remarks:

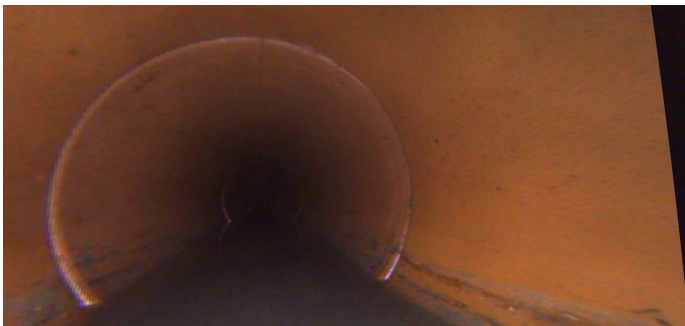
Code: **CL**  
Description: **Crack Longitudinal**

Distance (ft): **74.6**  
Structural Grade: **2**  
O&M Grade: **0**  
Clock Start/From: **12**  
Clock To:  
1st Value:  
2nd Value:  
Value Percent:  
Continuous Index:  
Within 8" of Joint: **YES**  
Remarks:

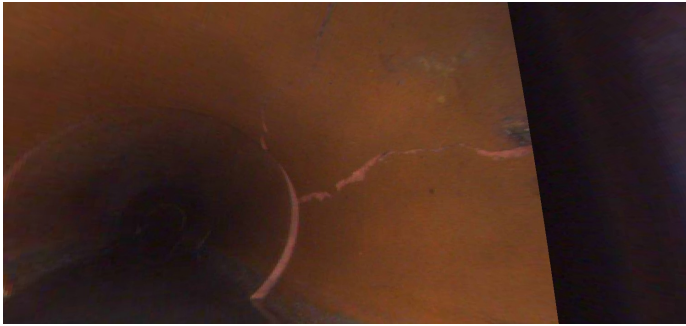
Code: **CM**  
Description: **Crack Multiple**

Distance (ft): **82.6**  
Structural Grade: **3**  
O&M Grade: **0**  
Clock Start/From: **2**  
Clock To: **3**  
1st Value:  
2nd Value:  
Value Percent:  
Continuous Index:  
Within 8" of Joint: **YES**  
Remarks:

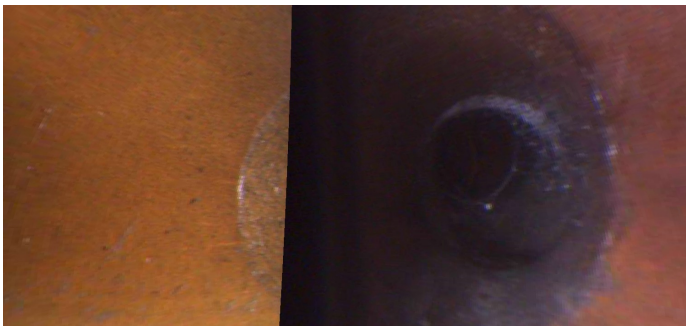
Code: **TF**  
Description: **Tap Factory**

Distance (ft): **92.8**  
Structural Grade: **0**  
O&M Grade: **0**  
Clock Start/From: **3**  
Clock To:  
1st Value: **4.000**  
2nd Value:  
Value Percent:  
Continuous Index:  
Within 8" of Joint:  
Remarks:

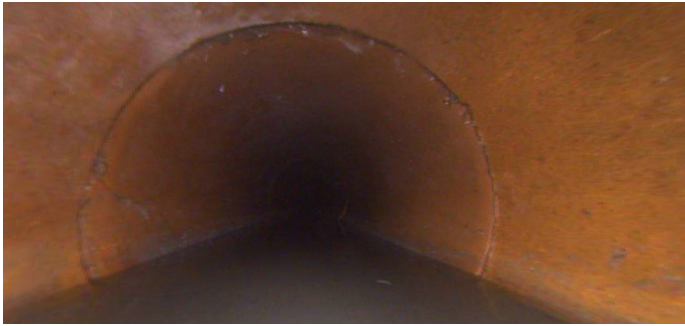
Code: **RFJ**  
Description: **Roots Fine Joint**

Distance (ft): **93.3**  
Structural Grade: **0**  
O&M Grade: **1**  
Clock Start/From: **8**  
Clock To: **3**  
1st Value:  
2nd Value:  
Value Percent:  
Continuous Index:  
Within 8" of Joint: **YES**  
Remarks:

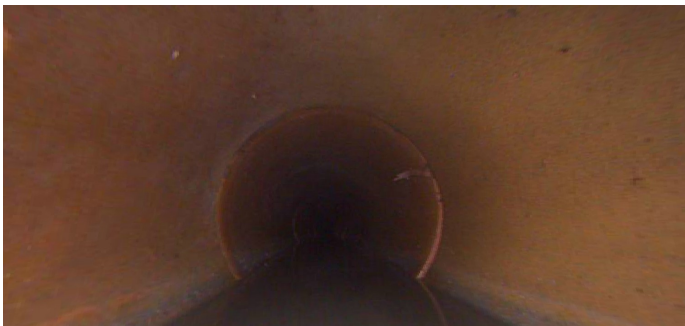
Code: **ISSR**  
Description: **Intruding Sealing Ring**

Distance (ft): **95.6**  
Structural Grade: **0**  
O&M Grade: **2**  
Clock Start/From: **2**  
Clock To: **3**  
1st Value:  
2nd Value:  
Value Percent: **5.000**  
Continuous Index:  
Within 8" of Joint: **NO**  
Remarks:

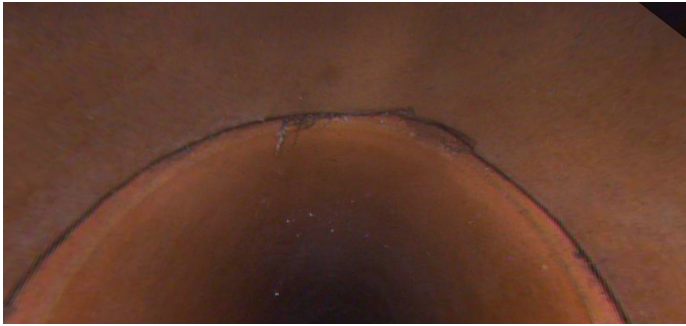
Code: **RFJ**  
Description: **Roots Fine Joint**

Distance (ft): **101.5**  
Structural Grade: **0**  
O&M Grade: **1**  
Clock Start/From: **12**  
Clock To:  
1st Value:  
2nd Value:  
Value Percent:  
Continuous Index:  
Within 8" of Joint: **YES**  
Remarks:

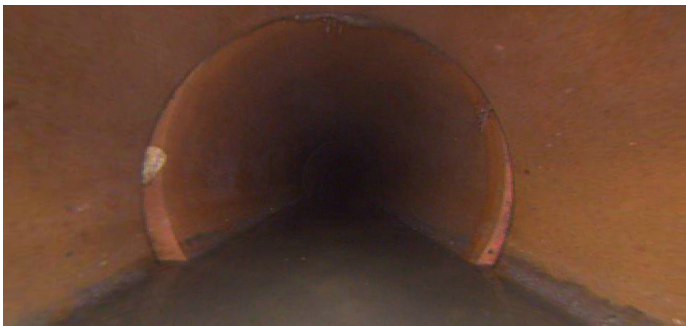
Code: **RFJ**  
Description: **Roots Fine Joint**

Distance (ft): **106.7**  
Structural Grade: **0**  
O&M Grade: **1**  
Clock Start/From: **12**  
Clock To: **3**  
1st Value:  
2nd Value:  
Value Percent:  
Continuous Index:  
Within 8" of Joint: **YES**  
Remarks:

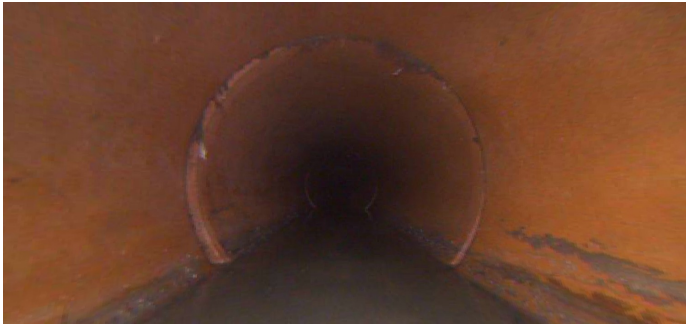
Code: **RFJ**  
Description: **Roots Fine Joint**

Distance (ft): **112.0**  
Structural Grade: **0**  
O&M Grade: **1**  
Clock Start/From: **9**  
Clock To: **2**  
1st Value:  
2nd Value:  
Value Percent:  
Continuous Index:  
Within 8" of Joint: **YES**  
Remarks:

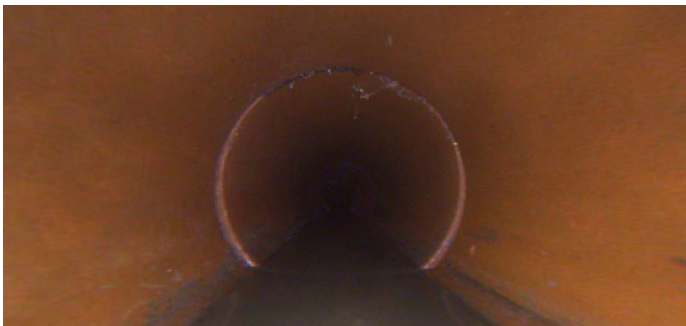
Code: **RFJ**  
Description: **Roots Fine Joint**

Distance (ft): **114.6**  
Structural Grade: **0**  
O&M Grade: **1**  
Clock Start/From: **11**  
Clock To: **1**  
1st Value:  
2nd Value:  
Value Percent:  
Continuous Index:  
Within 8" of Joint: **YES**  
Remarks:

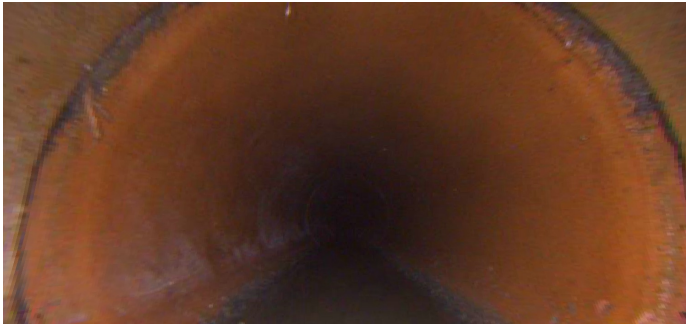
Code: **RFJ**  
Description: **Roots Fine Joint**

Distance (ft): **125.6**  
Structural Grade: **0**  
O&M Grade: **1**  
Clock Start/From: **10**  
Clock To: **2**  
1st Value:  
2nd Value:  
Value Percent:  
Continuous Index:  
Within 8" of Joint: **YES**  
Remarks:

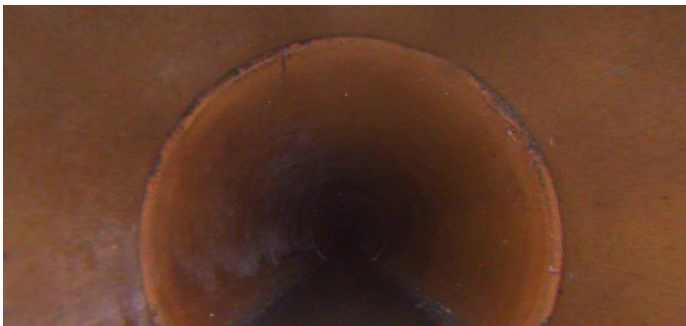
Code: **RFJ**  
Description: **Roots Fine Joint**

Distance (ft): **127.8**  
Structural Grade: **0**  
O&M Grade: **1**  
Clock Start/From: **10**  
Clock To: **2**  
1st Value:  
2nd Value:  
Value Percent:  
Continuous Index:  
Within 8" of Joint: **YES**  
Remarks:

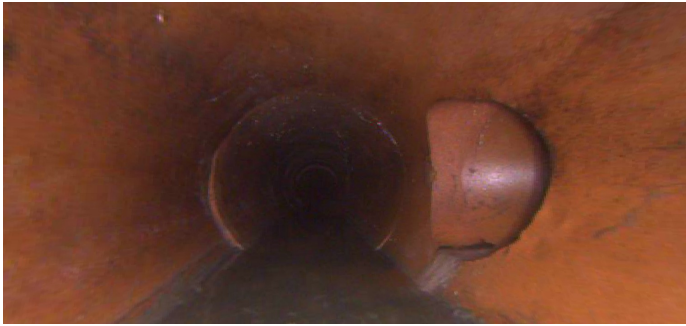
Code: **TF**  
Description: **Tap Factory**

Distance (ft): **135.6**  
Structural Grade: **0**  
O&M Grade: **0**  
Clock Start/From: **3**  
Clock To:  
1st Value: **4.000**  
2nd Value:  
Value Percent:  
Continuous Index:  
Within 8" of Joint:  
Remarks:

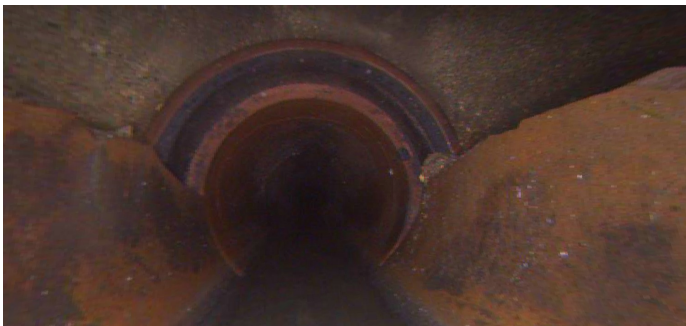
Code: **AMH**  
Description: **Manhole**

Distance (ft): **140.6**  
Structural Grade: **0**  
O&M Grade: **0**  
Clock Start/From:  
Clock To:  
1st Value:  
2nd Value:  
Value Percent:  
Continuous Index:  
Within 8" of Joint: **NO**  
Remarks: **M-903-017**

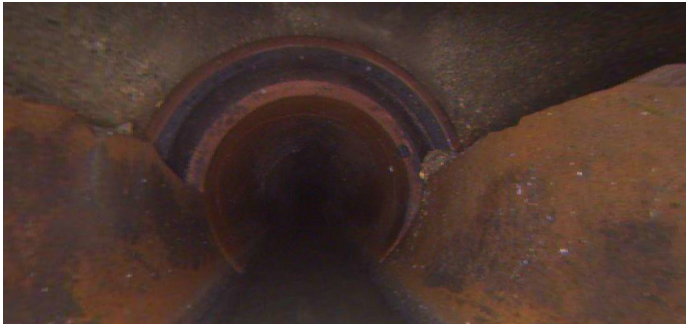
Code:	<b>DAGS</b>
Description:	<b>Deposits Attached Grease</b>
Distance (ft):	<b>140.6</b>
Structural Grade:	<b>0</b>
O&M Grade:	<b>2</b>
Clock Start/From:	<b>7</b>
Clock To:	<b>5</b>
1st Value:	
2nd Value:	
Value Percent:	<b>5.000</b>
Continuous Index:	<b>F01</b>
Within 8" of Joint:	<b>YES</b>
Remarks:	<b>WANDER</b>
