Profile/Photo Observation Report

Street:	E RAND ST	Flow Control:	Not Controlled
City:	Hobart, IN	Year Renewed:	
Location:	Other	Tape/Media #:	
Purpose:	Not Known	Dia/Height:	10"
Use:	Sanitary	Material:	PVC
Drain Area:	NA	Lining:	
Category:	NA		
Comment:

Location Details:		Direction of Survey:	Upstream
US MH:	M-903-017	DS MH:	M-903-018
		Total Length Surveyed (ft):	221.9

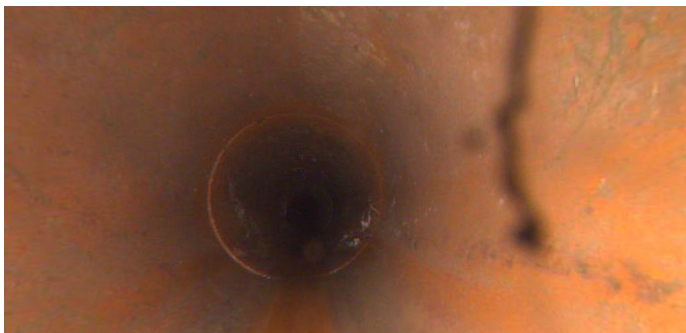
Code: **AMH**
Description: **Manhole**

Distance (ft): **.0**
Structural Grade: **0**
O&M Grade: **0**
Clock Start/From:
Clock To:
1st Value:
2nd Value:
Value Percent:
Continuous Index:
Within 8" of Joint: **NO**
Remarks: **M-903-018**

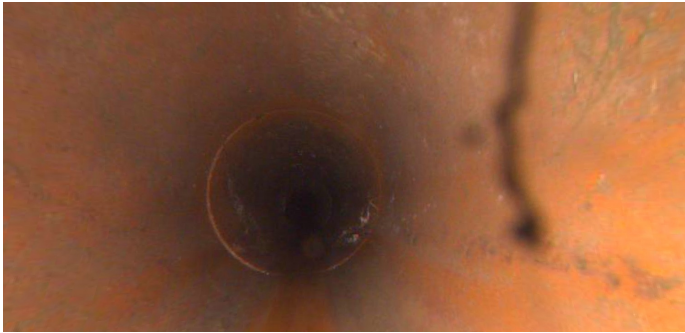
Code:	MWL
Description:	Water Level

Distance (ft):	.0
Structural Grade:	0
O&M Grade:	0
Clock Start/From:	
Clock To:	
1st Value:	
2nd Value:	
Value Percent:	5.000
Continuous Index:	
Within 8" of Joint:	NO
Remarks:

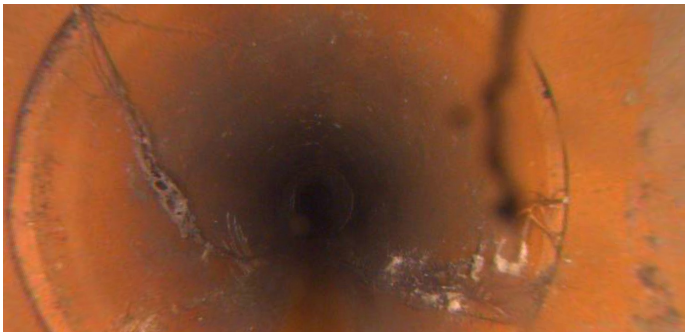
Code:	RFJ
Description:	Roots Fine Joint

Distance (ft):	2.2
Structural Grade:	0
O&M Grade:	1
Clock Start/From:	8
Clock To:	4
1st Value:	
2nd Value:	
Value Percent:	
Continuous Index:	S01
Within 8" of Joint:	YES
Remarks:

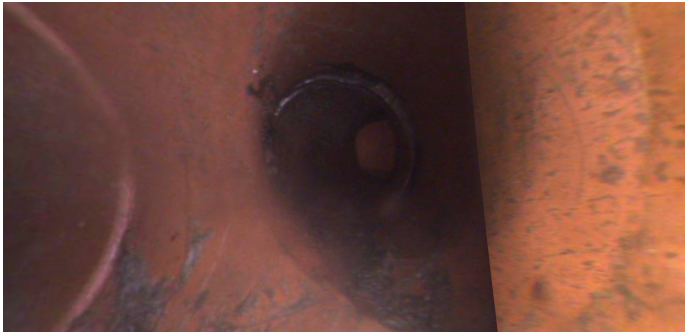
Code: **TF**
Description: **Tap Factory**

Distance (ft): **9.1**
Structural Grade: **0**
O&M Grade: **0**
Clock Start/From: **9**
Clock To:
1st Value: **4.000**
2nd Value:
Value Percent:
Continuous Index:
Within 8" of Joint:
Remarks:

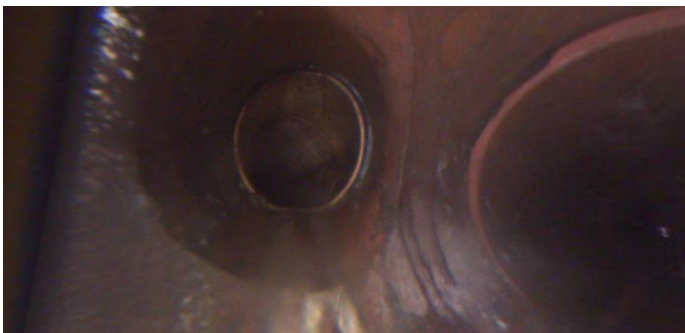
Code: **TF**
Description: **Tap Factory**

Distance (ft): **12.2**
Structural Grade: **0**
O&M Grade: **0**
Clock Start/From: **3**
Clock To:
1st Value: **4.000**
2nd Value:
Value Percent:
Continuous Index:
Within 8" of Joint:
Remarks:

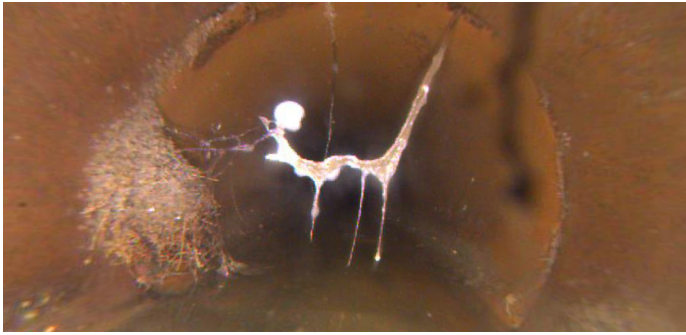
Code: **RMJ**
Description: **Roots Medium Joint**

Distance (ft): **34.3**
Structural Grade: **0**
O&M Grade: **3**
Clock Start/From: **8**
Clock To: **4**
1st Value:
2nd Value:
Value Percent: **10.000**
Continuous Index:
Within 8" of Joint: **YES**
Remarks:

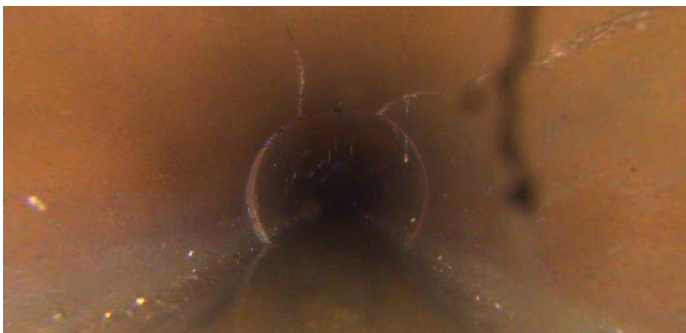
Code: **FM**
Description: **Fracture Multiple**

Distance (ft): **36.5**
Structural Grade: **4**
O&M Grade: **0**
Clock Start/From: **11**
Clock To: **1**
1st Value:
2nd Value:
Value Percent:
Continuous Index:
Within 8" of Joint: **YES**
Remarks:

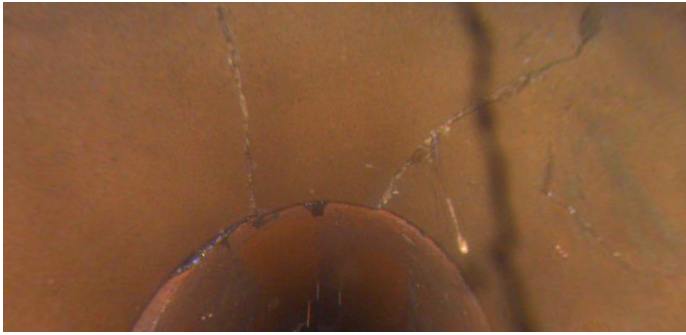
Code: **RFB**
Description: **Roots Fine Barrel**

Distance (ft): **36.8**
Structural Grade: **0**
O&M Grade: **2**
Clock Start/From: **1**
Clock To:
1st Value:
2nd Value:
Value Percent:
Continuous Index:
Within 8" of Joint: **NO**
Remarks:

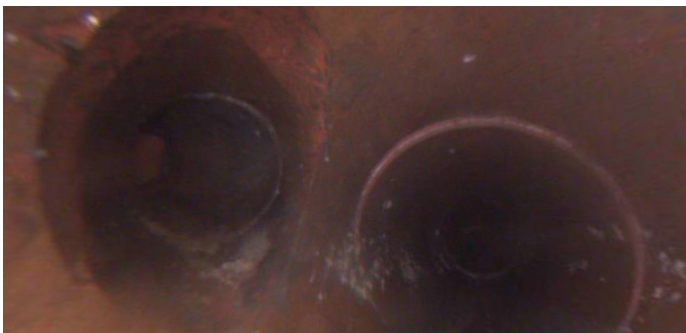
Code: **TF**
Description: **Tap Factory**

Distance (ft): **56.3**
Structural Grade: **0**
O&M Grade: **0**
Clock Start/From: **2**
Clock To:
1st Value: **4.000**
2nd Value:
Value Percent:
Continuous Index:
Within 8" of Joint:
Remarks:

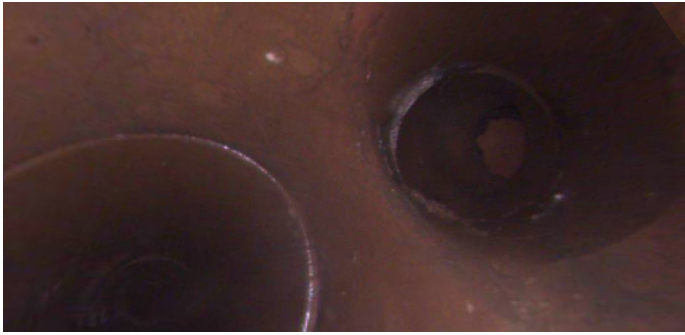
Code: **TF**
Description: **Tap Factory**

Distance (ft): **59.0**
Structural Grade: **0**
O&M Grade: **0**
Clock Start/From: **10**
Clock To:
1st Value: **4.000**
2nd Value:
Value Percent:
Continuous Index:
Within 8" of Joint:
Remarks:

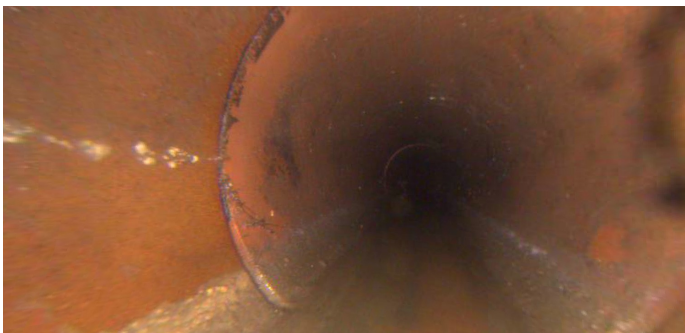
Code: **CL**
Description: **Crack Longitudinal**

Distance (ft): **63.5**
Structural Grade: **2**
O&M Grade: **0**
Clock Start/From: **9**
Clock To:
1st Value:
2nd Value:
Value Percent:
Continuous Index:
Within 8" of Joint: **YES**
Remarks:

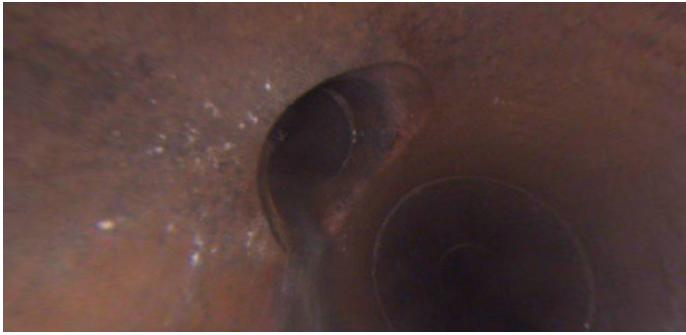
Code: **TF**
Description: **Tap Factory**

Distance (ft): **83.2**
Structural Grade: **0**
O&M Grade: **0**
Clock Start/From: **2**
Clock To:
1st Value: **4.000**
2nd Value:
Value Percent:
Continuous Index:
Within 8" of Joint:
Remarks:

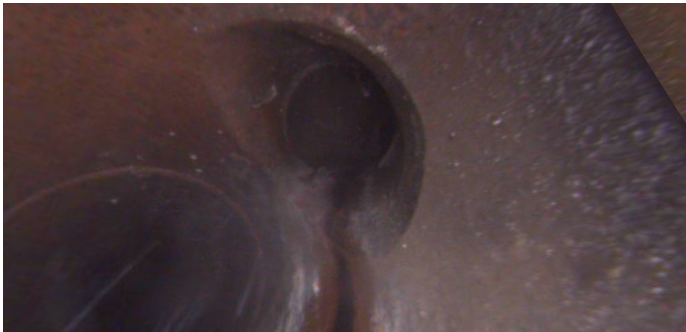
Code: **TFA**
Description: **Tap Factory Active**

Distance (ft): **91.9**
Structural Grade: **0**
O&M Grade: **0**
Clock Start/From: **10**
Clock To:
1st Value: **4.000**
2nd Value:
Value Percent:
Continuous Index:
Within 8" of Joint:
Remarks:

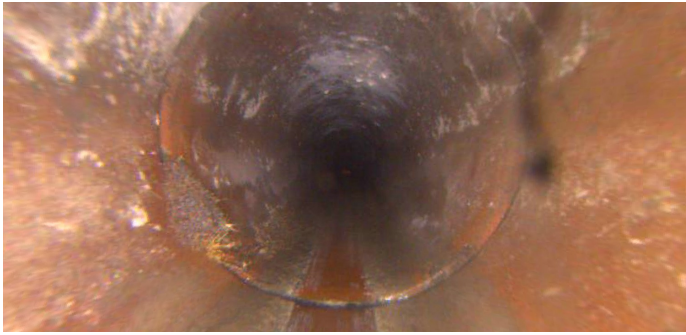
Code: **RMJ**
Description: **Roots Medium Joint**

Distance (ft): **101.8**
Structural Grade: **0**
O&M Grade: **3**
Clock Start/From: **8**
Clock To: **9**
1st Value:
2nd Value:
Value Percent: **5.000**
Continuous Index:
Within 8" of Joint: **YES**
Remarks:

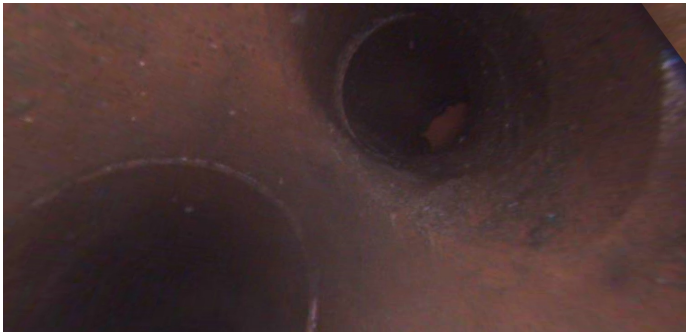
Code: **TF**
Description: **Tap Factory**

Distance (ft): **156.6**
Structural Grade: **0**
O&M Grade: **0**
Clock Start/From: **10**
Clock To:
1st Value: **4.000**
2nd Value:
Value Percent:
Continuous Index:
Within 8" of Joint:
Remarks:

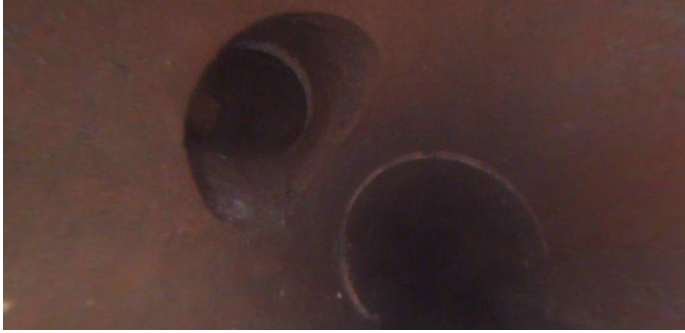
Code: **TF**
Description: **Tap Factory**

Distance (ft): **160.0**
Structural Grade: **0**
O&M Grade: **0**
Clock Start/From: **2**
Clock To:
1st Value: **4.000**
2nd Value:
Value Percent:
Continuous Index:
Within 8" of Joint:
Remarks:

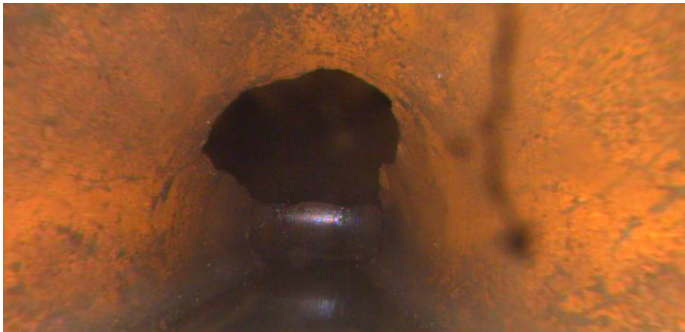
Code: **RFJ**
Description: **Roots Fine Joint**

Distance (ft): **219.3**
Structural Grade: **0**
O&M Grade: **1**
Clock Start/From: **8**
Clock To: **4**
1st Value:
2nd Value:
Value Percent:
Continuous Index: **F01**
Within 8" of Joint: **YES**
Remarks:

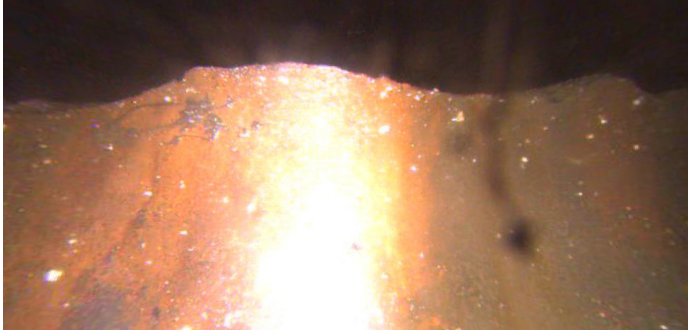
Code:	AMH
Description:	Manhole
Distance (ft):	221.9
Structural Grade:	0
O&M Grade:	0
Clock Start/From:	
Clock To:	
1st Value:	
2nd Value:	
Value Percent:	
Continuous Index:	
Within 8" of Joint:	NO
Remarks:	M-903-017
