## Profile/Photo Observation Report

Street:	<b>brandit st</b>	Flow Control:	<b>Not Controlled</b>
City:	<b>Hobart, IN</b>	Year Renewed:	
Location:	<b>Other</b>	Tape/Media #:	
Purpose:	<b>Not Known</b>	Dia/Height:	<b>10"</b>
Use:	<b>Sanitary</b>	Material:	<b>PVC</b>
Drain Area:	<b>NA</b>	Lining:	
Category:	<b>NA</b>		
Comment:

Location Details:		Direction of Survey:	<b>Upstream</b>
US MH:	<b>M-903-017</b>	DS MH:	<b>M-903-018</b>
		Total Length Surveyed (ft):	<b>221.9</b>

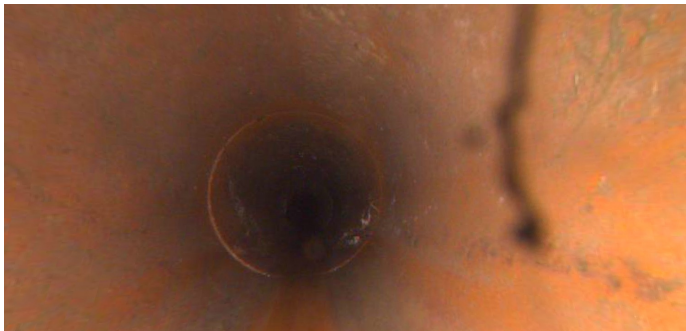
Code: **AMH**  
Description: **Manhole**

Distance (ft): **.0**  
Structural Grade: **0**  
O&M Grade: **0**  
Clock Start/From:  
Clock To:  
1st Value:  
2nd Value:  
Value Percent:  
Continuous Index:  
Within 8" of Joint: **NO**  
Remarks: **M-903-018**

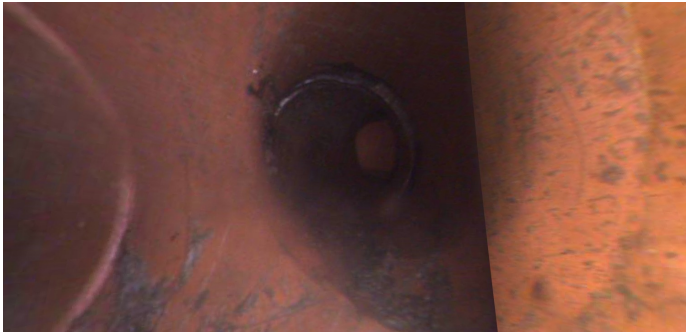
Code: **TF**  
Description: **Tap Factory**

Distance (ft): **9.1**  
Structural Grade: **0**  
O&M Grade: **0**  
Clock Start/From: **9**  
Clock To:  
1st Value: **4.000**  
2nd Value:  
Value Percent:  
Continuous Index:  
Within 8" of Joint:  
Remarks:

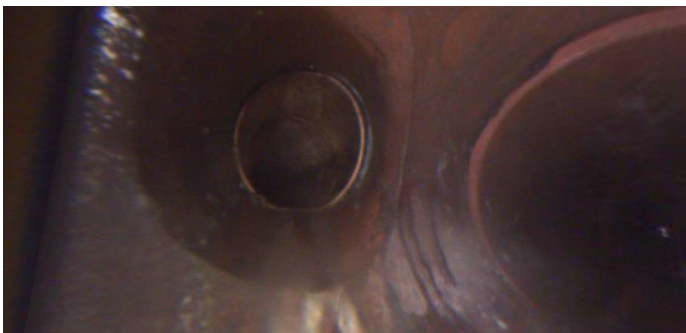
Code: **TF**  
Description: **Tap Factory**

Distance (ft): **12.2**  
Structural Grade: **0**  
O&M Grade: **0**  
Clock Start/From: **3**  
Clock To:  
1st Value: **4.000**  
2nd Value:  
Value Percent:  
Continuous Index:  
Within 8" of Joint:  
Remarks:

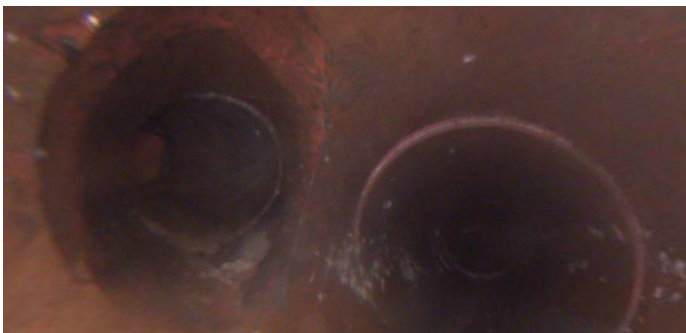
Code: **TF**  
Description: **Tap Factory**

Distance (ft): **56.3**  
Structural Grade: **0**  
O&M Grade: **0**  
Clock Start/From: **2**  
Clock To:  
1st Value: **4.000**  
2nd Value:  
Value Percent:  
Continuous Index:  
Within 8" of Joint:  
Remarks:

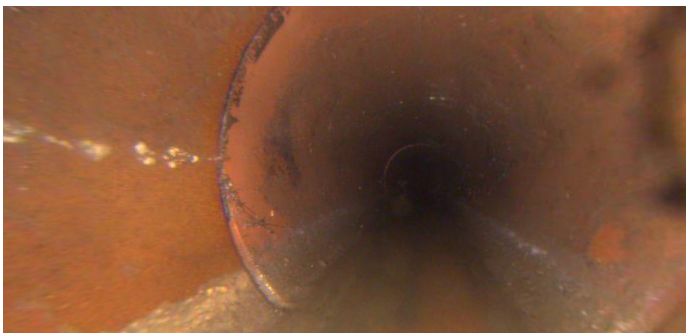
Code: **CL**  
Description: **Crack Longitudinal**

Distance (ft): **63.5**  
Structural Grade: **2**  
O&M Grade: **0**  
Clock Start/From: **9**  
Clock To:  
1st Value:  
2nd Value:  
Value Percent:  
Continuous Index:  
Within 8" of Joint: **YES**  
Remarks:

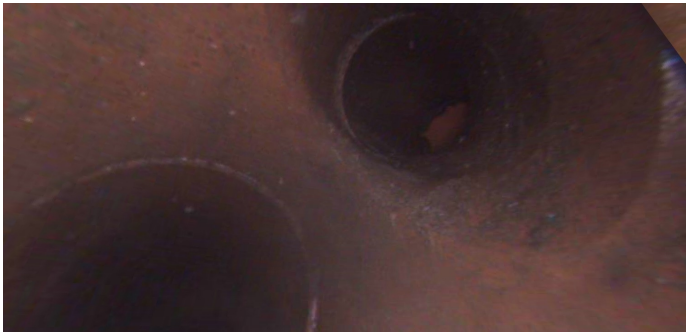
Code: **TF**  
Description: **Tap Factory**

Distance (ft): **156.6**  
Structural Grade: **0**  
O&M Grade: **0**  
Clock Start/From: **10**  
Clock To:  
1st Value: **4.000**  
2nd Value:  
Value Percent:  
Continuous Index:  
Within 8" of Joint:  
Remarks:

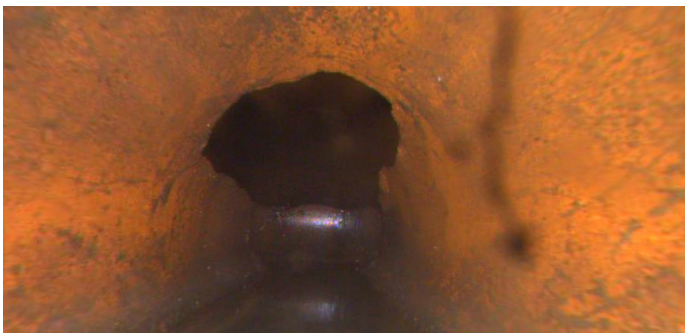
Code: **RFJ**  
Description: **Roots Fine Joint**

Distance (ft): **219.3**  
Structural Grade: **0**  
O&M Grade: **1**  
Clock Start/From: **8**  
Clock To: **4**  
1st Value:  
2nd Value:  
Value Percent:  
Continuous Index: **F01**  
Within 8" of Joint: **YES**  
Remarks:
