## Profile/Photo Observation Report

Street:	<b>brandit st</b>	Flow Control:	<b>Not Controlled</b>
City:	<b>Hobart, IN</b>	Year Renewed:	
Location:	<b>Other</b>	Tape/Media #:	
Purpose:	<b>Not Known</b>	Dia/Height:	<b>10"</b>
Use:	<b>Sanitary</b>	Material:	<b>VCP</b>
Drain Area:	<b>NA</b>	Lining:	
Category:	<b>NA</b>		
Comment:

Location Details:		Direction of Survey:	<b>Downstream</b>
US MH:	<b>M-903-018</b>	DS MH:	<b>M-903-019</b>
		Total Length Surveyed (ft):	<b>103.9</b>

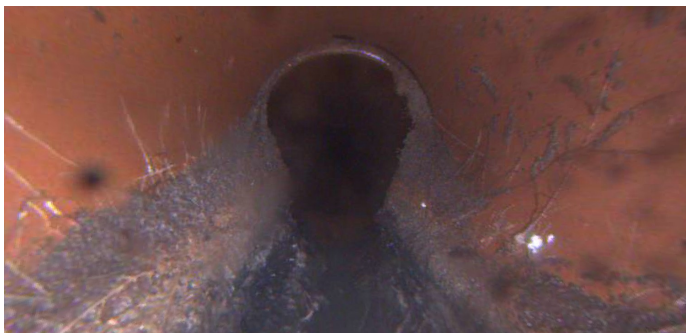
Code: **AMH**  
Description: **Manhole**

Distance (ft): **.0**  
Structural Grade: **0**  
O&M Grade: **0**  
Clock Start/From:  
Clock To:  
1st Value:  
2nd Value:  
Value Percent:  
Continuous Index:  
Within 8" of Joint: **NO**  
Remarks: **M-903-018**

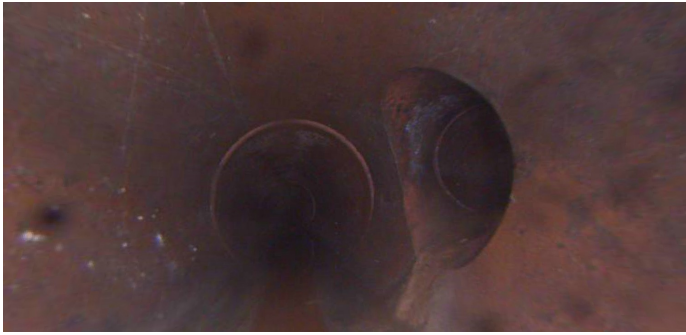
Code: **TFA**  
Description: **Tap Factory Active**

Distance (ft): **42.6**  
Structural Grade: **0**  
O&M Grade: **0**  
Clock Start/From: **3**  
Clock To:  
1st Value: **4.000**  
2nd Value:  
Value Percent:  
Continuous Index:  
Within 8" of Joint:  
Remarks:

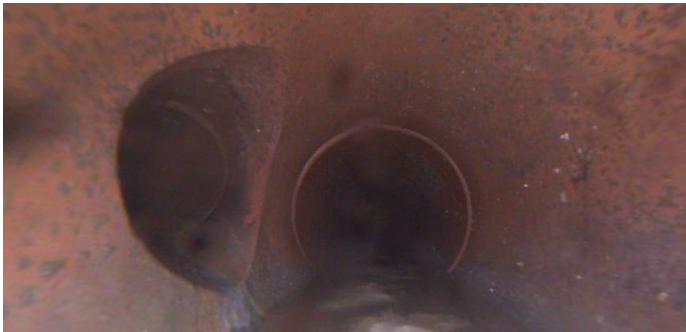
Code: **TF**  
Description: **Tap Factory**

Distance (ft): **48.8**  
Structural Grade: **0**  
O&M Grade: **0**  
Clock Start/From: **9**  
Clock To:  
1st Value: **4.000**  
2nd Value:  
Value Percent:  
Continuous Index:  
Within 8" of Joint:  
Remarks:

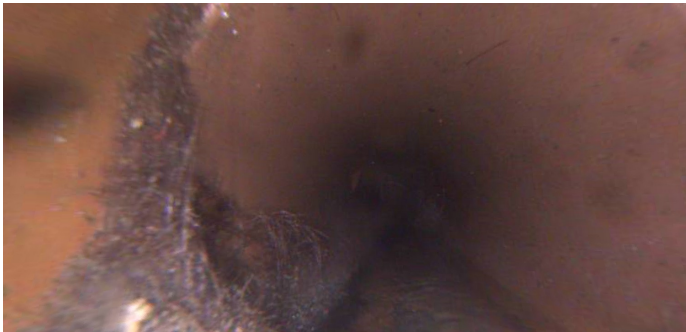
Code: **RMJ**  
Description: **Roots Medium Joint**

Distance (ft): **97.5**  
Structural Grade: **0**  
O&M Grade: **3**  
Clock Start/From: **7**  
Clock To: **11**  
1st Value:  
2nd Value:  
Value Percent: **10.000**  
Continuous Index:  
Within 8" of Joint: **YES**  
Remarks:

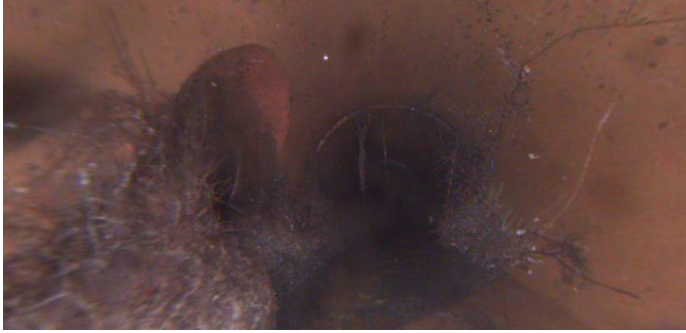
Code: **TFD**  
Description: **Tap Factory Defective**

Distance (ft): **99.4**  
Structural Grade: **0**  
O&M Grade: **2**  
Clock Start/From: **9**  
Clock To:  
1st Value: **4.000**  
2nd Value:  
Value Percent:  
Continuous Index:  
Within 8" of Joint:  
Remarks: **RML**

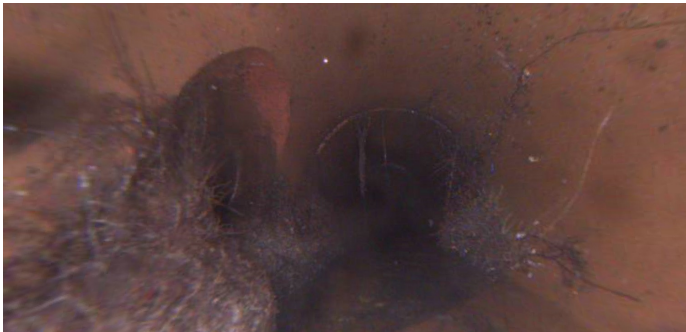
Code: **RML**  
Description: **Roots Medium Lateral**

Distance (ft): **99.4**  
Structural Grade: **0**  
O&M Grade: **3**  
Clock Start/From: **7**  
Clock To: **9**  
1st Value:  
2nd Value:  
Value Percent: **10.000**  
Continuous Index:  
Within 8" of Joint: **NO**  
Remarks:

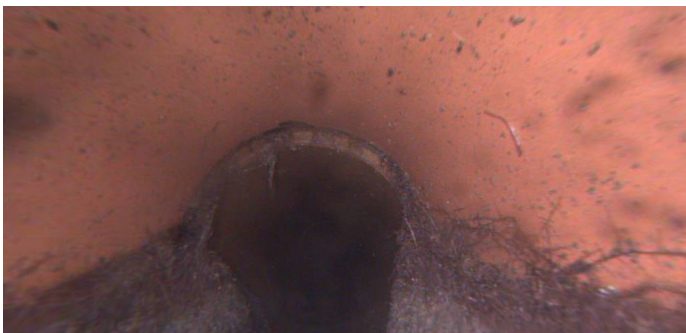
Code: **RMJ**  
Description: **Roots Medium Joint**

Distance (ft): **102.9**  
Structural Grade: **0**  
O&M Grade: **3**  
Clock Start/From: **8**  
Clock To: **4**  
1st Value:  
2nd Value:  
Value Percent: **20.000**  
Continuous Index:  
Within 8" of Joint: **YES**  
Remarks:

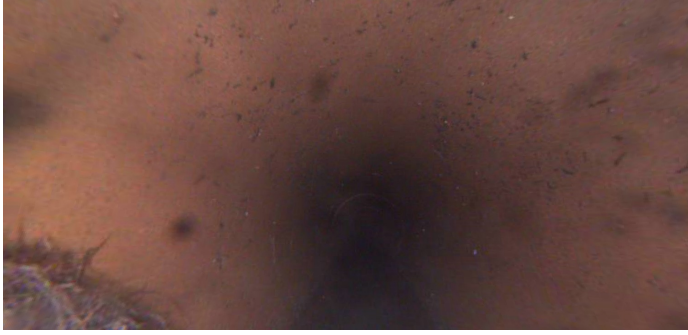
Code:	<b>MSA</b>
Description:	<b>Abandoned Survey</b>
Distance (ft):	<b>103.9</b>
Structural Grade:	<b>0</b>
O&M Grade:	<b>0</b>
Clock Start/From:	
Clock To:	
1st Value:	
2nd Value:	
Value Percent:	
Continuous Index:	
Within 8" of Joint:	<b>NO</b>
Remarks:	<b>ROOTS</b>
