## Profile/Photo Observation Report

Street:	<b>Rand St.</b>	Flow Control:	<b>Not Controlled</b>
City:	<b>Hobart, IN</b>	Year Renewed:	
Location:	<b>Light Highway</b>	Tape/Media #:	
Purpose:	<b>Routine Assessment</b>	Dia/Height:	<b>10"</b>
Use:	<b>Sanitary</b>	Material:	<b>VCP</b>
Drain Area:	<b>NA</b>	Lining:	
Category:	<b>NA</b>		
Comment:

Location Details:		Direction of Survey:	<b>Downstream</b>
US MH:	<b>M-903-018</b>	DS MH:	<b>M-903-019</b>
		Total Length Surveyed (ft):	<b>194.3</b>

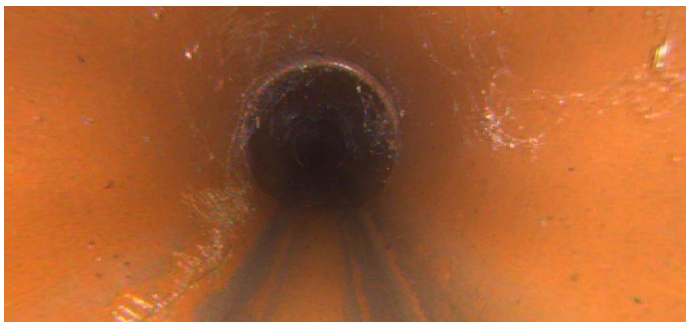
Code: **AMH**  
Description: **Manhole**

Distance (ft): **.0**  
Structural Grade: **0**  
O&M Grade: **0**  
Clock Start/From:  
Clock To:  
1st Value:  
2nd Value:  
Value Percent:  
Continuous Index:  
Within 8" of Joint: **NO**  
Remarks: **M-903-018**

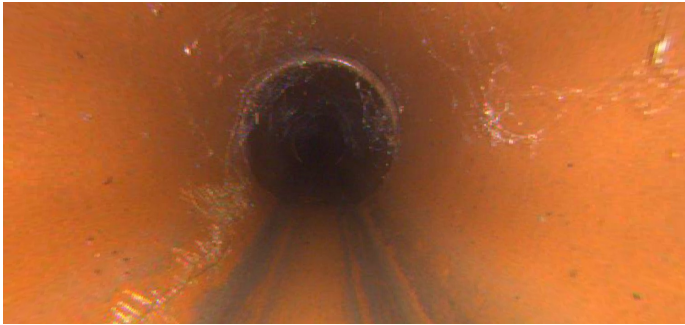
Code:	<b>MWL</b>
Description:	<b>Water Level</b>

Distance (ft):	<b>.0</b>
Structural Grade:	<b>0</b>
O&M Grade:	<b>0</b>
Clock Start/From:	
Clock To:	
1st Value:	
2nd Value:	
Value Percent:	<b>5.000</b>
Continuous Index:	
Within 8" of Joint:	<b>NO</b>
Remarks:

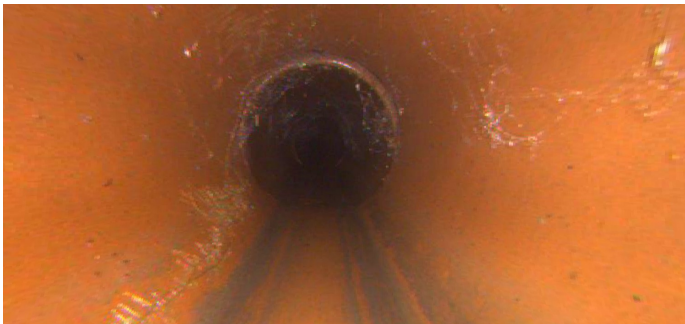
Code:	<b>RFB</b>
Description:	<b>Roots Fine Barrel</b>

Distance (ft):	<b>.0</b>
Structural Grade:	<b>0</b>
O&M Grade:	<b>2</b>
Clock Start/From:	<b>7</b>
Clock To:	
1st Value:	
2nd Value:	
Value Percent:	
Continuous Index:	
Within 8" of Joint:	<b>NO</b>
Remarks:

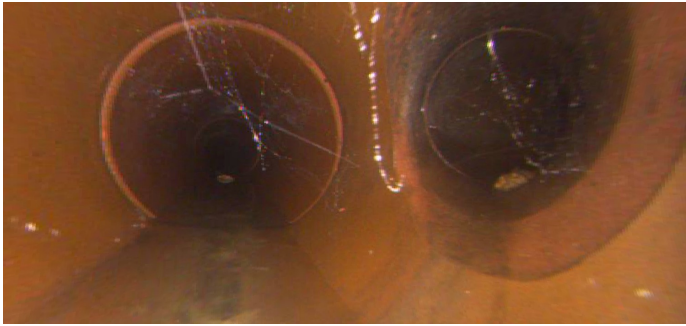
Code: **TF**  
Description: **Tap Factory**

Distance (ft): **42.5**  
Structural Grade: **0**  
O&M Grade: **0**  
Clock Start/From: **3**  
Clock To:  
1st Value: **4.000**  
2nd Value:  
Value Percent:  
Continuous Index:  
Within 8" of Joint:  
Remarks:

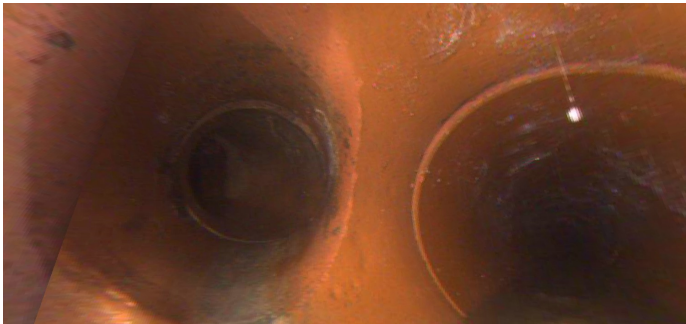
Code: **TF**  
Description: **Tap Factory**

Distance (ft): **48.5**  
Structural Grade: **0**  
O&M Grade: **0**  
Clock Start/From: **9**  
Clock To:  
1st Value: **4.000**  
2nd Value:  
Value Percent:  
Continuous Index:  
Within 8" of Joint:  
Remarks:

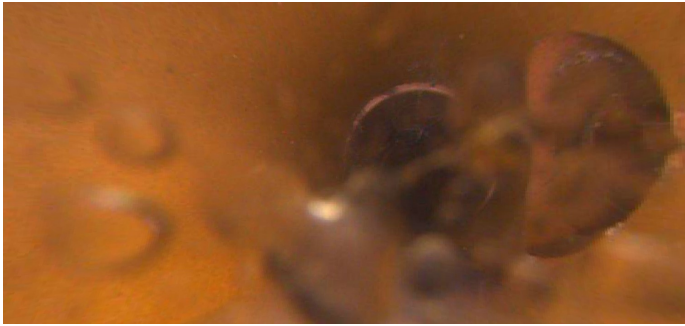
Code: **TF**  
Description: **Tap Factory**

Distance (ft): **95.0**  
Structural Grade: **0**  
O&M Grade: **0**  
Clock Start/From: **3**  
Clock To:  
1st Value: **4.000**  
2nd Value:  
Value Percent:  
Continuous Index:  
Within 8" of Joint:  
Remarks:

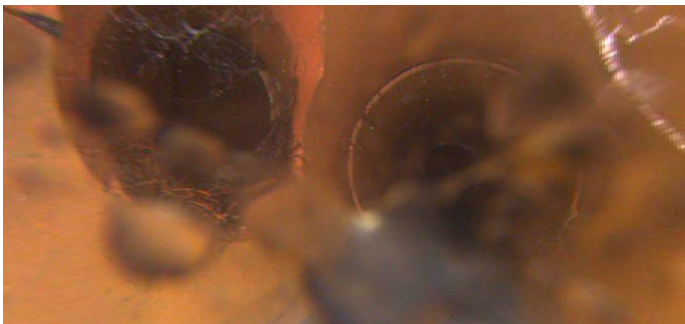
Code: **TFD**  
Description: **Tap Factory Defective**

Distance (ft): **98.3**  
Structural Grade: **0**  
O&M Grade: **2**  
Clock Start/From: **9**  
Clock To:  
1st Value: **4.000**  
2nd Value:  
Value Percent:  
Continuous Index:  
Within 8" of Joint:  
Remarks: **RF COMING FROM TAP**

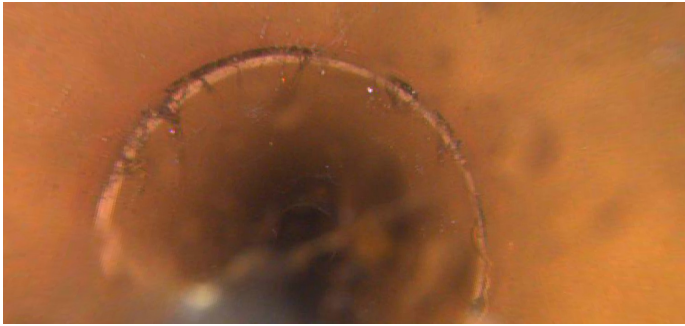
Code: **RFJ**  
Description: **Roots Fine Joint**

Distance (ft): **98.8**  
Structural Grade: **0**  
O&M Grade: **1**  
Clock Start/From: **10**  
Clock To: **5**  
1st Value:  
2nd Value:  
Value Percent:  
Continuous Index:  
Within 8" of Joint: **YES**  
Remarks:

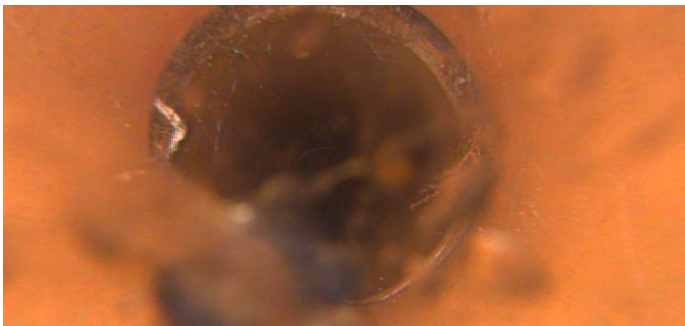
Code: **RFJ**  
Description: **Roots Fine Joint**

Distance (ft): **101.6**  
Structural Grade: **0**  
O&M Grade: **1**  
Clock Start/From: **7**  
Clock To: **5**  
1st Value:  
2nd Value:  
Value Percent:  
Continuous Index:  
Within 8" of Joint: **YES**  
Remarks:

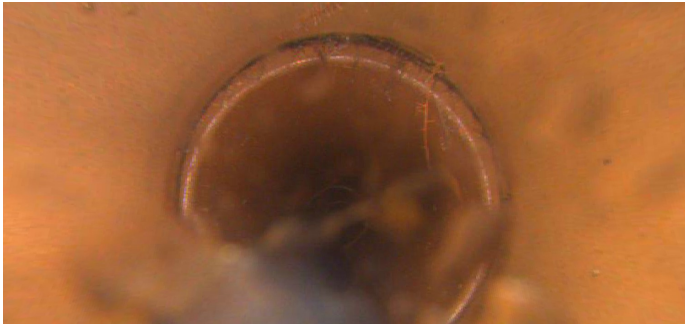
Code: **RFJ**  
Description: **Roots Fine Joint**

Distance (ft): **107.5**  
Structural Grade: **0**  
O&M Grade: **1**  
Clock Start/From: **10**  
Clock To: **3**  
1st Value:  
2nd Value:  
Value Percent:  
Continuous Index:  
Within 8" of Joint: **YES**  
Remarks:

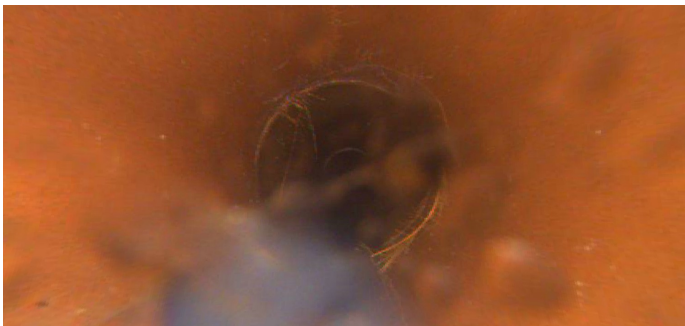
Code: **RFJ**  
Description: **Roots Fine Joint**

Distance (ft): **110.0**  
Structural Grade: **0**  
O&M Grade: **1**  
Clock Start/From: **10**  
Clock To: **5**  
1st Value:  
2nd Value:  
Value Percent:  
Continuous Index:  
Within 8" of Joint: **YES**  
Remarks:

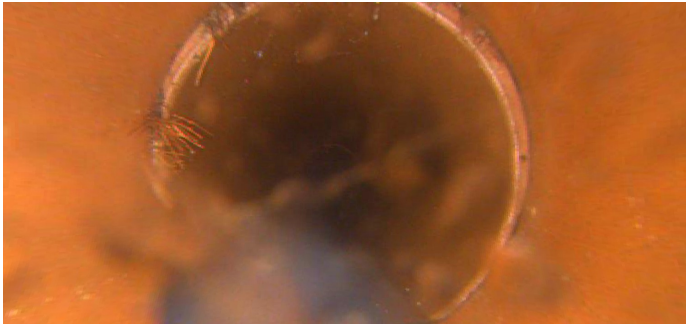
Code: **RFJ**  
Description: **Roots Fine Joint**

Distance (ft): **113.6**  
Structural Grade: **0**  
O&M Grade: **1**  
Clock Start/From: **9**  
Clock To: **1**  
1st Value:  
2nd Value:  
Value Percent:  
Continuous Index:  
Within 8" of Joint: **YES**  
Remarks:

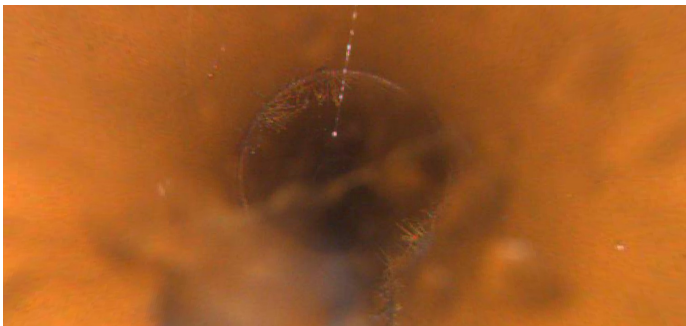
Code: **RFJ**  
Description: **Roots Fine Joint**

Distance (ft): **116.0**  
Structural Grade: **0**  
O&M Grade: **1**  
Clock Start/From: **10**  
Clock To: **5**  
1st Value:  
2nd Value:  
Value Percent:  
Continuous Index:  
Within 8" of Joint: **YES**  
Remarks:

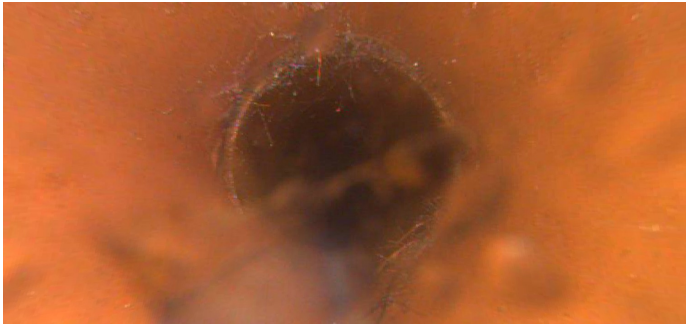
Code: **RFJ**  
Description: **Roots Fine Joint**

Distance (ft): **119.1**  
Structural Grade: **0**  
O&M Grade: **1**  
Clock Start/From: **7**  
Clock To: **5**  
1st Value:  
2nd Value:  
Value Percent:  
Continuous Index: **S01**  
Within 8" of Joint: **YES**  
Remarks: **WANDER**

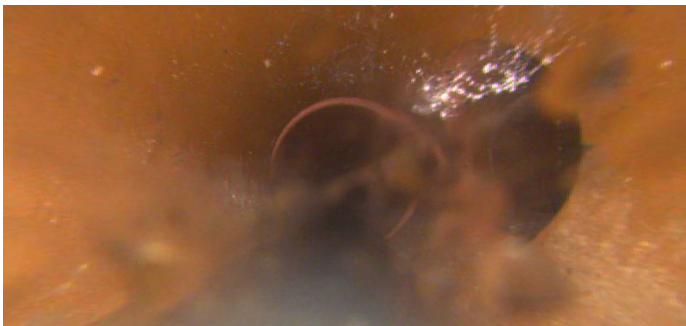
Code: **TF**  
Description: **Tap Factory**

Distance (ft): **156.7**  
Structural Grade: **0**  
O&M Grade: **0**  
Clock Start/From: **3**  
Clock To:  
1st Value: **4.000**  
2nd Value:  
Value Percent:  
Continuous Index:  
Within 8" of Joint:  
Remarks:

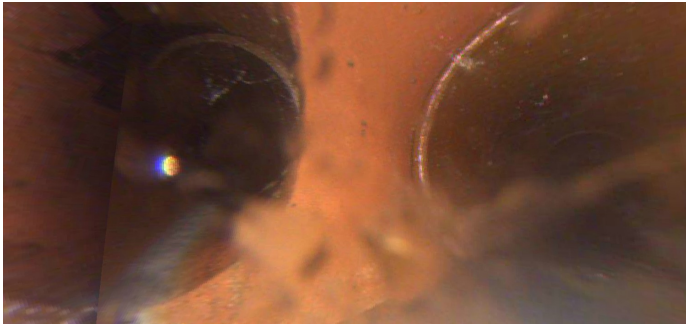
Code: **TF**  
Description: **Tap Factory**

Distance (ft): **160.4**  
Structural Grade: **0**  
O&M Grade: **0**  
Clock Start/From: **9**  
Clock To:  
1st Value: **4.000**  
2nd Value:  
Value Percent:  
Continuous Index:  
Within 8" of Joint:  
Remarks:

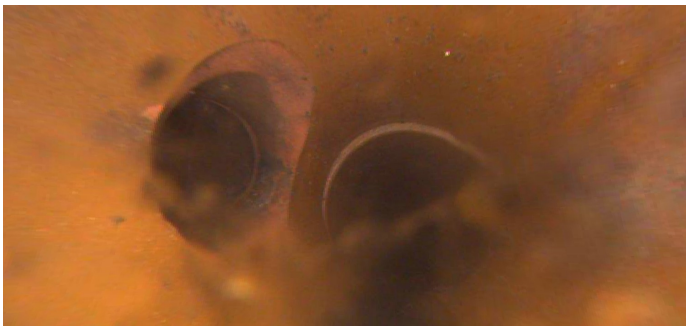
Code: **TF**  
Description: **Tap Factory**

Distance (ft): **186.3**  
Structural Grade: **0**  
O&M Grade: **0**  
Clock Start/From: **9**  
Clock To:  
1st Value: **4.000**  
2nd Value:  
Value Percent:  
Continuous Index:  
Within 8" of Joint:  
Remarks:

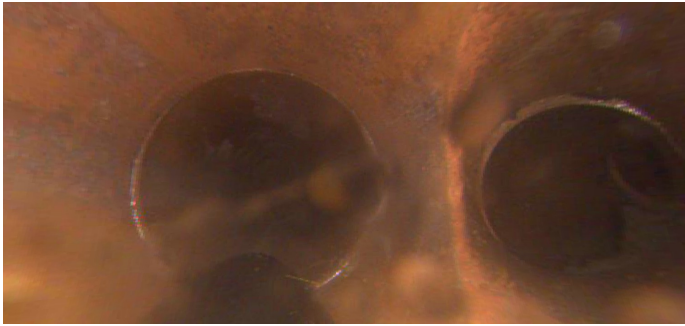
Code: **TF**  
Description: **Tap Factory**

Distance (ft): **189.5**  
Structural Grade: **0**  
O&M Grade: **0**  
Clock Start/From: **3**  
Clock To:  
1st Value: **4.000**  
2nd Value:  
Value Percent:  
Continuous Index:  
Within 8" of Joint:  
Remarks:

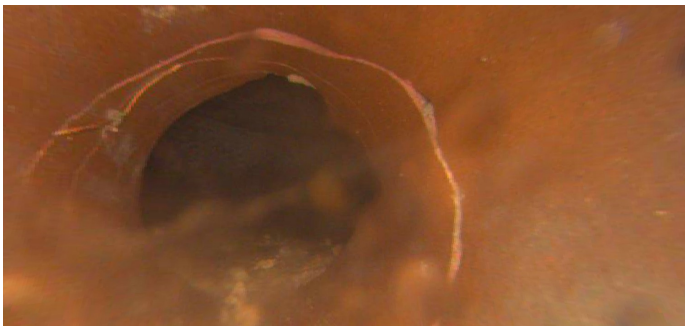
Code: **FM**  
Description: **Fracture Multiple**

Distance (ft): **192.3**  
Structural Grade: **4**  
O&M Grade: **0**  
Clock Start/From: **7**  
Clock To: **5**  
1st Value:  
2nd Value:  
Value Percent:  
Continuous Index:  
Within 8" of Joint: **YES**  
Remarks:

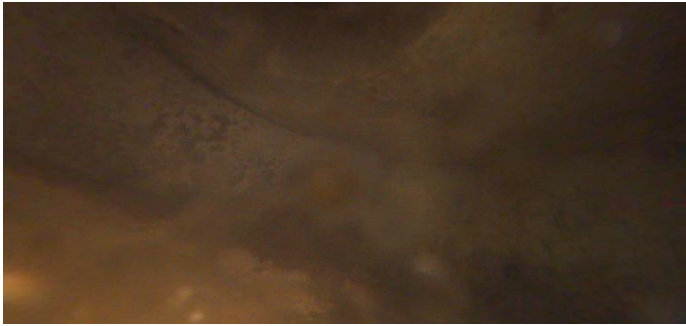
Code: **AMH**  
Description: **Manhole**

Distance (ft): **194.3**  
Structural Grade: **0**  
O&M Grade: **0**  
Clock Start/From:  
Clock To:  
1st Value:  
2nd Value:  
Value Percent:  
Continuous Index:  
Within 8" of Joint: **NO**  
Remarks: **M-903-019**

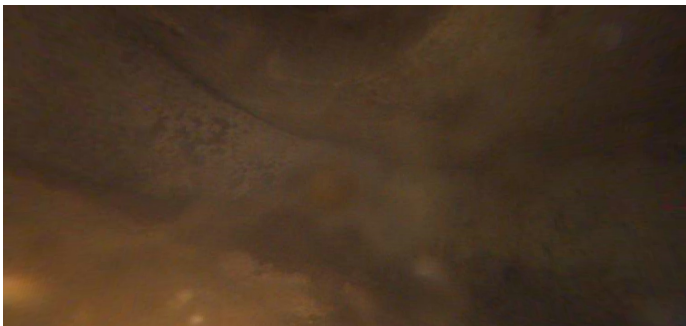
Code: **RFJ**  
Description: **Roots Fine Joint**

Distance (ft): **194.3**  
Structural Grade: **0**  
O&M Grade: **1**  
Clock Start/From: **7**  
Clock To: **5**  
1st Value:  
2nd Value:  
Value Percent:  
Continuous Index: **F01**  
Within 8" of Joint: **YES**  
Remarks: **WANDER**
