Profile/Photo Observation Report

Street:	E RAND ST	Flow Control:	Not Controlled
City:	Hobart, IN	Year Renewed:	
Location:	Other	Tape/Media #:	
Purpose:	Not Known	Dia/Height:	10"
Use:	Sanitary	Material:	PVC
Drain Area:	NA	Lining:	
Category:	NA		
Comment:

Location Details:		Direction of Survey:	Upstream
US MH:	M-903-021	DS MH:	M-903-022
		Total Length Surveyed (ft):	223.9

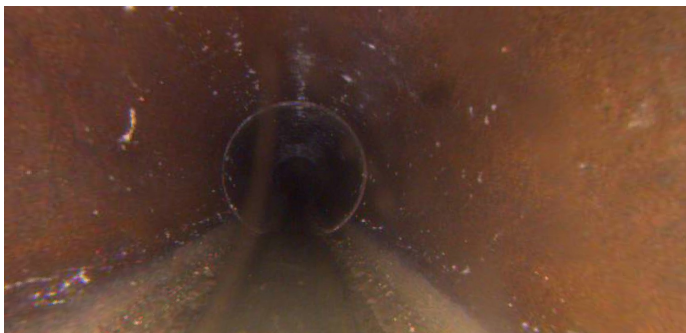
Code: **AMH**
Description: **Manhole**

Distance (ft): **.0**
Structural Grade: **0**
O&M Grade: **0**
Clock Start/From:
Clock To:
1st Value:
2nd Value:
Value Percent:
Continuous Index:
Within 8" of Joint: **NO**
Remarks: **M-903-022**

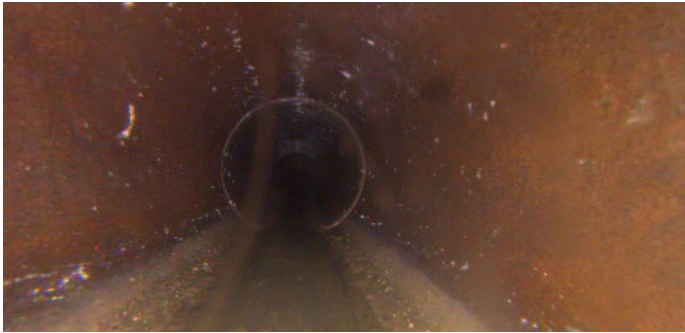
Code:	MWL
Description:	Water Level

Distance (ft):	.0
Structural Grade:	0
O&M Grade:	0
Clock Start/From:	
Clock To:	
1st Value:	
2nd Value:	
Value Percent:	5.000
Continuous Index:	
Within 8" of Joint:	NO
Remarks:

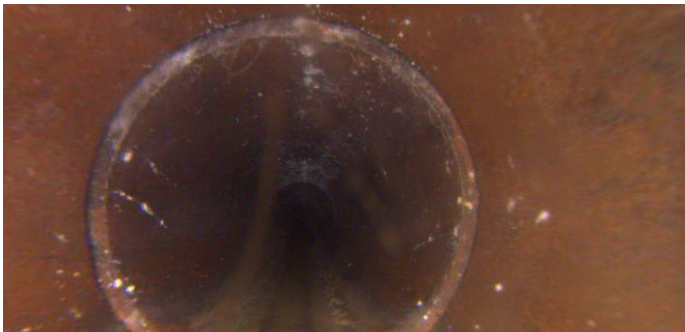
Code:	CM
Description:	Crack Multiple

Distance (ft):	2.3
Structural Grade:	3
O&M Grade:	0
Clock Start/From:	8
Clock To:	4
1st Value:	
2nd Value:	
Value Percent:	
Continuous Index:	
Within 8" of Joint:	YES
Remarks:

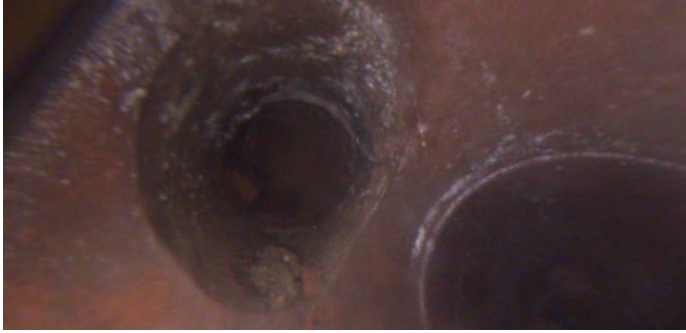
Code: **TF**
Description: **Tap Factory**

Distance (ft): **18.5**
Structural Grade: **0**
O&M Grade: **0**
Clock Start/From: **2**
Clock To:
1st Value: **4.000**
2nd Value:
Value Percent:
Continuous Index:
Within 8" of Joint:
Remarks:

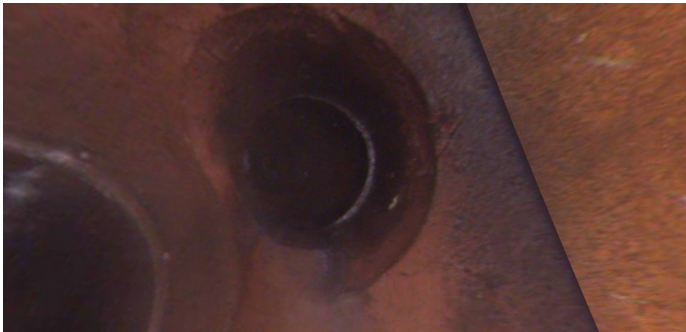
Code: **TF**
Description: **Tap Factory**

Distance (ft): **24.5**
Structural Grade: **0**
O&M Grade: **0**
Clock Start/From: **10**
Clock To:
1st Value: **4.000**
2nd Value:
Value Percent:
Continuous Index:
Within 8" of Joint:
Remarks:

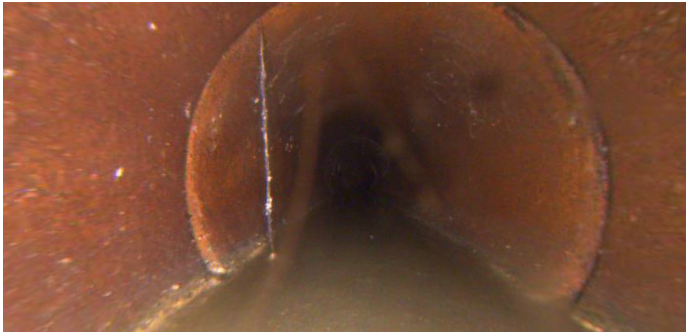
Code: **RFJ**
Description: **Roots Fine Joint**

Distance (ft): **52.4**
Structural Grade: **0**
O&M Grade: **1**
Clock Start/From: **11**
Clock To:
1st Value:
2nd Value:
Value Percent:
Continuous Index:
Within 8" of Joint: **YES**
Remarks:

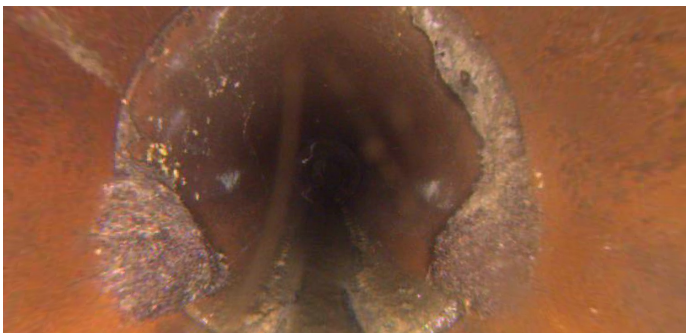
Code: **RMJ**
Description: **Roots Medium Joint**

Distance (ft): **58.4**
Structural Grade: **0**
O&M Grade: **3**
Clock Start/From: **8**
Clock To: **4**
1st Value:
2nd Value:
Value Percent: **10.000**
Continuous Index: **S01**
Within 8" of Joint: **YES**
Remarks:

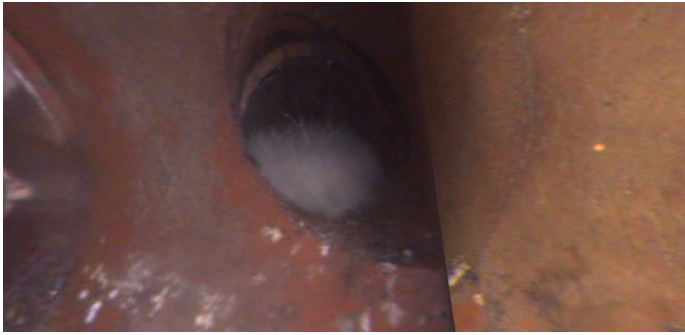
Code: **TF**
Description: **Tap Factory**

Distance (ft): **62.8**
Structural Grade: **0**
O&M Grade: **0**
Clock Start/From: **10**
Clock To:
1st Value: **4.000**
2nd Value:
Value Percent:
Continuous Index:
Within 8" of Joint:
Remarks:

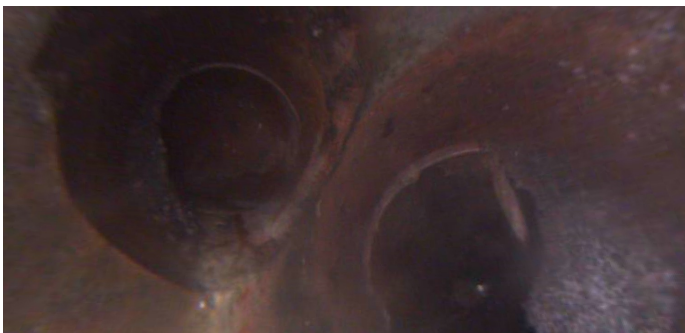
Code: **TF**
Description: **Tap Factory**

Distance (ft): **66.0**
Structural Grade: **0**
O&M Grade: **0**
Clock Start/From: **2**
Clock To:
1st Value: **4.000**
2nd Value:
Value Percent:
Continuous Index:
Within 8" of Joint:
Remarks:

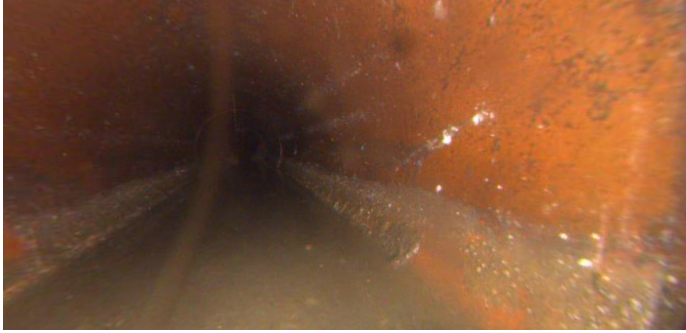
Code: **MWL**
Description: **Water Level**

Distance (ft): **85.6**
Structural Grade: **0**
O&M Grade: **0**
Clock Start/From:
Clock To:
1st Value:
2nd Value:
Value Percent: **20.000**
Continuous Index:
Within 8" of Joint: **NO**
Remarks:

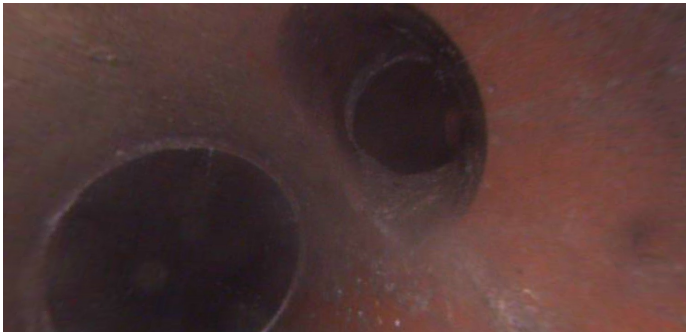
Code: **TF**
Description: **Tap Factory**

Distance (ft): **110.7**
Structural Grade: **0**
O&M Grade: **0**
Clock Start/From: **10**
Clock To:
1st Value: **4.000**
2nd Value:
Value Percent:
Continuous Index:
Within 8" of Joint:
Remarks:

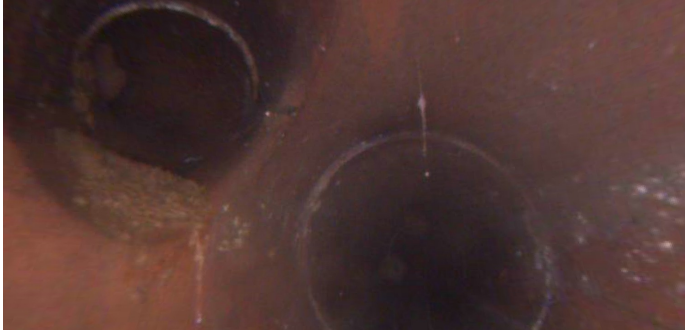
Code: **TF**
Description: **Tap Factory**

Distance (ft): **113.6**
Structural Grade: **0**
O&M Grade: **0**
Clock Start/From: **2**
Clock To:
1st Value: **4.000**
2nd Value:
Value Percent:
Continuous Index:
Within 8" of Joint:
Remarks:

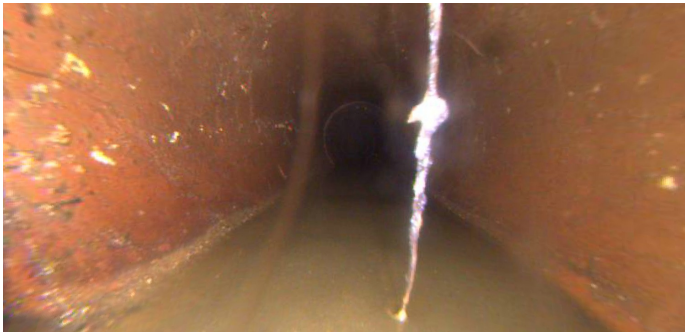
Code: **RMJ**
Description: **Roots Medium Joint**

Distance (ft): **121.2**
Structural Grade: **0**
O&M Grade: **3**
Clock Start/From: **8**
Clock To: **4**
1st Value:
2nd Value:
Value Percent: **10.000**
Continuous Index: **F01**
Within 8" of Joint: **YES**
Remarks:

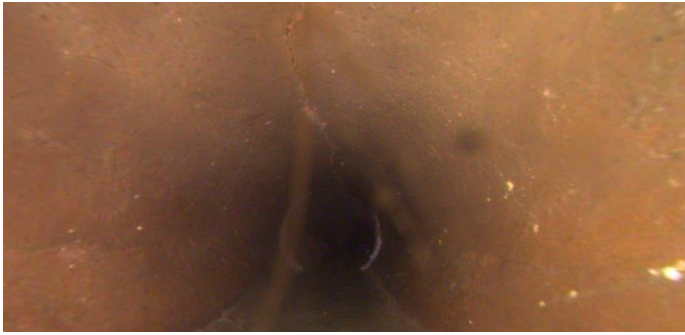
Code: **FL**
Description: **Fracture Longitudinal**

Distance (ft): **127.8**
Structural Grade: **3**
O&M Grade: **0**
Clock Start/From: **12**
Clock To:
1st Value:
2nd Value:
Value Percent:
Continuous Index:
Within 8" of Joint: **YES**
Remarks:

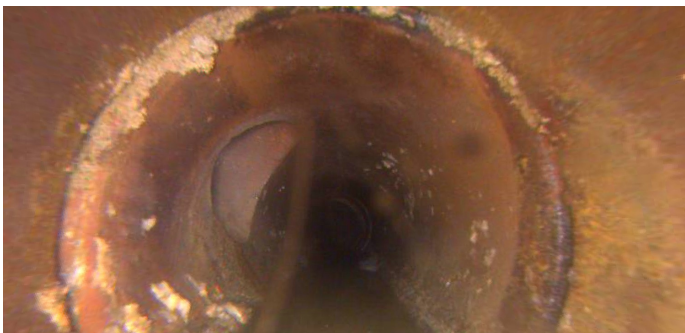
Code: **DAGS**
Description: **Deposits Attached Grease**

Distance (ft): **138.8**
Structural Grade: **0**
O&M Grade: **2**
Clock Start/From: **8**
Clock To: **4**
1st Value:
2nd Value:
Value Percent: **5.000**
Continuous Index:
Within 8" of Joint: **YES**
Remarks:

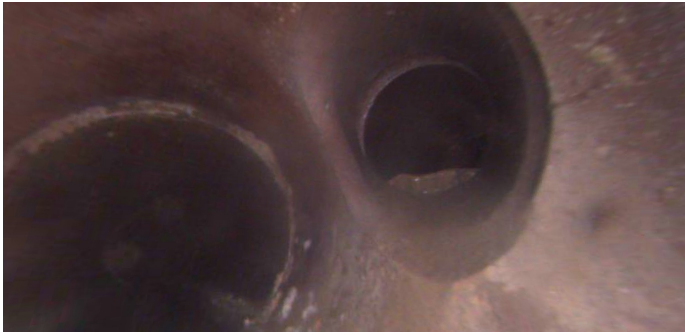
Code: **TF**
Description: **Tap Factory**

Distance (ft): **140.4**
Structural Grade: **0**
O&M Grade: **0**
Clock Start/From: **10**
Clock To:
1st Value: **4.000**
2nd Value:
Value Percent:
Continuous Index:
Within 8" of Joint:
Remarks:

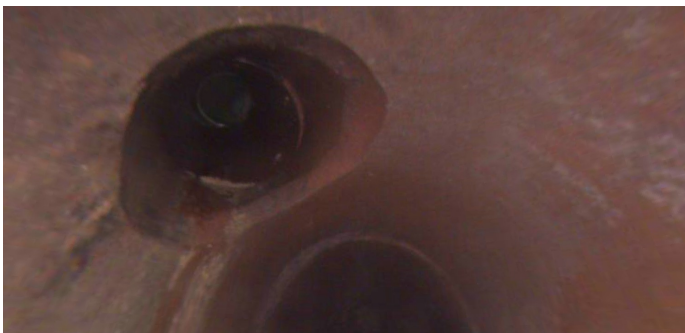
Code: **TF**
Description: **Tap Factory**

Distance (ft): **143.6**
Structural Grade: **0**
O&M Grade: **0**
Clock Start/From: **1**
Clock To:
1st Value: **4.000**
2nd Value:
Value Percent:
Continuous Index:
Within 8" of Joint:
Remarks:

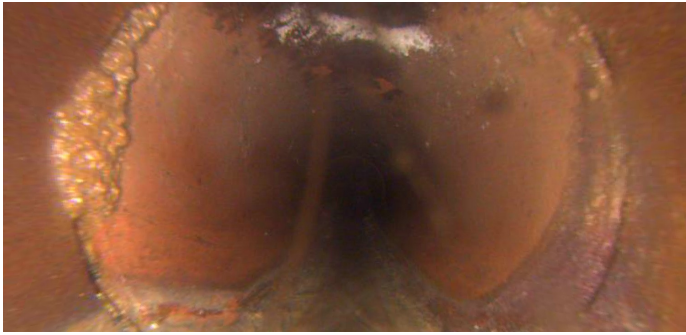
Code: **IW**
Description: **Infil Weeper**

Distance (ft): **153.8**
Structural Grade: **0**
O&M Grade: **2**
Clock Start/From: **8**
Clock To: **4**
1st Value:
2nd Value:
Value Percent:
Continuous Index:
Within 8" of Joint: **YES**
Remarks:

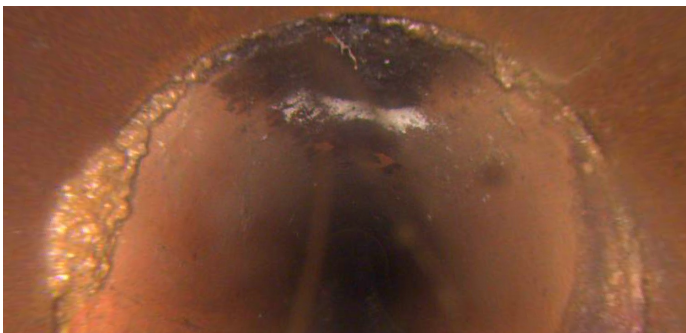
Code: **RFJ**
Description: **Roots Fine Joint**

Distance (ft): **153.8**
Structural Grade: **0**
O&M Grade: **1**
Clock Start/From: **12**
Clock To:
1st Value:
2nd Value:
Value Percent:
Continuous Index:
Within 8" of Joint: **YES**
Remarks:

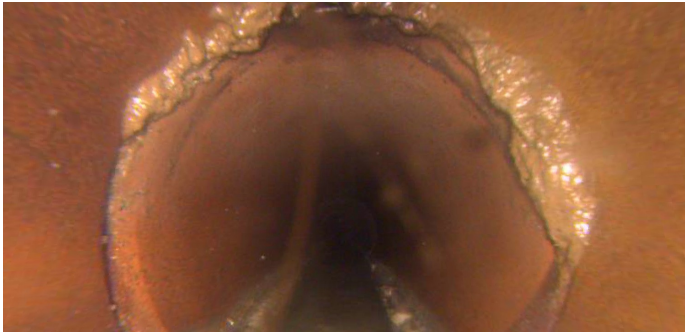
Code: **DAGS**
Description: **Deposits Attached Grease**

Distance (ft): **165.7**
Structural Grade: **0**
O&M Grade: **2**
Clock Start/From: **8**
Clock To: **4**
1st Value:
2nd Value:
Value Percent: **5.000**
Continuous Index:
Within 8" of Joint: **YES**
Remarks:

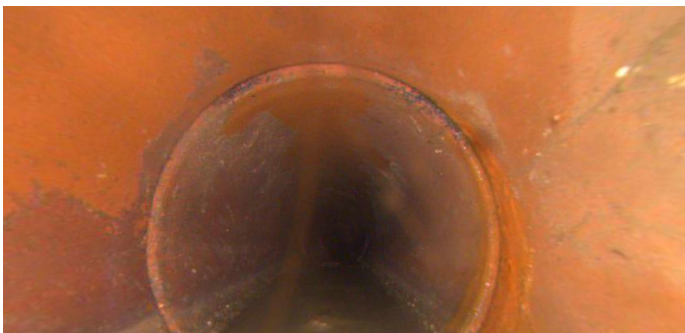
Code: **IW**
Description: **Infil Weeper**

Distance (ft): **198.5**
Structural Grade: **0**
O&M Grade: **2**
Clock Start/From: **2**
Clock To: **4**
1st Value:
2nd Value:
Value Percent:
Continuous Index:
Within 8" of Joint: **YES**
Remarks:

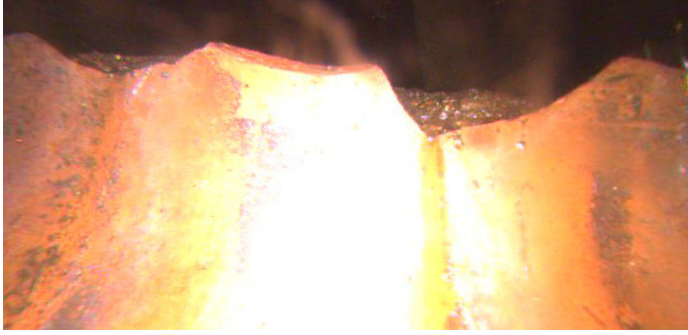
Code:	AMH
Description:	Manhole
Distance (ft):	223.9
Structural Grade:	0
O&M Grade:	0
Clock Start/From:	
Clock To:	
1st Value:	
2nd Value:	
Value Percent:	
Continuous Index:	
Within 8" of Joint:	NO
Remarks:	M-903-021
