## Profile/Photo Observation Report

Street:	<b>brandit st</b>	Flow Control:	<b>Not Controlled</b>
City:	<b>Hobart, IN</b>	Year Renewed:	
Location:	<b>Other</b>	Tape/Media #:	
Purpose:	<b>Not Known</b>	Dia/Height:	<b>10"</b>
Use:	<b>Sanitary</b>	Material:	<b>PVC</b>
Drain Area:	<b>NA</b>	Lining:	
Category:	<b>NA</b>		
Comment:

Location Details:		Direction of Survey:	<b>Upstream</b>
US MH:	<b>M-903-021</b>	DS MH:	<b>M-903-022</b>
		Total Length Surveyed (ft):	<b>223.9</b>

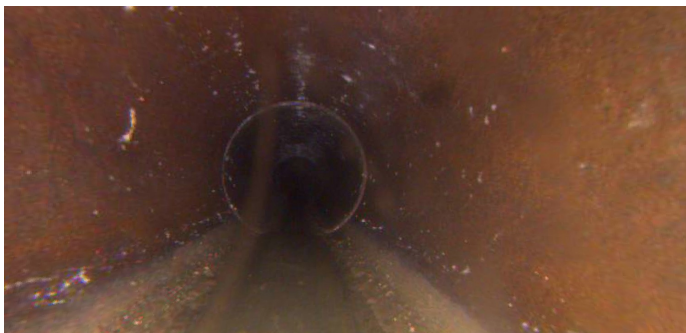
Code: **AMH**  
Description: **Manhole**

Distance (ft): **.0**  
Structural Grade: **0**  
O&M Grade: **0**  
Clock Start/From:  
Clock To:  
1st Value:  
2nd Value:  
Value Percent:  
Continuous Index:  
Within 8" of Joint: **NO**  
Remarks: **M-903-022**

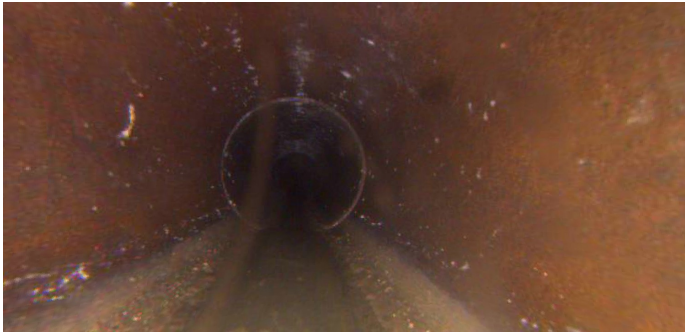
Code:	<b>MWL</b>
Description:	<b>Water Level</b>

Distance (ft):	<b>.0</b>
Structural Grade:	<b>0</b>
O&M Grade:	<b>0</b>
Clock Start/From:	
Clock To:	
1st Value:	
2nd Value:	
Value Percent:	<b>5.000</b>
Continuous Index:	
Within 8" of Joint:	<b>NO</b>
Remarks:

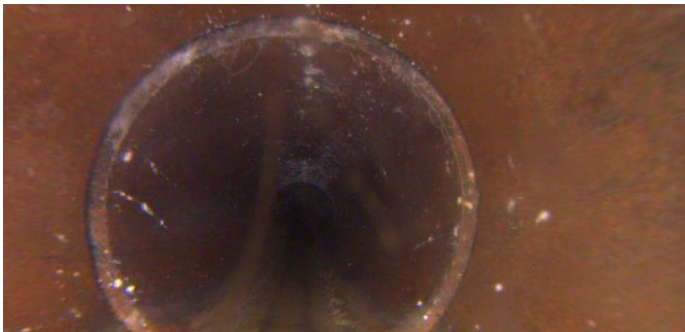
Code:	<b>CM</b>
Description:	<b>Crack Multiple</b>

Distance (ft):	<b>2.3</b>
Structural Grade:	<b>3</b>
O&M Grade:	<b>0</b>
Clock Start/From:	<b>8</b>
Clock To:	<b>4</b>
1st Value:	
2nd Value:	
Value Percent:	
Continuous Index:	
Within 8" of Joint:	<b>YES</b>
Remarks:

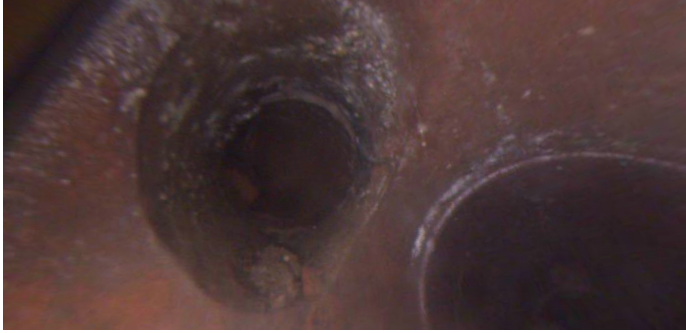
Code: **TF**  
Description: **Tap Factory**

Distance (ft): **18.5**  
Structural Grade: **0**  
O&M Grade: **0**  
Clock Start/From: **2**  
Clock To:  
1st Value: **4.000**  
2nd Value:  
Value Percent:  
Continuous Index:  
Within 8" of Joint:  
Remarks:

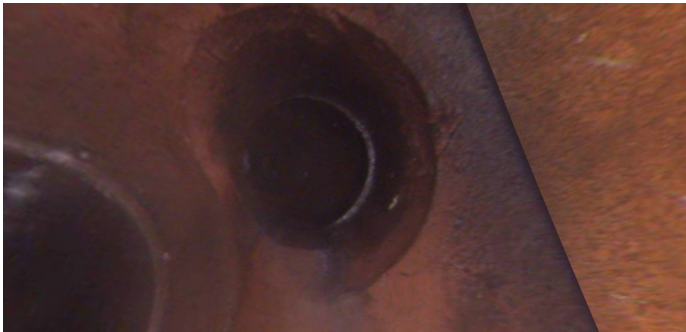
Code: **TF**  
Description: **Tap Factory**

Distance (ft): **24.5**  
Structural Grade: **0**  
O&M Grade: **0**  
Clock Start/From: **10**  
Clock To:  
1st Value: **4.000**  
2nd Value:  
Value Percent:  
Continuous Index:  
Within 8" of Joint:  
Remarks:

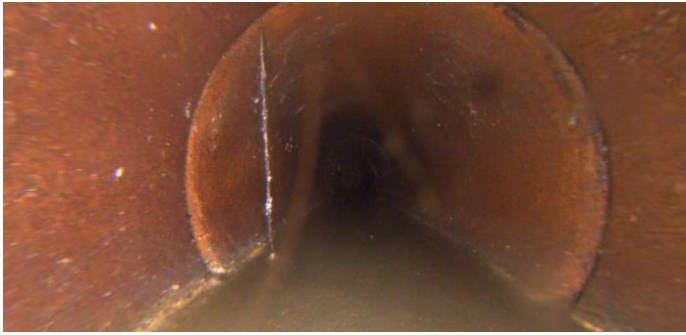
Code: **RFJ**  
Description: **Roots Fine Joint**

Distance (ft): **52.4**  
Structural Grade: **0**  
O&M Grade: **1**  
Clock Start/From: **11**  
Clock To:  
1st Value:  
2nd Value:  
Value Percent:  
Continuous Index:  
Within 8" of Joint: **YES**  
Remarks:

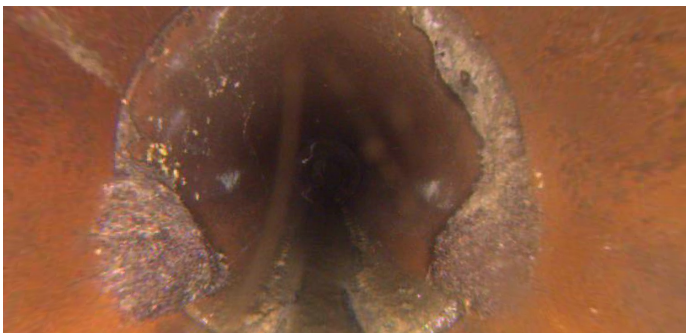
Code: **RMJ**  
Description: **Roots Medium Joint**

Distance (ft): **58.4**  
Structural Grade: **0**  
O&M Grade: **3**  
Clock Start/From: **8**  
Clock To: **4**  
1st Value:  
2nd Value:  
Value Percent: **10.000**  
Continuous Index: **S01**  
Within 8" of Joint: **YES**  
Remarks:

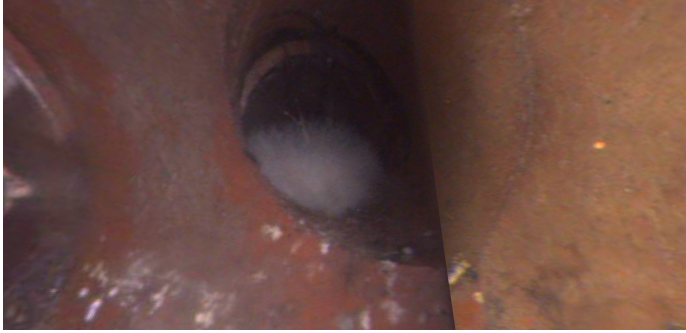
Code: **TF**  
Description: **Tap Factory**

Distance (ft): **62.8**  
Structural Grade: **0**  
O&M Grade: **0**  
Clock Start/From: **10**  
Clock To:  
1st Value: **4.000**  
2nd Value:  
Value Percent:  
Continuous Index:  
Within 8" of Joint:  
Remarks:

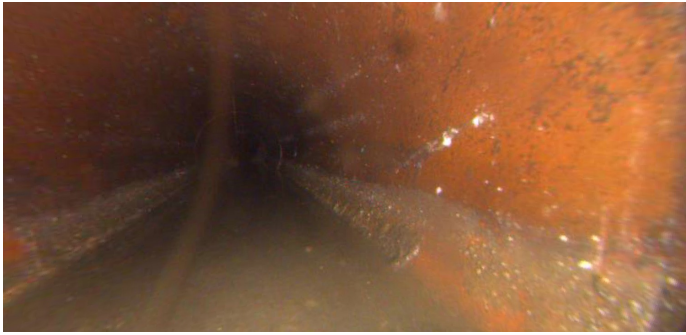
Code: **MWL**  
Description: **Water Level**

Distance (ft): **85.6**  
Structural Grade: **0**  
O&M Grade: **0**  
Clock Start/From:  
Clock To:  
1st Value:  
2nd Value:  
Value Percent: **20.000**  
Continuous Index:  
Within 8" of Joint: **NO**  
Remarks:

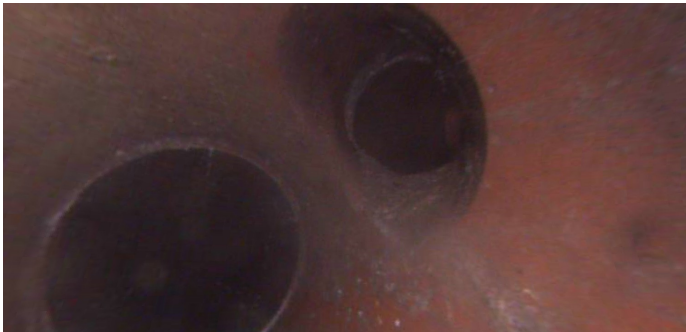
Code: **TF**  
Description: **Tap Factory**

Distance (ft): **110.7**  
Structural Grade: **0**  
O&M Grade: **0**  
Clock Start/From: **10**  
Clock To:  
1st Value: **4.000**  
2nd Value:  
Value Percent:  
Continuous Index:  
Within 8" of Joint:  
Remarks:

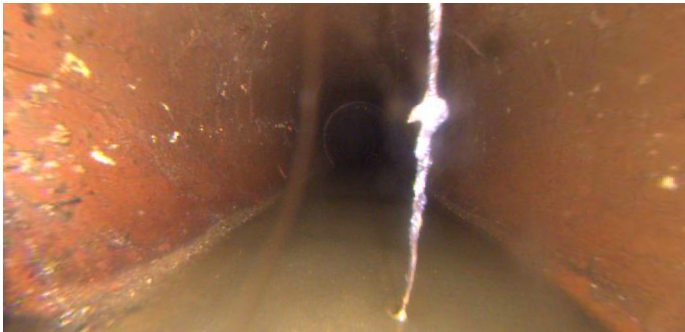
Code: **RMJ**  
Description: **Roots Medium Joint**

Distance (ft): **121.2**  
Structural Grade: **0**  
O&M Grade: **3**  
Clock Start/From: **8**  
Clock To: **4**  
1st Value:  
2nd Value:  
Value Percent: **10.000**  
Continuous Index: **F01**  
Within 8" of Joint: **YES**  
Remarks:

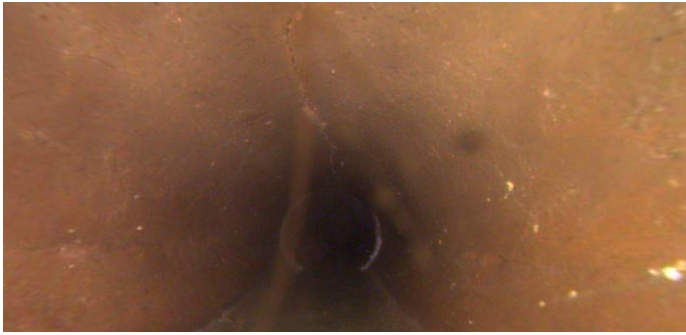
Code: **FL**  
Description: **Fracture Longitudinal**

Distance (ft): **127.8**  
Structural Grade: **3**  
O&M Grade: **0**  
Clock Start/From: **12**  
Clock To:  
1st Value:  
2nd Value:  
Value Percent:  
Continuous Index:  
Within 8" of Joint: **YES**  
Remarks:

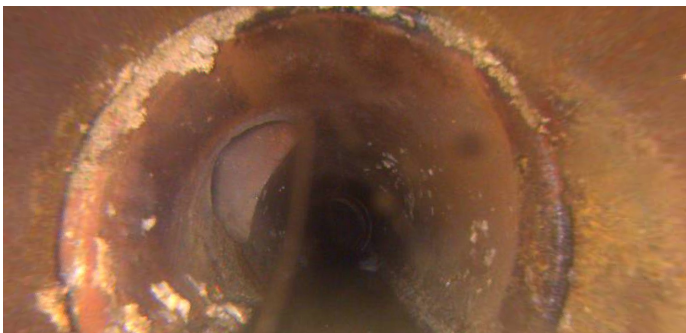
Code: **DAGS**  
Description: **Deposits Attached Grease**

Distance (ft): **138.8**  
Structural Grade: **0**  
O&M Grade: **2**  
Clock Start/From: **8**  
Clock To: **4**  
1st Value:  
2nd Value:  
Value Percent: **5.000**  
Continuous Index:  
Within 8" of Joint: **YES**  
Remarks:

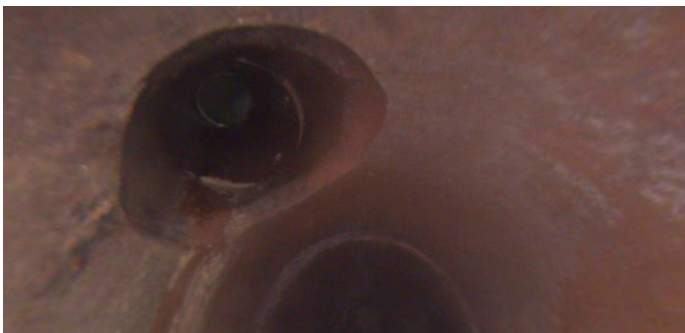
Code: **TF**  
Description: **Tap Factory**

Distance (ft): **143.6**  
Structural Grade: **0**  
O&M Grade: **0**  
Clock Start/From: **1**  
Clock To:  
1st Value: **4.000**  
2nd Value:  
Value Percent:  
Continuous Index:  
Within 8" of Joint:  
Remarks:

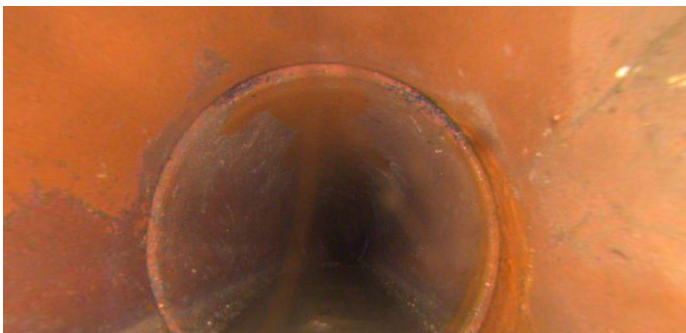
Code: **IW**  
Description: **Infil Weeper**

Distance (ft): **198.5**  
Structural Grade: **0**  
O&M Grade: **2**  
Clock Start/From: **2**  
Clock To: **4**  
1st Value:  
2nd Value:  
Value Percent:  
Continuous Index:  
Within 8" of Joint: **YES**  
Remarks:

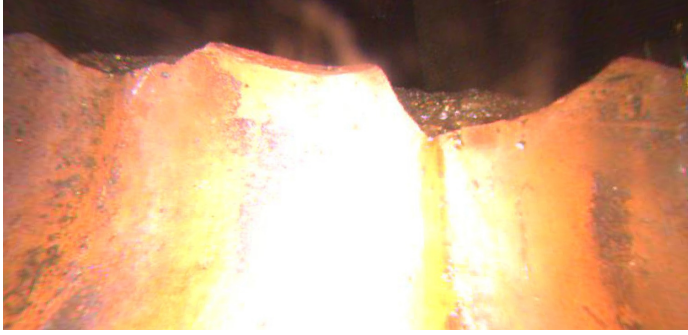
Code:	AMH
Description:	Manhole
Distance (ft):	223.9
Structural Grade:	0
O&M Grade:	0
Clock Start/From:	
Clock To:	
1st Value:	
2nd Value:	
Value Percent:	
Continuous Index:	
Within 8" of Joint:	NO
Remarks:	M-903-021
