Profile/Photo Observation Report

Street:	Rand St.	Flow Control:	Not Controlled
City:	Hobart, IN	Year Renewed:	
Location:	Other	Tape/Media #:	
Purpose:	Not Known	Dia/Height:	12"
Use:	Sanitary	Material:	VCP
Drain Area:	NA	Lining:	
Category:	NA		
Comment:

Location Details:		Direction of Survey:	Upstream
US MH:	M-903-021	DS MH:	M-903-024
		Total Length Surveyed (ft):	5.2

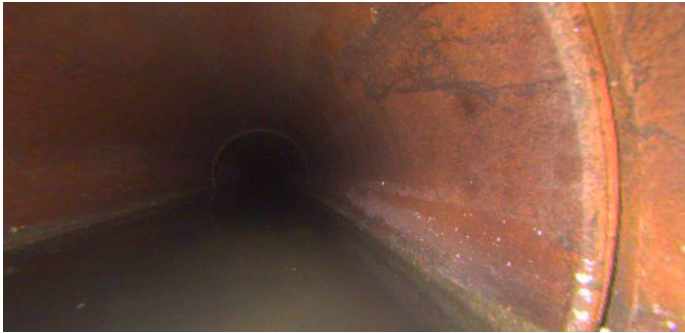
Code:	MWL
Description:	Water Level

Distance (ft):	.0
Structural Grade:	0
O&M Grade:	0
Clock Start/From:	
Clock To:	
1st Value:	
2nd Value:	
Value Percent:	30.000
Continuous Index:	
Within 8" of Joint:	NO
Remarks:

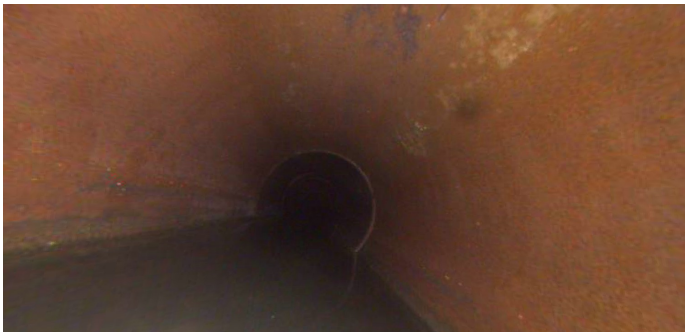
Code:	MSA
Description:	Abandoned Survey

Distance (ft):	5.2
Structural Grade:	0
O&M Grade:	0
Clock Start/From:	
Clock To:	
1st Value:	
2nd Value:	
Value Percent:	
Continuous Index:	
Within 8" of Joint:	NO
Remarks:	overturned
