Profile/Photo Observation Report

Date:	10/02/2018	Weather:		Coding:	PACP 6.0
Pipe Length (ft):	167.1	Owner:	NA	Pre Clean:	Not Known
P.O.#:		Surveyor:	Justin Gonzales	PSR:	P-903-021-024
Customer:		Clean Date:	01/01/1900	Shape:	C

Street:	E RAND ST & RUSH ST	Flow Control:	Not Controlled
City:	Hobart, IN	Year Renewed:	
Location:	Light Highway	Tape/Media #:	
Purpose:	Routine Assessment	Dia/Height:	12"
Use:	Sanitary	Material:	VCP
Drain Area:	NA	Lining:	
Category:	NA		
Comment:

Location Details:		Direction of Survey:	Upstream
US MH:	M-903-021	DS MH:	M-903-024
		Total Length Surveyed (ft):	163.9

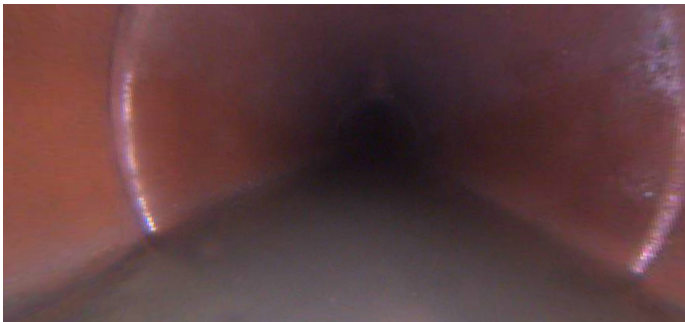
Code: **AMH**
Description: **Manhole**

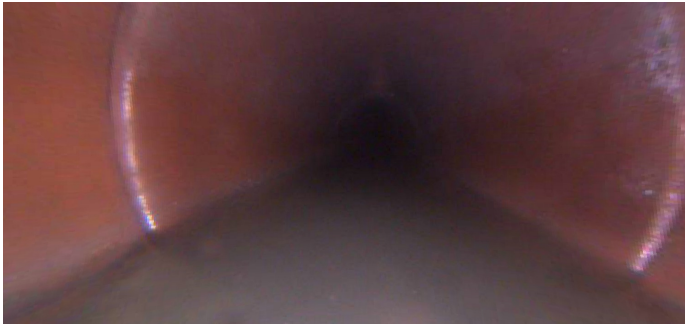
Code:	MWL
Description:	Water Level

Distance (ft):	.0
Structural Grade:	0
O&M Grade:	0
Clock Start/From:	
Clock To:	
1st Value:	
2nd Value:	
Value Percent:	10.000
Continuous Index:	
Within 8" of Joint:	NO
Remarks:

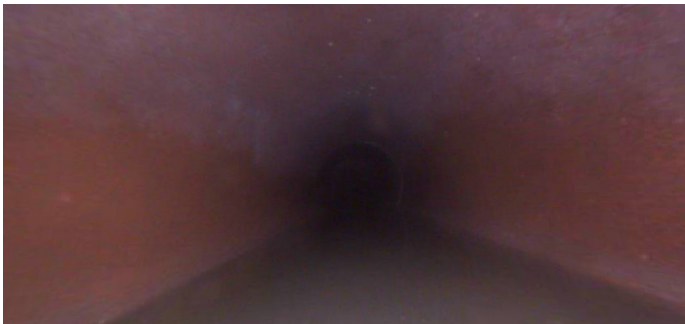
Code:	DAGS
Description:	Deposits Attached Grease

Distance (ft):	4.2
Structural Grade:	0
O&M Grade:	2
Clock Start/From:	7
Clock To:	5
1st Value:	
2nd Value:	
Value Percent:	5.000
Continuous Index:	
Within 8" of Joint:	YES
Remarks:	WANDER

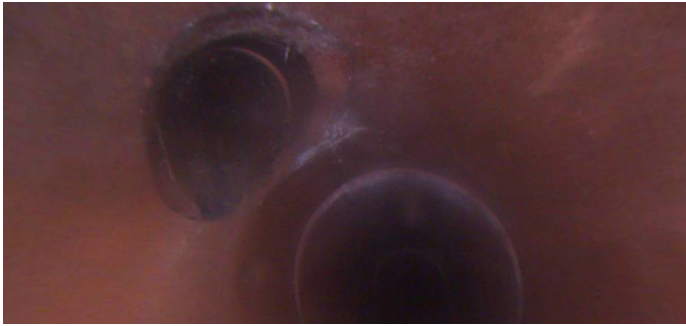
Code: **TF**
Description: **Tap Factory**

Distance (ft): **9.0**
Structural Grade: **0**
O&M Grade: **0**
Clock Start/From: **10**
Clock To:
1st Value: **4.000**
2nd Value:
Value Percent:
Continuous Index:
Within 8" of Joint:
Remarks:

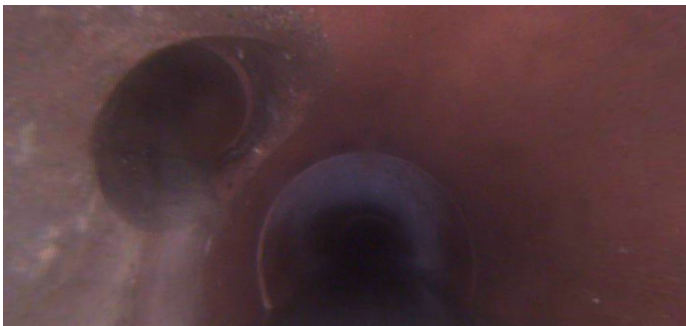
Code: **TF**
Description: **Tap Factory**

Distance (ft): **81.5**
Structural Grade: **0**
O&M Grade: **0**
Clock Start/From: **10**
Clock To:
1st Value: **4.000**
2nd Value:
Value Percent:
Continuous Index:
Within 8" of Joint:
Remarks:

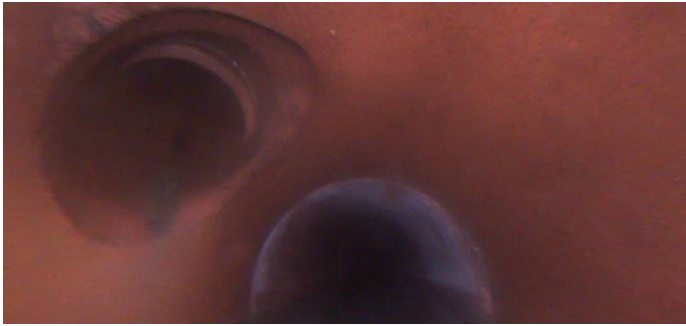
Code: **TF**
Description: **Tap Factory**

Distance (ft): **126.7**
Structural Grade: **0**
O&M Grade: **0**
Clock Start/From: **10**
Clock To:
1st Value: **4.000**
2nd Value:
Value Percent:
Continuous Index:
Within 8" of Joint:
Remarks:

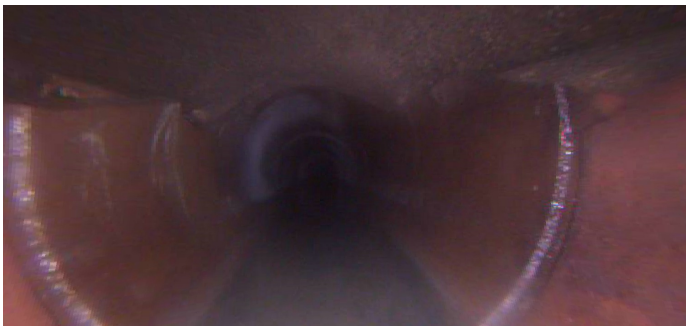
Code: **AMH**
Description: **Manhole**

Distance (ft): **163.9**
Structural Grade: **0**
O&M Grade: **0**
Clock Start/From:
Clock To:
1st Value:
2nd Value:
Value Percent:
Continuous Index:
Within 8" of Joint: **NO**
Remarks: **M-903-021**
