Profile/Photo Observation Report

Street:	ALLEY BETWEEN BRANDT ST & RUSH	Flow Control:	Not Controlled
City:	Hobart, IN	Year Renewed:	
Location:	Other	Tape/Media #:	
Purpose:	Not Known	Dia/Height:	10"
Use:	Sanitary	Material:	PVC
Drain Area:	NA	Lining:	
Category:	NA		
Comment:

Location Details:		Direction of Survey:	Downstream
US MH:	M-903-022	DS MH:	M-903-023
		Total Length Surveyed (ft):	73.1

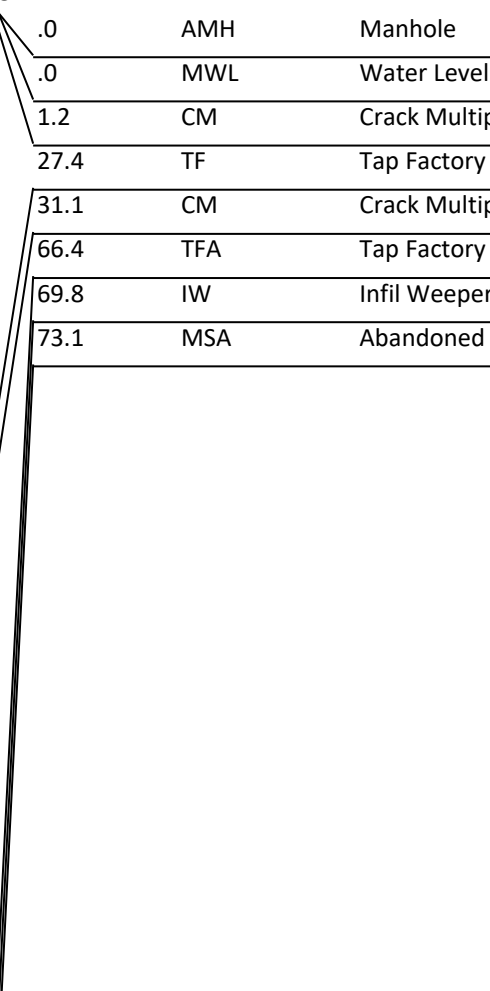
.0	AMH	Manhole	10	NA
.0	MWL	Water Level	21	NA
1.2	CM	Crack Multiple	35	S 3
27.4	TF	Tap Factory	99	NA
31.1	CM	Crack Multiple	118	S 3
66.4	TFA	Tap Factory Active	201	NA
69.8	IW	Infil Weeper	220	M 2
73.1	MSA	Abandoned Survey	238	NA

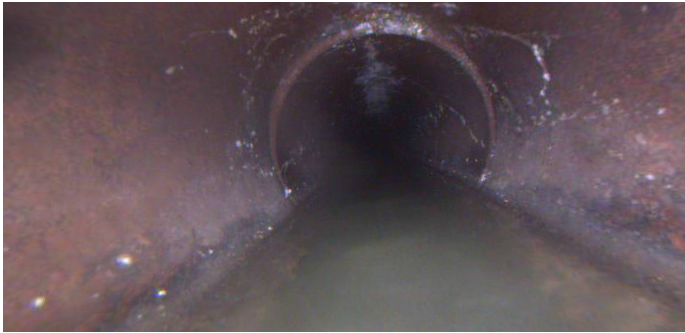
Code:	MWL
Description:	Water Level

Distance (ft):	.0
Structural Grade:	0
O&M Grade:	0
Clock Start/From:	
Clock To:	
1st Value:	
2nd Value:	
Value Percent:	10.000
Continuous Index:	
Within 8" of Joint:	NO
Remarks:

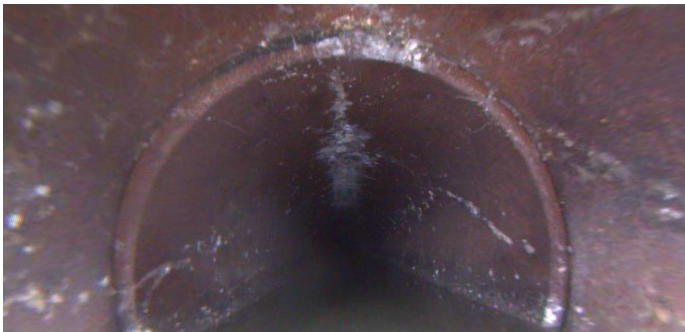
Code:	CM
Description:	Crack Multiple

Distance (ft):	1.2
Structural Grade:	3
O&M Grade:	0
Clock Start/From:	8
Clock To:	4
1st Value:	
2nd Value:	
Value Percent:	
Continuous Index:	
Within 8" of Joint:	YES
Remarks:

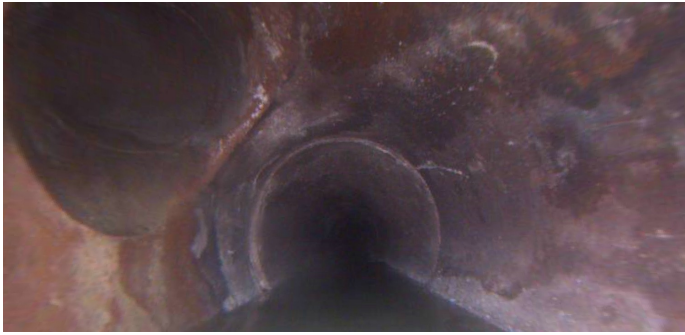
Code: **TF**
Description: **Tap Factory**

Distance (ft): **27.4**
Structural Grade: **0**
O&M Grade: **0**
Clock Start/From: **10**
Clock To:
1st Value: **4.000**
2nd Value:
Value Percent:
Continuous Index:
Within 8" of Joint:
Remarks:

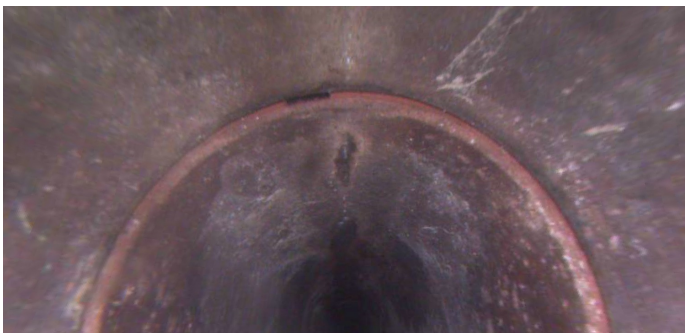
Code: **CM**
Description: **Crack Multiple**

Distance (ft): **31.1**
Structural Grade: **3**
O&M Grade: **0**
Clock Start/From: **8**
Clock To: **4**
1st Value:
2nd Value:
Value Percent:
Continuous Index:
Within 8" of Joint: **YES**
Remarks:

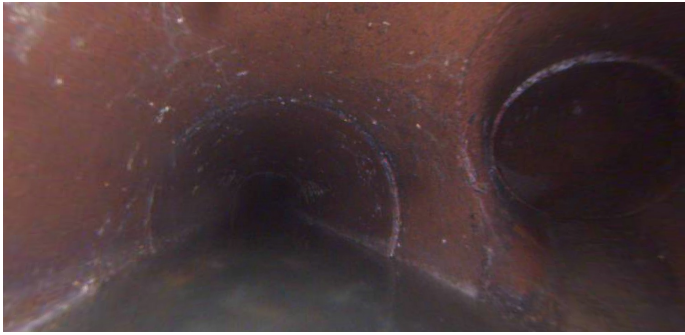
Code: **TFA**
Description: **Tap Factory Active**

Distance (ft): **66.4**
Structural Grade: **0**
O&M Grade: **0**
Clock Start/From: **3**
Clock To:
1st Value: **4.000**
2nd Value:
Value Percent:
Continuous Index:
Within 8" of Joint:
Remarks:

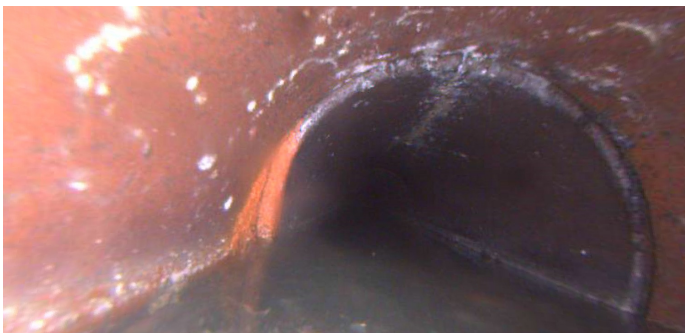
Code: **IW**
Description: **Infil Weeper**

Distance (ft): **69.8**
Structural Grade: **0**
O&M Grade: **2**
Clock Start/From: **8**
Clock To: **9**
1st Value:
2nd Value:
Value Percent:
Continuous Index:
Within 8" of Joint: **YES**
Remarks:

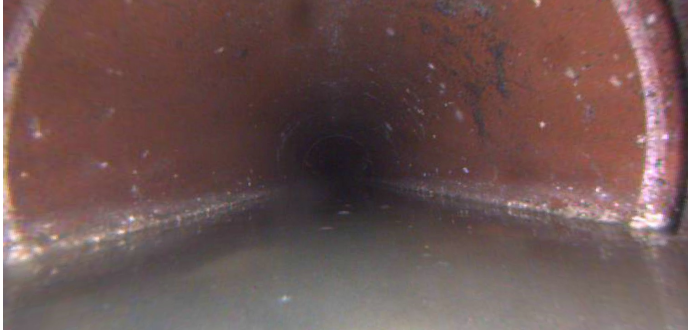
Code:	MSA
Description:	Abandoned Survey
Distance (ft):	73.1
Structural Grade:	0
O&M Grade:	0
Clock Start/From:	
Clock To:	
1st Value:	
2nd Value:	
Value Percent:	
Continuous Index:	
Within 8" of Joint:	NO
Remarks:	debris under water
