Profile/Ph	oto Observatio	n Report			RedZone
Date:	03/30/2018	Weather:		Coding:	PACP 6.0
Pipe Length (ft)): 59.4	Owner:	NA	Pre Clean:	Not Known
P.O.#:		Surveyor:	Jen Costello	PSR:	P-903-048-023
Customer:		Clean Date:	01/01/1900	Shape:	С
Street:	ALLEY BETWEEN	EY BETWEEN RUSH ST & BRANDT Flow Control:		Not Controlled	ł
City:	Hobart, IN		Year Renewed:		
Location:	Other		Tape/Media #:		
Purpose:	Not Known		Dia/Height:	10"	
Use:	Sanitary		Material:	PVC	
Drain Area:	NA		Lining:		
Category:	NA				
Comment:					
Location Detail	S:		Direction of Sur	vey: Upstream	
US MH:	M-903-023	DS MH:	M-903-048	Total Length Surveyed (ft): 54.5
0&M Index:	0.00	O&M Quick:	000	00 O&M Rating:	0.00
itructural Index:	0.00	Structural Qu	uick: 000	00 Structural Rating	0.00
Overall Index:	0.00	Overall Quicl	<: 000	00 Overall Rating:	0.00

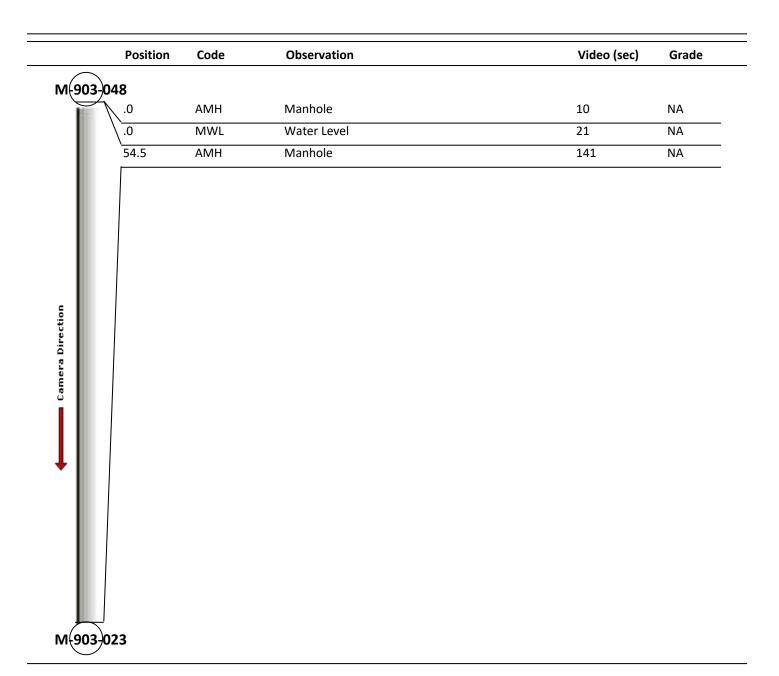
Code: Description:	AMH Manhole
Distance (ft):	.0
Structural Grade:	0
O&M Grade:	0
Clock Start/From:	
Clock To:	
1st Value:	
2nd Value:	
Value Percent:	
Continuous Index:	
Within 8" of Joint:	NO
Remarks:	M-903-048

Code: MWL Description: Water Level

Distance (ft): .0 Structural Grade: 0 O&M Grade: 0 Clock Start/From: Clock To: 1st Value: 2nd Value: Value Percent: 5.000 Continuous Index: Within 8" of Joint: NO Remarks:
