Profile/Photo Observation Report

Street:	brandit st	Flow Control:	Not Controlled
City:	Hobart, IN	Year Renewed:	
Location:	Other	Tape/Media #:	
Purpose:	Not Known	Dia/Height:	10"
Use:	Sanitary	Material:	PVC
Drain Area:	NA	Lining:	
Category:	NA		
Comment:

Location Details:		Direction of Survey:	Upstream
US MH:	M-903-023	DS MH:	M-903-048
		Total Length Surveyed (ft):	54.5

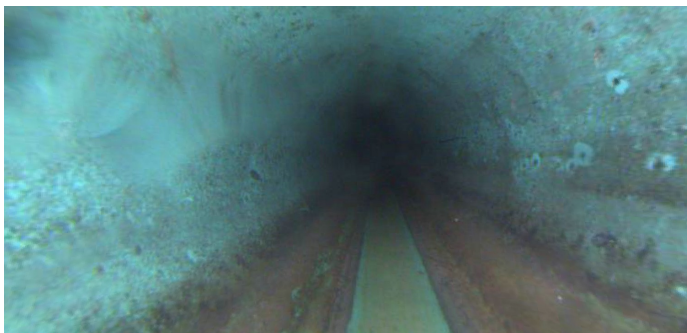
Code: **AMH**
Description: **Manhole**

Distance (ft): **.0**
Structural Grade: **0**
O&M Grade: **0**
Clock Start/From:
Clock To:
1st Value:
2nd Value:
Value Percent:
Continuous Index:
Within 8" of Joint: **NO**
Remarks: **M-903-048**

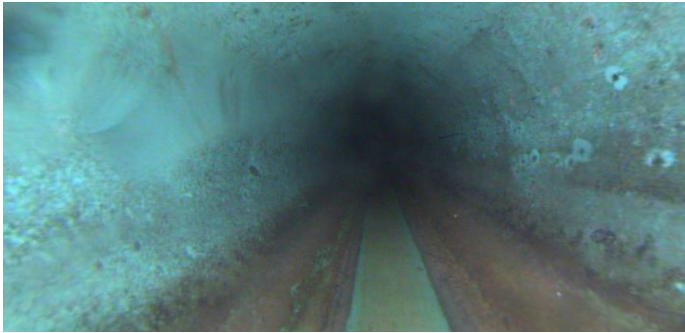
Code:	MWL
Description:	Water Level

Distance (ft):	.0
Structural Grade:	0
O&M Grade:	0
Clock Start/From:	
Clock To:	
1st Value:	
2nd Value:	
Value Percent:	5.000
Continuous Index:	
Within 8" of Joint:	NO
Remarks:

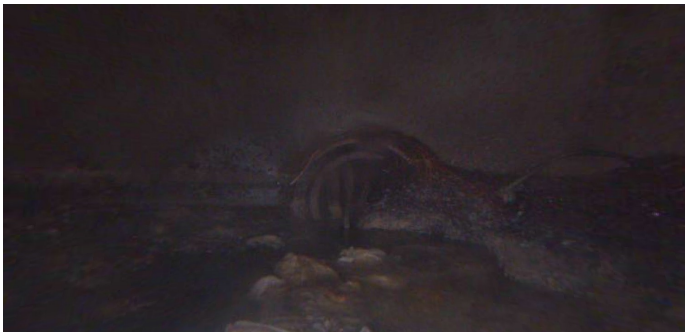
Code:	AMH
Description:	Manhole

Distance (ft):	54.5
Structural Grade:	0
O&M Grade:	0
Clock Start/From:	
Clock To:	
1st Value:	
2nd Value:	
Value Percent:	
Continuous Index:	
Within 8" of Joint:	NO
Remarks:	M-903-023
