Profile/Photo Observation Report

Street:	E RAND ST & RUSH ST	Flow Control:	Not Controlled
City:	Hobart, IN	Year Renewed:	
Location:	Other	Tape/Media #:	
Purpose:	Not Known	Dia/Height:	12"
Use:	Sanitary	Material:	VCP
Drain Area:	NA	Lining:	
Category:	NA		
Comment:

Location Details:		Direction of Survey:	Downstream
US MH:	M-903-024	DS MH:	M-903-025
		Total Length Surveyed (ft):	9.1

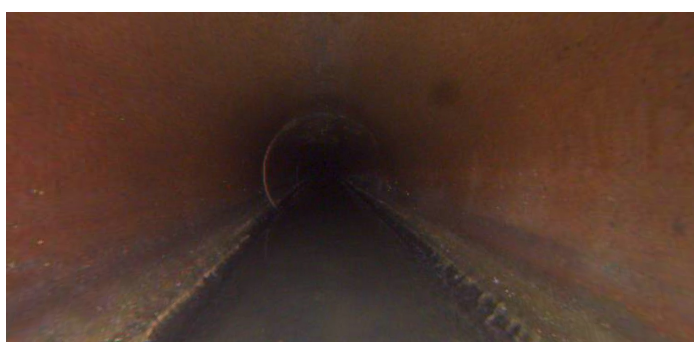
Code: **AMH**
Description: **Manhole**

Distance (ft): **.0**
Structural Grade: **0**
O&M Grade: **0**
Clock Start/From:
Clock To:
1st Value:
2nd Value:
Value Percent:
Continuous Index:
Within 8" of Joint: **NO**
Remarks: **M-903-024**

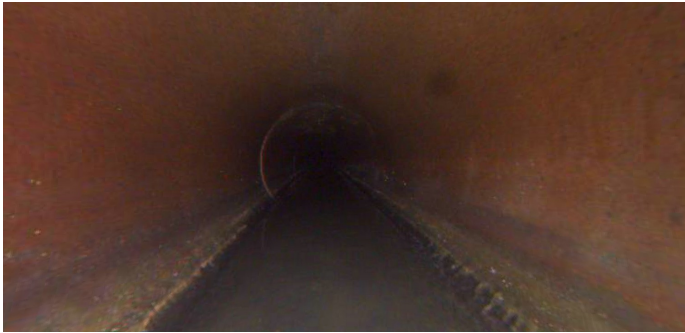
Code:	MWL
Description:	Water Level

Distance (ft):	.0
Structural Grade:	0
O&M Grade:	0
Clock Start/From:	
Clock To:	
1st Value:	
2nd Value:	
Value Percent:	5.000
Continuous Index:	
Within 8" of Joint:	NO
Remarks:

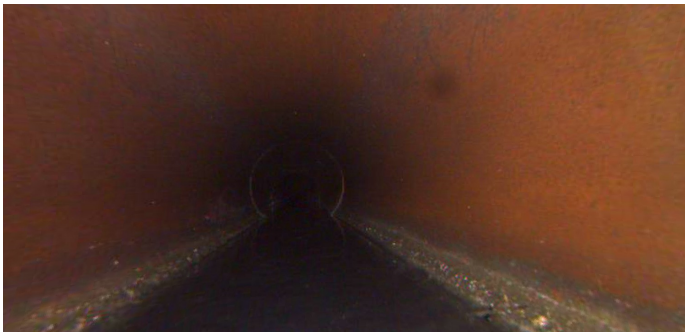
Code:	MSA
Description:	Abandoned Survey

Distance (ft):	9.1
Structural Grade:	0
O&M Grade:	0
Clock Start/From:	
Clock To:	
1st Value:	
2nd Value:	
Value Percent:	
Continuous Index:	
Within 8" of Joint:	NO
Remarks:	debris under water
