Profile/Photo Observation Report

Street:	Rand St.	Flow Control:	Not Controlled
City:	Hobart, IN	Year Renewed:	
Location:	Other	Tape/Media #:	
Purpose:	Not Known	Dia/Height:	12"
Use:	Sanitary	Material:	VCP
Drain Area:	NA	Lining:	
Category:	NA		
Comment:

Location Details:		Direction of Survey:	Downstream
US MH:	M-903-024	DS MH:	M-903-025
		Total Length Surveyed (ft):	9.1

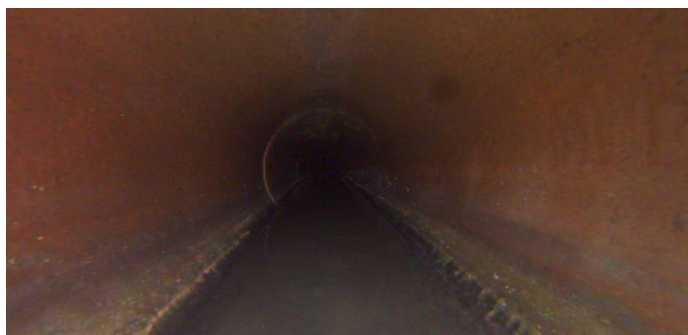
Code: **AMH**
Description: **Manhole**

Distance (ft): **.0**
Structural Grade: **0**
O&M Grade: **0**
Clock Start/From:
Clock To:
1st Value:
2nd Value:
Value Percent:
Continuous Index:
Within 8" of Joint: **NO**
Remarks: **M-903-024**

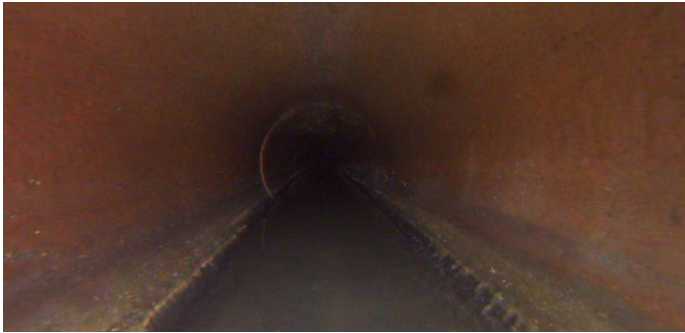
Code:	MWL
Description:	Water Level

Distance (ft):	.0
Structural Grade:	0
O&M Grade:	0
Clock Start/From:	
Clock To:	
1st Value:	
2nd Value:	
Value Percent:	5.000
Continuous Index:	
Within 8" of Joint:	NO
Remarks:

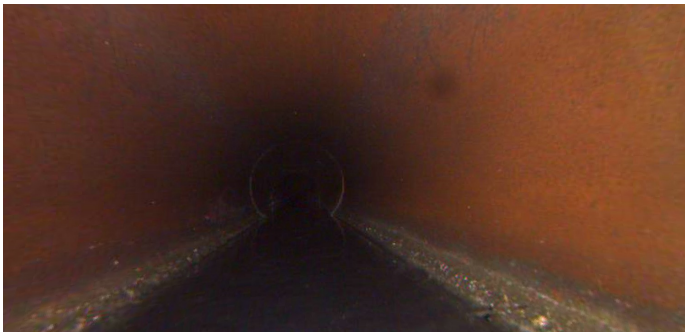
Code:	MSA
Description:	Abandoned Survey

Distance (ft):	9.1
Structural Grade:	0
O&M Grade:	0
Clock Start/From:	
Clock To:	
1st Value:	
2nd Value:	
Value Percent:	
Continuous Index:	
Within 8" of Joint:	NO
Remarks:	debris under water
