Profile/Photo Observation Report

Street:	Rand St.	Flow Control:	Not Controlled
City:	Hobart, IN	Year Renewed:	
Location:	Other	Tape/Media #:	
Purpose:	Not Known	Dia/Height:	12"
Use:	Sanitary	Material:	VCP
Drain Area:	NA	Lining:	
Category:	NA		
Comment:

Location Details:		Direction of Survey:	Upstream
US MH:	M-903-024	DS MH:	M-903-025
		Total Length Surveyed (ft):	2.5

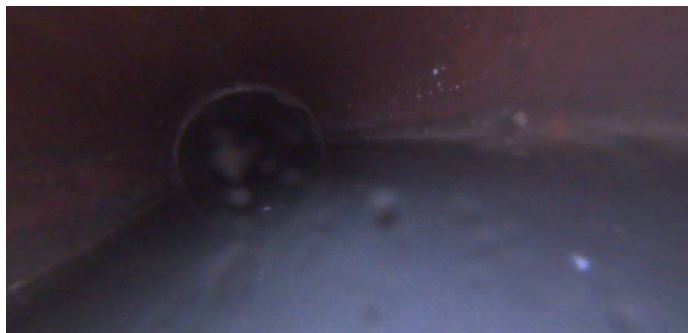
Code: **AMH**
 Description: **Manhole**

Distance (ft): **.0**
 Structural Grade: **0**
 O&M Grade: **0**
 Clock Start/From:
 Clock To:
 1st Value:
 2nd Value:
 Value Percent:
 Continuous Index:
 Within 8" of Joint: **NO**
 Remarks: **M-903-025**

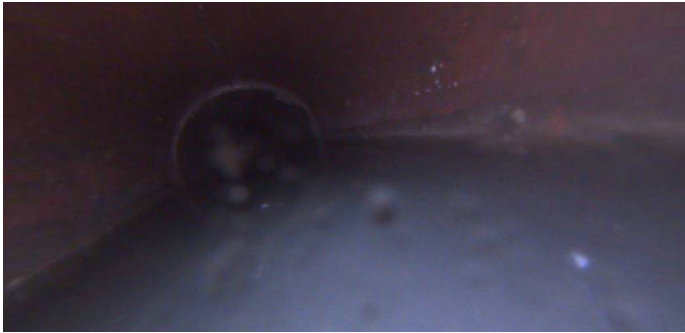
Code:	MWL
Description:	Water Level

Distance (ft):	.0
Structural Grade:	0
O&M Grade:	0
Clock Start/From:	
Clock To:	
1st Value:	
2nd Value:	
Value Percent:	40.000
Continuous Index:	
Within 8" of Joint:	NO
Remarks:

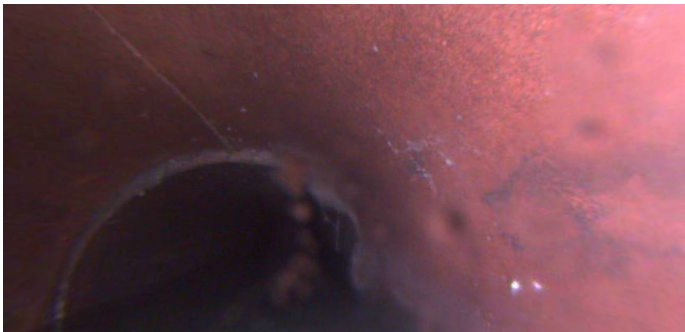
Code:	MSA
Description:	Abandoned Survey

Distance (ft):	2.5
Structural Grade:	0
O&M Grade:	0
Clock Start/From:	
Clock To:	
1st Value:	
2nd Value:	
Value Percent:	
Continuous Index:	
Within 8" of Joint:	NO
Remarks:	UNKNOWN
