Profile/Photo Observation Report

Street:	Rand St.	Flow Control:	Not Controlled
City:	Hobart, IN	Year Renewed:	
Location:	Light Highway	Tape/Media #:	
Purpose:	Routine Assessment	Dia/Height:	10"
Use:	Sanitary	Material:	VCP
Drain Area:	NA	Lining:	
Category:	NA		
Comment:

Location Details:		Direction of Survey:	Downstream
US MH:	M-903-025	DS MH:	M-903-026
		Total Length Surveyed (ft):	219.6

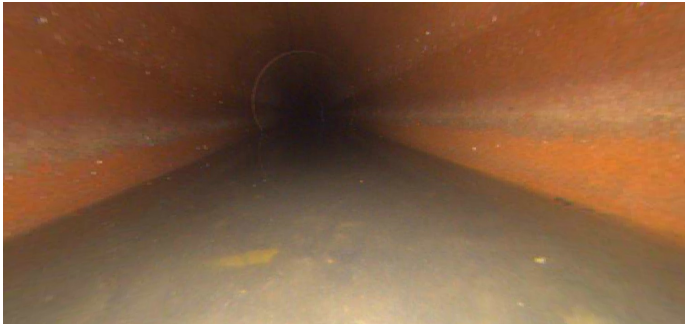
Code: **AMH**
Description: **Manhole**

Distance (ft): **.0**
Structural Grade: **0**
O&M Grade: **0**
Clock Start/From:
Clock To:
1st Value:
2nd Value:
Value Percent:
Continuous Index:
Within 8" of Joint: **NO**
Remarks: **M-903-025**

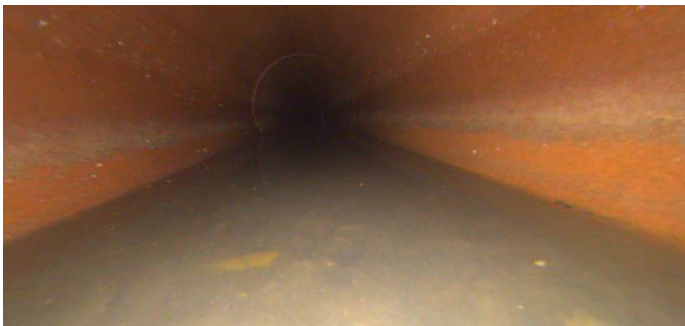
Code: **MWL**
Description: **Water Level**

Distance (ft): **.0**
Structural Grade: **0**
O&M Grade: **0**
Clock Start/From:
Clock To:
1st Value:
2nd Value:
Value Percent: **15.000**
Continuous Index:
Within 8" of Joint: **NO**
Remarks:

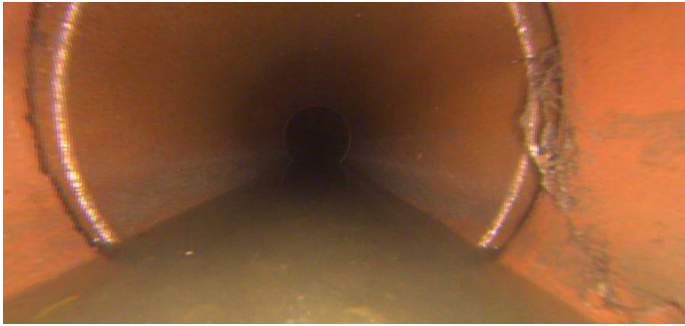
Code: **RFJ**
Description: **Roots Fine Joint**

Distance (ft): **17.5**
Structural Grade: **0**
O&M Grade: **1**
Clock Start/From: **3**
Clock To:
1st Value:
2nd Value:
Value Percent:
Continuous Index:
Within 8" of Joint: **YES**
Remarks:

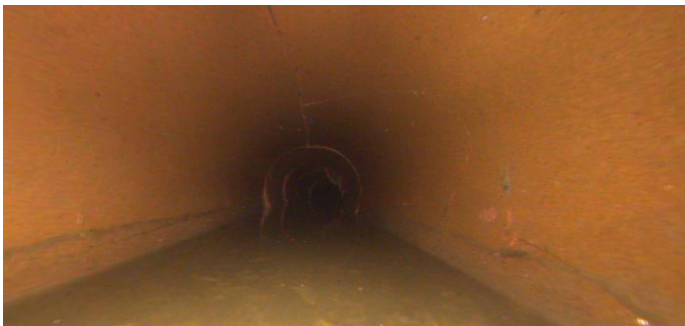
Code: **FM**
Description: **Fracture Multiple**

Distance (ft): **59.0**
Structural Grade: **4**
O&M Grade: **0**
Clock Start/From: **12**
Clock To: **5**
1st Value:
2nd Value:
Value Percent:
Continuous Index:
Within 8" of Joint: **YES**
Remarks:

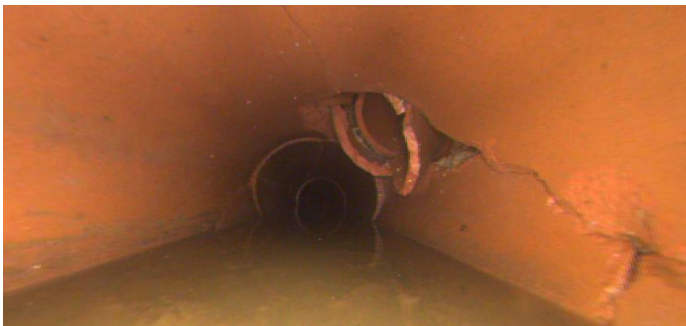
Code: **FM**
Description: **Fracture Multiple**

Distance (ft): **62.5**
Structural Grade: **4**
O&M Grade: **0**
Clock Start/From: **7**
Clock To: **5**
1st Value:
2nd Value:
Value Percent:
Continuous Index:
Within 8" of Joint: **YES**
Remarks:

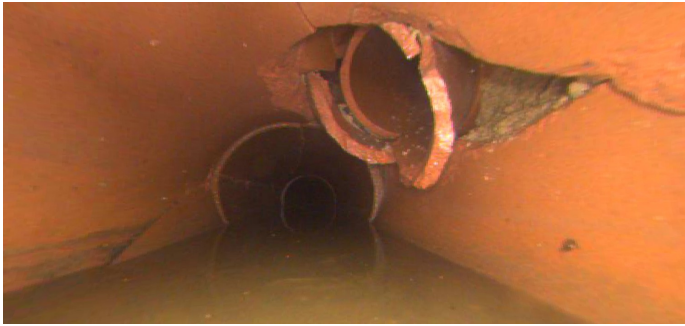
Code: **TFD**
Description: **Tap Factory Defective**

Distance (ft): **62.9**
Structural Grade: **0**
O&M Grade: **2**
Clock Start/From: **2**
Clock To:
1st Value: **5.000**
2nd Value:
Value Percent:
Continuous Index:
Within 8" of Joint:
Remarks: **MOUTH OF TAP BROKEN**

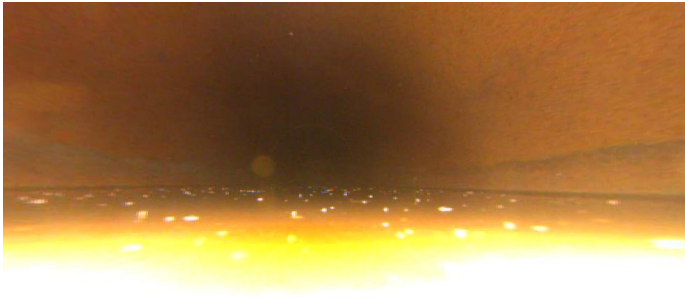
Code: **MWLS**
Description: **Water Level Sag**

Distance (ft): **67.7**
Structural Grade: **3**
O&M Grade: **3**
Clock Start/From:
Clock To:
1st Value:
2nd Value:
Value Percent: **40.000**
Continuous Index:
Within 8" of Joint: **NO**
Remarks:

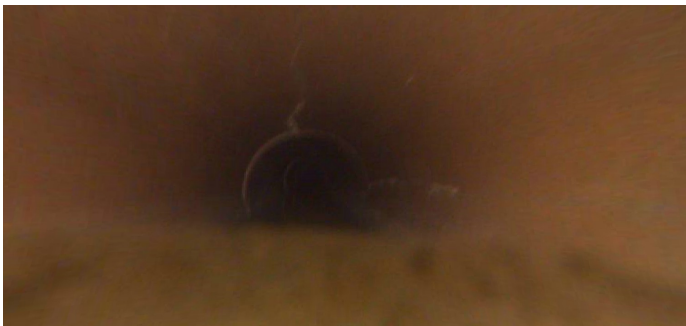
Code: **CM**
Description: **Crack Multiple**

Distance (ft): **97.3**
Structural Grade: **3**
O&M Grade: **0**
Clock Start/From: **12**
Clock To: **3**
1st Value:
2nd Value:
Value Percent:
Continuous Index:
Within 8" of Joint: **YES**
Remarks:

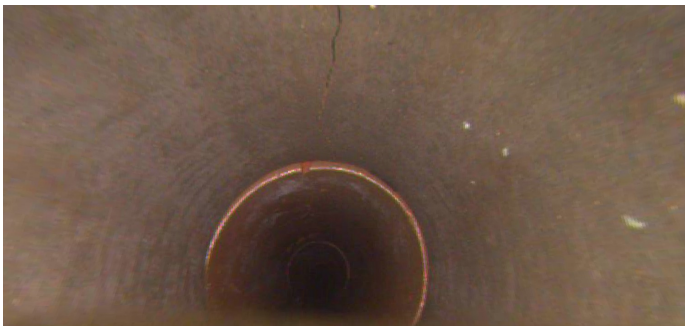
Code: **FL**
Description: **Fracture Longitudinal**

Distance (ft): **197.5**
Structural Grade: **3**
O&M Grade: **0**
Clock Start/From: **12**
Clock To:
1st Value:
2nd Value:
Value Percent:
Continuous Index:
Within 8" of Joint: **YES**
Remarks:

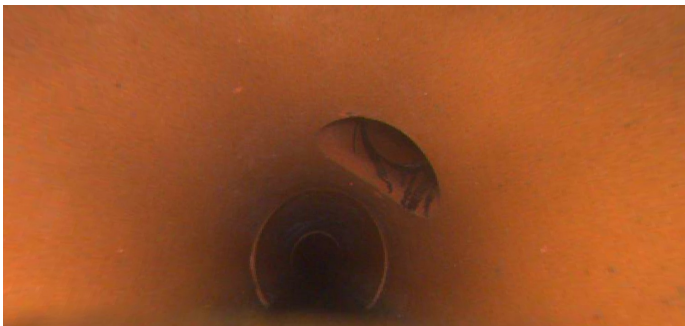
Code: **TF**
Description: **Tap Factory**

Distance (ft): **202.7**
Structural Grade: **0**
O&M Grade: **0**
Clock Start/From: **2**
Clock To:
1st Value: **4.000**
2nd Value:
Value Percent:
Continuous Index:
Within 8" of Joint:
Remarks:
