Profile/Photo Observation Report

Street:	E RAND ST	Flow Control:	Not Controlled
City:	Hobart, IN	Year Renewed:	
Location:	Other	Tape/Media #:	
Purpose:	Not Known	Dia/Height:	12"
Use:	Sanitary	Material:	VCP
Drain Area:	NA	Lining:	
Category:	NA		
Comment:

Location Details:		Direction of Survey:	Downstream
US MH:	M-903-025	DS MH:	M-903-028
		Total Length Surveyed (ft):	13.1

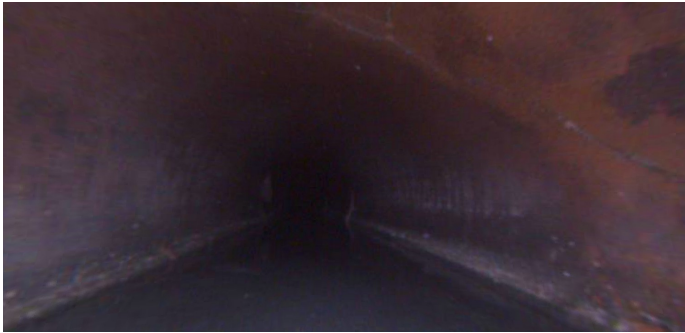
Code:	MWL
Description:	Water Level

Distance (ft):	.0
Structural Grade:	0
O&M Grade:	0
Clock Start/From:	
Clock To:	
1st Value:	
2nd Value:	
Value Percent:	30.000
Continuous Index:	
Within 8" of Joint:	NO
Remarks:

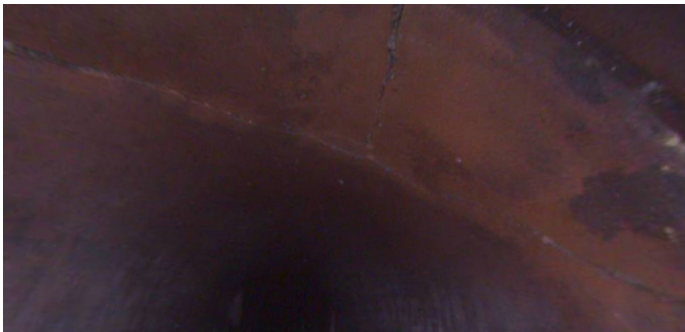
Code:	FM
Description:	Fracture Multiple

Distance (ft):	.0
Structural Grade:	4
O&M Grade:	0
Clock Start/From:	11
Clock To:	3
1st Value:	
2nd Value:	
Value Percent:	
Continuous Index:	
Within 8" of Joint:	YES
Remarks:

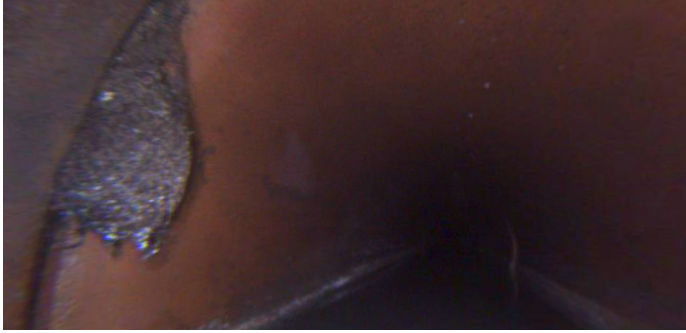
Code: **RMJ**
Description: **Roots Medium Joint**

Distance (ft): **4.1**
Structural Grade: **0**
O&M Grade: **3**
Clock Start/From: **9**
Clock To: **10**
1st Value:
2nd Value:
Value Percent: **5.000**
Continuous Index:
Within 8" of Joint: **YES**
Remarks:

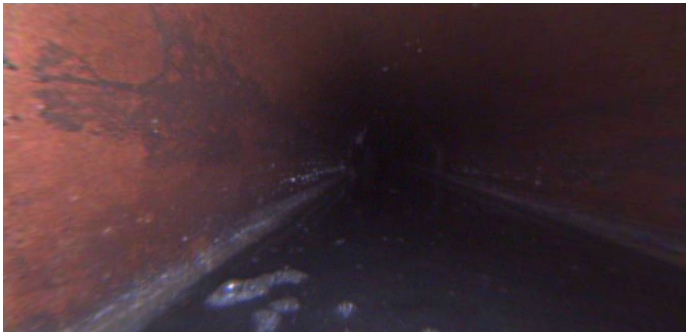
Code: **MSA**
Description: **Abandoned Survey**

Distance (ft): **13.1**
Structural Grade: **0**
O&M Grade: **0**
Clock Start/From:
Clock To:
1st Value:
2nd Value:
Value Percent:
Continuous Index:
Within 8" of Joint: **NO**
Remarks: **DEBRIS UNDER WATER**
