## Profile/Photo Observation Report

Street:	<b>Rand St.</b>	Flow Control:	<b>Not Controlled</b>
City:	<b>Hobart, IN</b>	Year Renewed:	
Location:	<b>Light Highway</b>	Tape/Media #:	
Purpose:	<b>Routine Assessment</b>	Dia/Height:	<b>12"</b>
Use:	<b>Sanitary</b>	Material:	<b>VCP</b>
Drain Area:	<b>NA</b>	Lining:	
Category:	<b>NA</b>		
Comment:

Location Details:		Direction of Survey:	<b>Downstream</b>
US MH:	<b>M-903-025</b>	DS MH:	<b>M-903-028</b>
		Total Length Surveyed (ft):	<b>160.2</b>

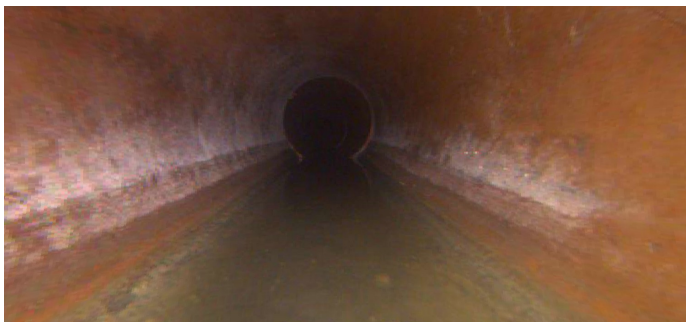
Code: **AMH**  
Description: **Manhole**

Distance (ft): **.0**  
Structural Grade: **0**  
O&M Grade: **0**  
Clock Start/From:  
Clock To:  
1st Value:  
2nd Value:  
Value Percent:  
Continuous Index:  
Within 8" of Joint: **NO**  
Remarks: **M-903-025**

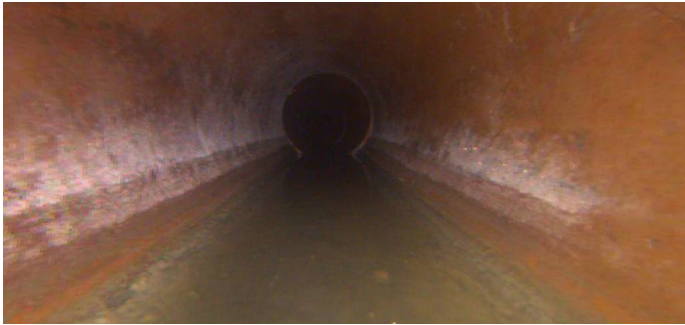
Code:	<b>MWL</b>
Description:	<b>Water Level</b>

Distance (ft):	<b>.0</b>
Structural Grade:	<b>0</b>
O&M Grade:	<b>0</b>
Clock Start/From:	
Clock To:	
1st Value:	
2nd Value:	
Value Percent:	<b>10.000</b>
Continuous Index:	
Within 8" of Joint:	<b>NO</b>
Remarks:

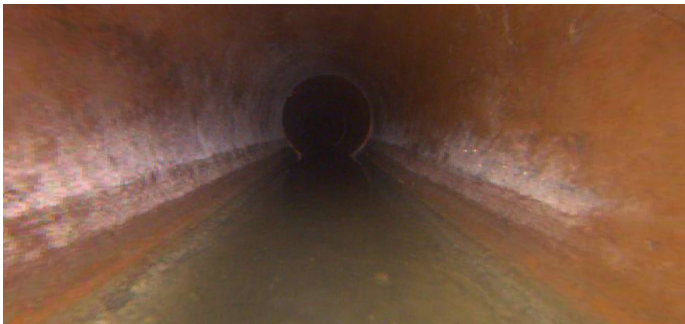
Code:	<b>DAGS</b>
Description:	<b>Deposits Attached Grease</b>

Distance (ft):	<b>.0</b>
Structural Grade:	<b>0</b>
O&M Grade:	<b>2</b>
Clock Start/From:	<b>7</b>
Clock To:	<b>5</b>
1st Value:	
2nd Value:	
Value Percent:	<b>5.000</b>
Continuous Index:	<b>S01</b>
Within 8" of Joint:	<b>YES</b>
Remarks:	<b>WANDER</b>

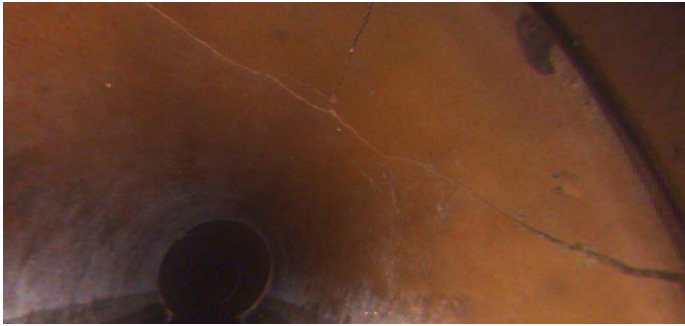
Code: **FM**  
Description: **Fracture Multiple**

Distance (ft): **.0**  
Structural Grade: **4**  
O&M Grade: **0**  
Clock Start/From: **10**  
Clock To: **4**  
1st Value:  
2nd Value:  
Value Percent:  
Continuous Index:  
Within 8" of Joint: **YES**  
Remarks:

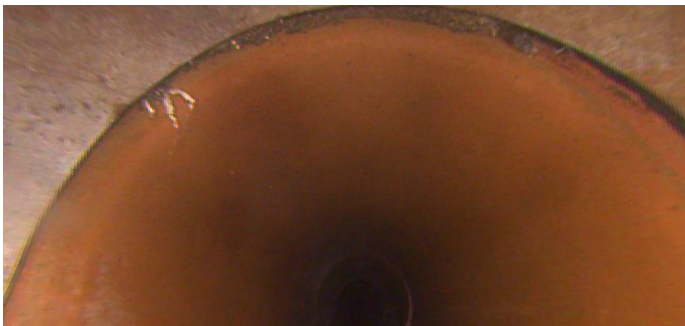
Code: **RFJ**  
Description: **Roots Fine Joint**

Distance (ft): **3.8**  
Structural Grade: **0**  
O&M Grade: **1**  
Clock Start/From: **10**  
Clock To: **2**  
1st Value:  
2nd Value:  
Value Percent:  
Continuous Index:  
Within 8" of Joint: **YES**  
Remarks:

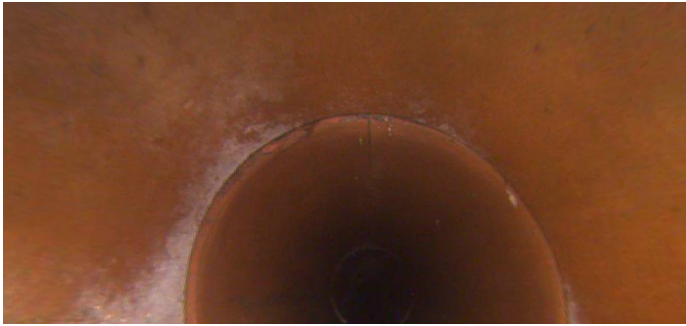
Code: **RFJ**  
Description: **Roots Fine Joint**

Distance (ft): **14.9**  
Structural Grade: **0**  
O&M Grade: **1**  
Clock Start/From: **11**  
Clock To: **12**  
1st Value:  
2nd Value:  
Value Percent:  
Continuous Index:  
Within 8" of Joint: **YES**  
Remarks:

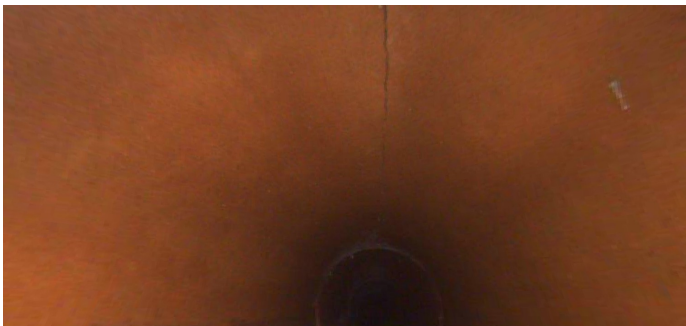
Code: **FL**  
Description: **Fracture Longitudinal**

Distance (ft): **16.2**  
Structural Grade: **3**  
O&M Grade: **0**  
Clock Start/From: **12**  
Clock To:  
1st Value:  
2nd Value:  
Value Percent:  
Continuous Index:  
Within 8" of Joint: **YES**  
Remarks:

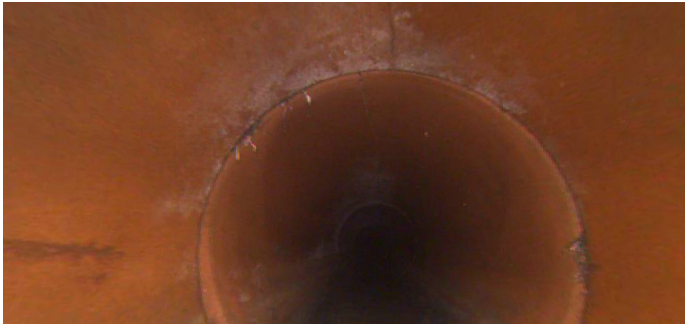
Code: **RFJ**  
Description: **Roots Fine Joint**

Distance (ft): **17.9**  
Structural Grade: **0**  
O&M Grade: **1**  
Clock Start/From: **9**  
Clock To: **4**  
1st Value:  
2nd Value:  
Value Percent:  
Continuous Index:  
Within 8" of Joint: **YES**  
Remarks:

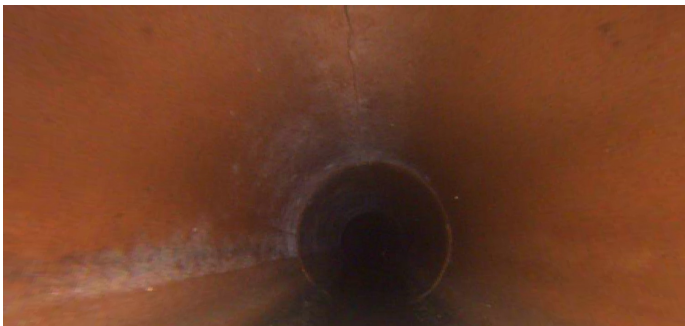
Code: **FL**  
Description: **Fracture Longitudinal**

Distance (ft): **19.8**  
Structural Grade: **3**  
O&M Grade: **0**  
Clock Start/From: **12**  
Clock To:  
1st Value:  
2nd Value:  
Value Percent:  
Continuous Index:  
Within 8" of Joint: **YES**  
Remarks:

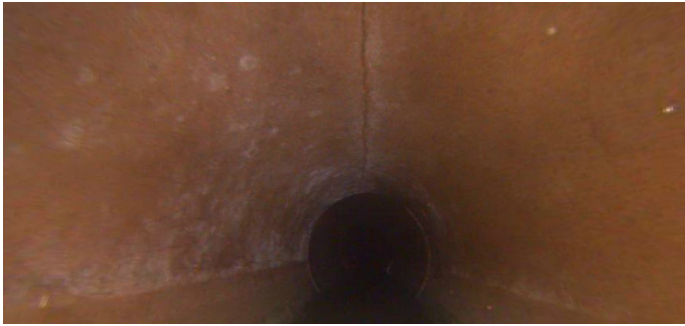
Code: **FL**  
Description: **Fracture Longitudinal**

Distance (ft): **22.3**  
Structural Grade: **3**  
O&M Grade: **0**  
Clock Start/From: **12**  
Clock To:  
1st Value:  
2nd Value:  
Value Percent:  
Continuous Index:  
Within 8" of Joint: **YES**  
Remarks:

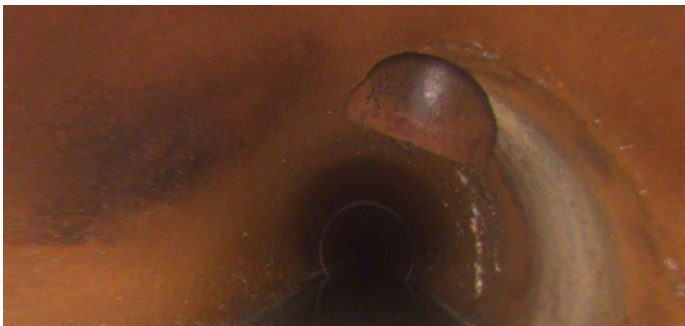
Code: **TF**  
Description: **Tap Factory**

Distance (ft): **45.2**  
Structural Grade: **0**  
O&M Grade: **0**  
Clock Start/From: **1**  
Clock To:  
1st Value: **4.000**  
2nd Value:  
Value Percent:  
Continuous Index:  
Within 8" of Joint:  
Remarks:

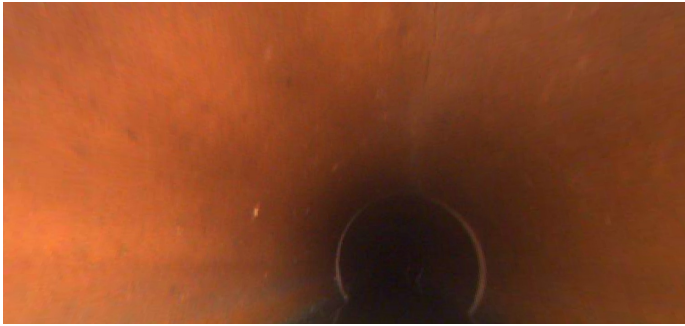
Code: **CL**  
Description: **Crack Longitudinal**

Distance (ft): **52.0**  
Structural Grade: **2**  
O&M Grade: **0**  
Clock Start/From: **12**  
Clock To:  
1st Value:  
2nd Value:  
Value Percent:  
Continuous Index:  
Within 8" of Joint: **YES**  
Remarks:

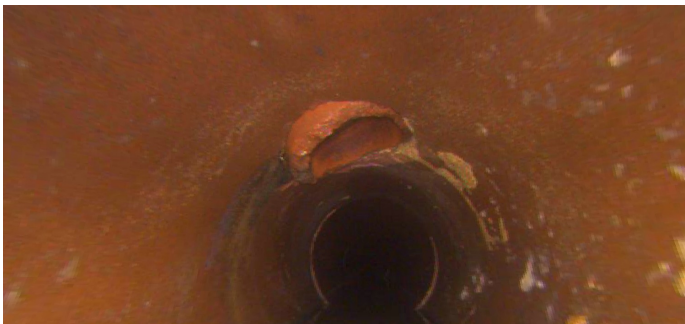
Code: **TFI**  
Description: **Tap Factory Intruding**

Distance (ft): **81.2**  
Structural Grade: **0**  
O&M Grade: **2**  
Clock Start/From: **11**  
Clock To:  
1st Value: **4.000**  
2nd Value: **0.500**  
Value Percent:  
Continuous Index:  
Within 8" of Joint:  
Remarks:

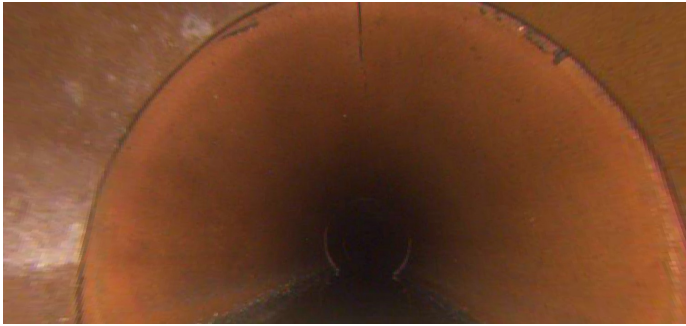
Code: **CL**  
Description: **Crack Longitudinal**

Distance (ft): **91.8**  
Structural Grade: **2**  
O&M Grade: **0**  
Clock Start/From: **12**  
Clock To:  
1st Value:  
2nd Value:  
Value Percent:  
Continuous Index:  
Within 8" of Joint: **YES**  
Remarks:

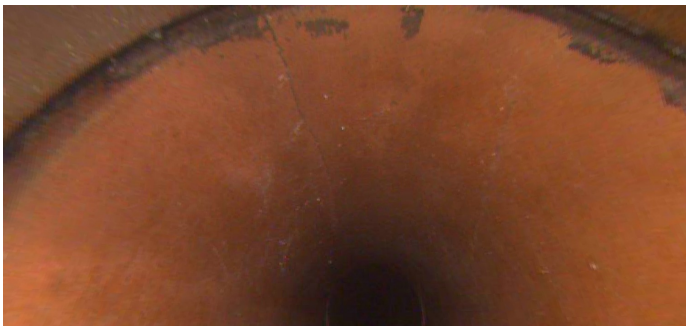
Code: **CL**  
Description: **Crack Longitudinal**

Distance (ft): **106.5**  
Structural Grade: **2**  
O&M Grade: **0**  
Clock Start/From: **11**  
Clock To:  
1st Value:  
2nd Value:  
Value Percent:  
Continuous Index:  
Within 8" of Joint: **YES**  
Remarks:

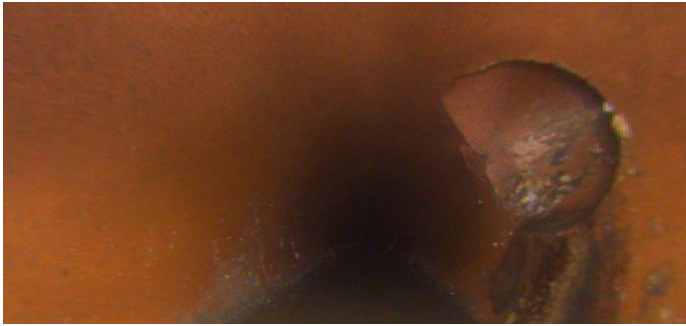
Code: **TF**  
Description: **Tap Factory**

Distance (ft): **133.1**  
Structural Grade: **0**  
O&M Grade: **0**  
Clock Start/From: **2**  
Clock To:  
1st Value: **4.000**  
2nd Value:  
Value Percent:  
Continuous Index:  
Within 8" of Joint:  
Remarks:

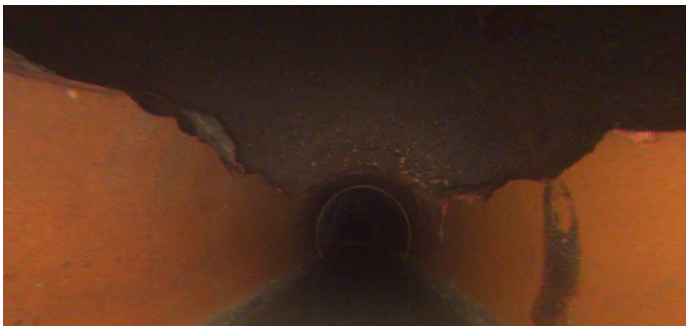
Code: **AMH**  
Description: **Manhole**

Distance (ft): **160.2**  
Structural Grade: **0**  
O&M Grade: **0**  
Clock Start/From:  
Clock To:  
1st Value:  
2nd Value:  
Value Percent:  
Continuous Index:  
Within 8" of Joint: **NO**  
Remarks: **M-903-028**

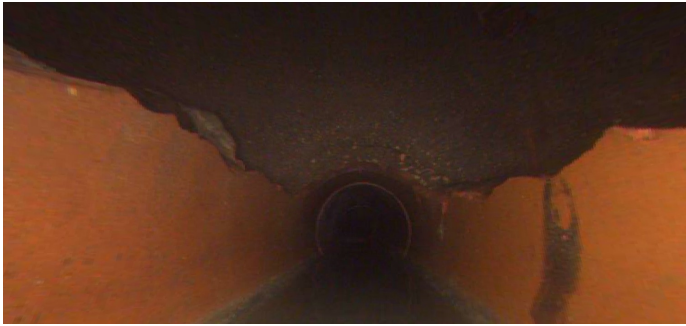
Code:	<b>DAGS</b>
Description:	<b>Deposits Attached Grease</b>
Distance (ft):	<b>160.2</b>
Structural Grade:	<b>0</b>
O&M Grade:	<b>2</b>
Clock Start/From:	<b>7</b>
Clock To:	<b>5</b>
1st Value:	
2nd Value:	
Value Percent:	<b>5.000</b>
Continuous Index:	<b>F01</b>
Within 8" of Joint:	<b>YES</b>
Remarks:	<b>WANDER</b>
