Profile/Photo Observation Report

Date:	04/03/2018	Weather:		Coding:	PACP 6.0
Pipe Length (ft):	215.1	Owner:	NA	Pre Clean:	Not Known
P.O.#:		Surveyor:	Jen Costello	PSR:	P-903-027-026
Customer:		Clean Date:	01/01/1900	Shape:	C

Street:	ALLEY BETWEEN PERSHING ST & RU	Flow Control:	Not Controlled
City:	Hobart, IN	Year Renewed:	
Location:	Other	Tape/Media #:	
Purpose:	Not Known	Dia/Height:	10"
Use:	Sanitary	Material:	VCP
Drain Area:	NA	Lining:	
Category:	NA		
Comment:

Location Details:		Direction of Survey:	Downstream
US MH:	M-903-026	DS MH:	M-903-027
		Total Length Surveyed (ft):	194.7

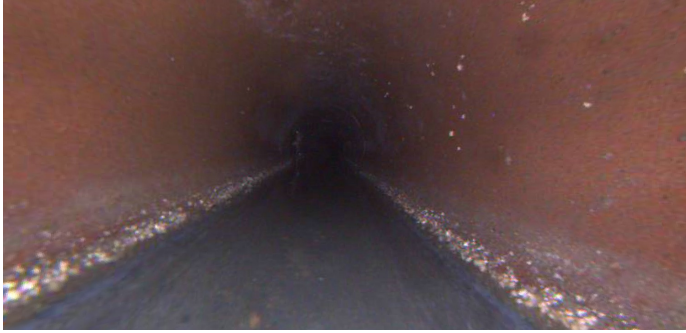
Code: **AMH**
Description: **Manhole**

Distance (ft): **.0**
Structural Grade: **0**
O&M Grade: **0**
Clock Start/From:
Clock To:
1st Value:
2nd Value:
Value Percent:
Continuous Index:
Within 8" of Joint: **NO**
Remarks: **M-903-026**

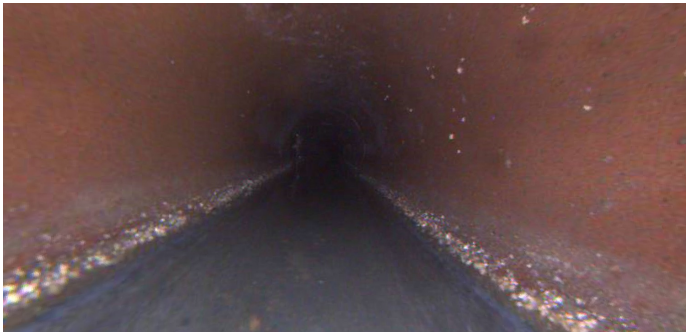
Code: **MWL**
Description: **Water Level**

Distance (ft): **.0**
Structural Grade: **0**
O&M Grade: **0**
Clock Start/From:
Clock To:
1st Value:
2nd Value:
Value Percent: **20.000**
Continuous Index:
Within 8" of Joint: **NO**
Remarks:

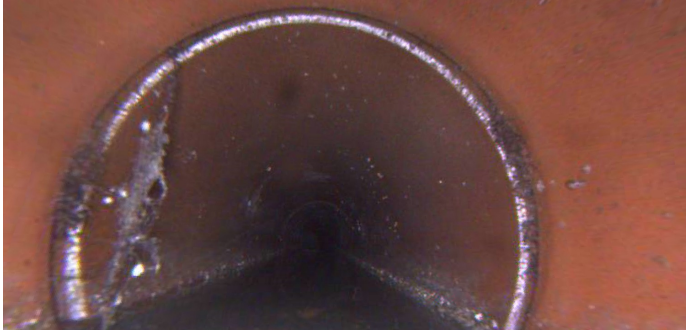
Code: **RFJ**
Description: **Roots Fine Joint**

Distance (ft): **3.6**
Structural Grade: **0**
O&M Grade: **1**
Clock Start/From: **8**
Clock To: **4**
1st Value:
2nd Value:
Value Percent:
Continuous Index:
Within 8" of Joint: **YES**
Remarks:

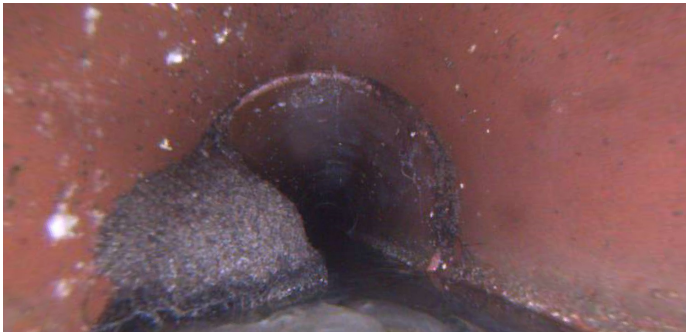
Code: **RMJ**
Description: **Roots Medium Joint**

Distance (ft): **9.2**
Structural Grade: **0**
O&M Grade: **3**
Clock Start/From: **8**
Clock To: **4**
1st Value:
2nd Value:
Value Percent: **40.000**
Continuous Index:
Within 8" of Joint: **YES**
Remarks:

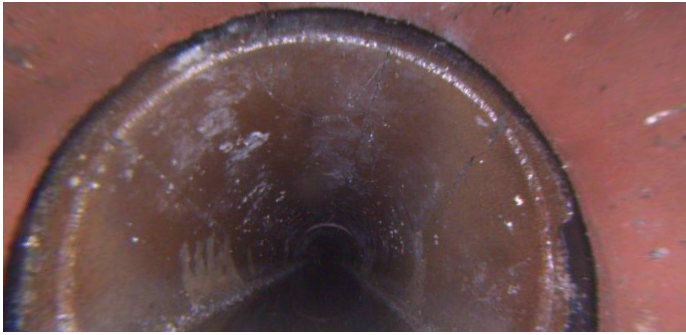
Code: **FM**
Description: **Fracture Multiple**

Distance (ft): **12.7**
Structural Grade: **4**
O&M Grade: **0**
Clock Start/From: **8**
Clock To: **4**
1st Value:
2nd Value:
Value Percent:
Continuous Index: **S01**
Within 8" of Joint: **YES**
Remarks:

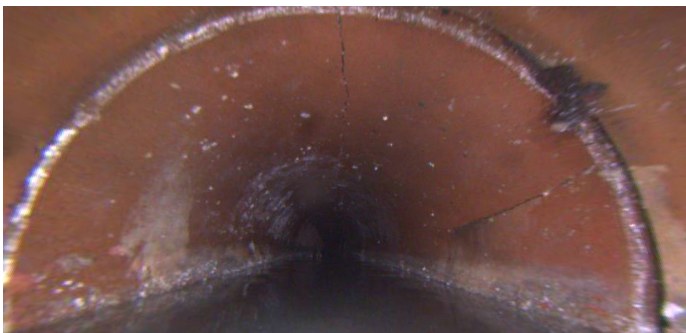
Code: **RFJ**
Description: **Roots Fine Joint**

Distance (ft): **15.8**
Structural Grade: **0**
O&M Grade: **1**
Clock Start/From: **2**
Clock To:
1st Value:
2nd Value:
Value Percent:
Continuous Index:
Within 8" of Joint: **YES**
Remarks:

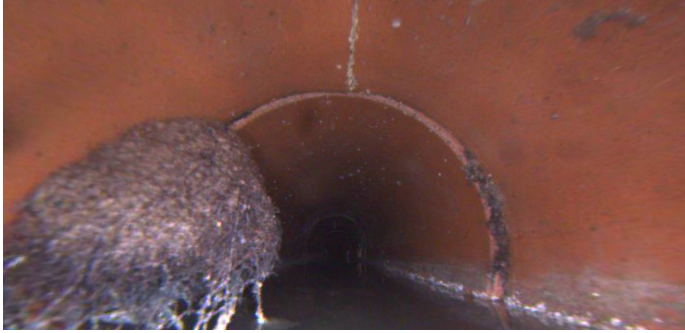
Code: **RMJ**
Description: **Roots Medium Joint**

Distance (ft): **18.5**
Structural Grade: **0**
O&M Grade: **3**
Clock Start/From: **8**
Clock To: **4**
1st Value:
2nd Value:
Value Percent: **20.000**
Continuous Index:
Within 8" of Joint: **YES**
Remarks:

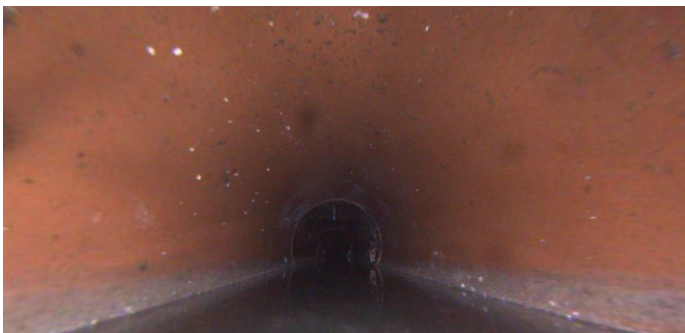
Code: **FM**
Description: **Fracture Multiple**

Distance (ft): **19.8**
Structural Grade: **4**
O&M Grade: **0**
Clock Start/From: **8**
Clock To: **4**
1st Value:
2nd Value:
Value Percent:
Continuous Index: **F01**
Within 8" of Joint: **YES**
Remarks:

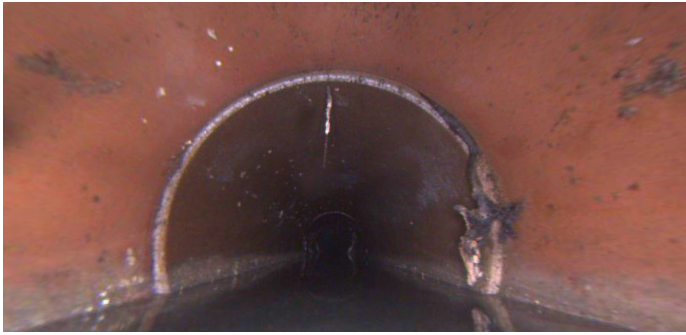
Code: **RFJ**
Description: **Roots Fine Joint**

Distance (ft): **21.6**
Structural Grade: **0**
O&M Grade: **1**
Clock Start/From: **8**
Clock To: **4**
1st Value:
2nd Value:
Value Percent:
Continuous Index: **S02**
Within 8" of Joint: **YES**
Remarks:

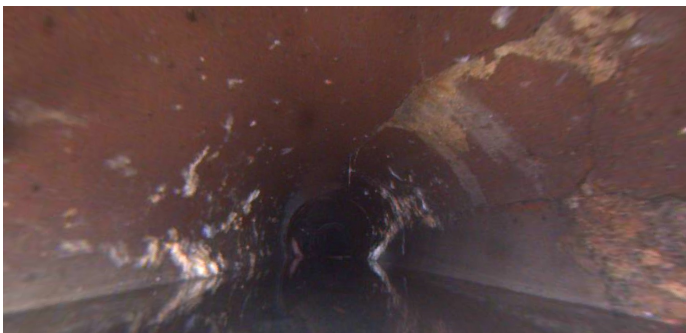
Code: **FM**
Description: **Fracture Multiple**

Distance (ft): **25.4**
Structural Grade: **4**
O&M Grade: **0**
Clock Start/From: **8**
Clock To: **4**
1st Value:
2nd Value:
Value Percent:
Continuous Index: **S03**
Within 8" of Joint: **YES**
Remarks:

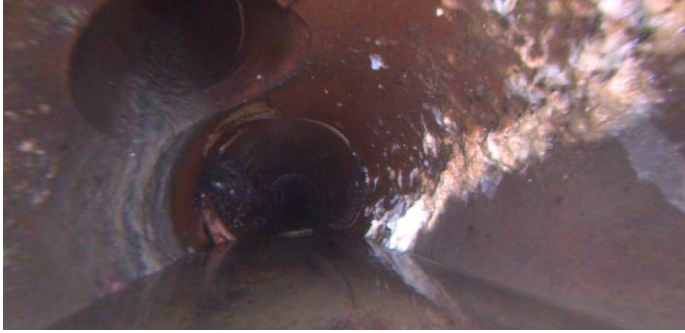
Code: **DAGS**
Description: **Deposits Attached Grease**

Distance (ft): **26.8**
Structural Grade: **0**
O&M Grade: **2**
Clock Start/From: **1**
Clock To: **4**
1st Value:
2nd Value:
Value Percent: **5.000**
Continuous Index:
Within 8" of Joint: **NO**
Remarks:

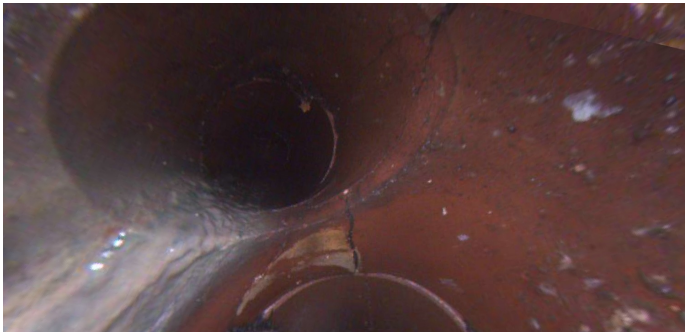
Code: **TF**
Description: **Tap Factory**

Distance (ft): **27.2**
Structural Grade: **0**
O&M Grade: **0**
Clock Start/From: **11**
Clock To:
1st Value: **4.000**
2nd Value:
Value Percent:
Continuous Index:
Within 8" of Joint:
Remarks:

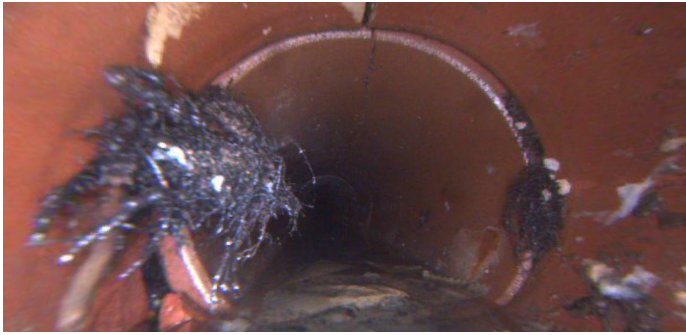
Code: **RMJ**
Description: **Roots Medium Joint**

Distance (ft): **27.7**
Structural Grade: **0**
O&M Grade: **3**
Clock Start/From: **8**
Clock To: **4**
1st Value:
2nd Value:
Value Percent: **10.000**
Continuous Index:
Within 8" of Joint: **YES**
Remarks:

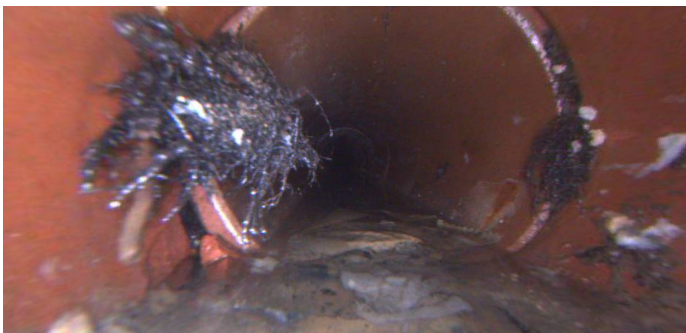
Code: **B**
Description: **Broken**

Distance (ft): **27.7**
Structural Grade: **3**
O&M Grade: **0**
Clock Start/From: **8**
Clock To:
1st Value:
2nd Value:
Value Percent:
Continuous Index:
Within 8" of Joint: **YES**
Remarks:

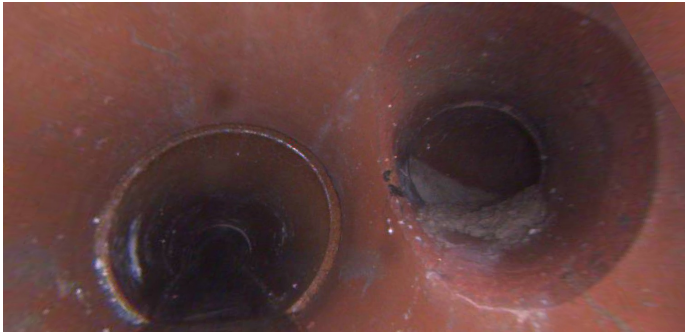
Code: **TF**
Description: **Tap Factory**

Distance (ft): **57.3**
Structural Grade: **0**
O&M Grade: **0**
Clock Start/From: **3**
Clock To:
1st Value: **4.000**
2nd Value:
Value Percent:
Continuous Index:
Within 8" of Joint:
Remarks:

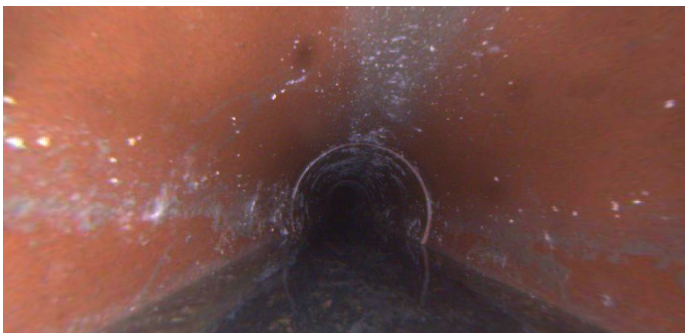
Code: **MWL**
Description: **Water Level**

Distance (ft): **63.0**
Structural Grade: **0**
O&M Grade: **0**
Clock Start/From:
Clock To:
1st Value:
2nd Value:
Value Percent: **20.000**
Continuous Index:
Within 8" of Joint: **NO**
Remarks:

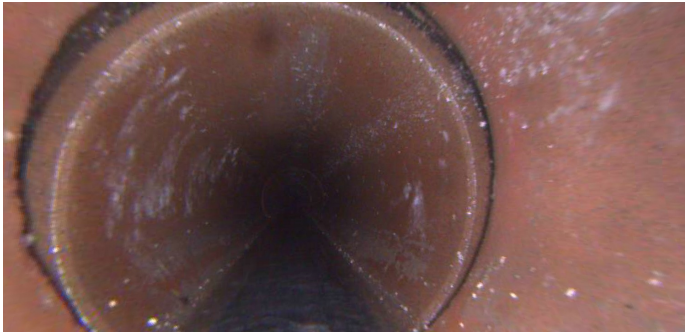
Code: **RFJ**
Description: **Roots Fine Joint**

Distance (ft): **69.9**
Structural Grade: **0**
O&M Grade: **1**
Clock Start/From: **8**
Clock To: **4**
1st Value:
2nd Value:
Value Percent:
Continuous Index: **F02**
Within 8" of Joint: **YES**
Remarks:

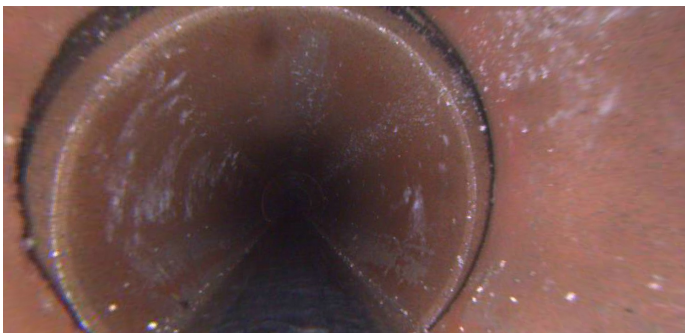
Code: **FM**
Description: **Fracture Multiple**

Distance (ft): **69.9**
Structural Grade: **4**
O&M Grade: **0**
Clock Start/From: **8**
Clock To: **4**
1st Value:
2nd Value:
Value Percent:
Continuous Index: **F03**
Within 8" of Joint: **YES**
Remarks:

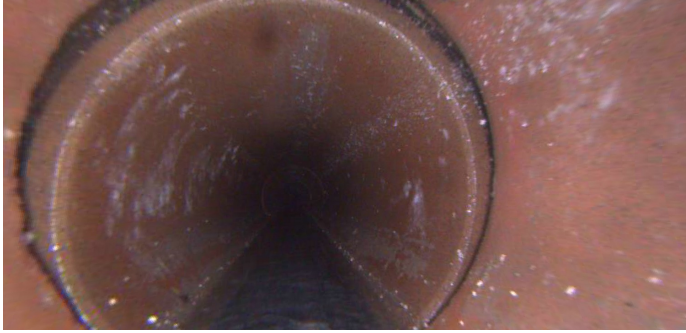
Code: **MWL**
Description: **Water Level**

Distance (ft): **69.9**
Structural Grade: **0**
O&M Grade: **0**
Clock Start/From:
Clock To:
1st Value:
2nd Value:
Value Percent: **5.000**
Continuous Index:
Within 8" of Joint: **NO**
Remarks:

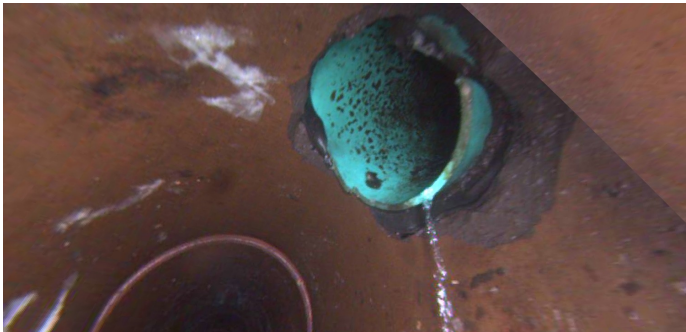
Code: **TBI**
Description: **Tap Break-in Intruding**

Distance (ft): **84.2**
Structural Grade: **0**
O&M Grade: **2**
Clock Start/From: **2**
Clock To:
1st Value: **4.000**
2nd Value: **1.000**
Value Percent:
Continuous Index:
Within 8" of Joint:
Remarks: **ACTIVE**

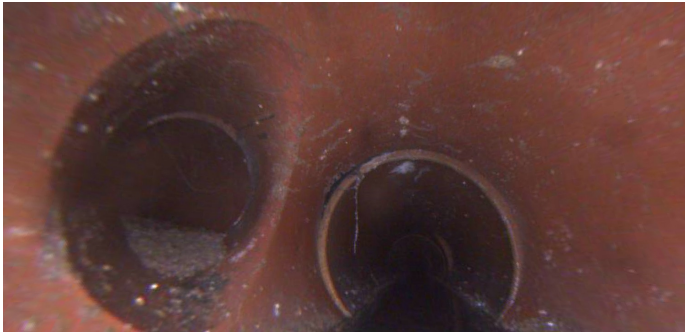
Code: **TF**
Description: **Tap Factory**

Distance (ft): **102.5**
Structural Grade: **0**
O&M Grade: **0**
Clock Start/From: **9**
Clock To:
1st Value: **4.000**
2nd Value:
Value Percent:
Continuous Index:
Within 8" of Joint: **NO**
Remarks:

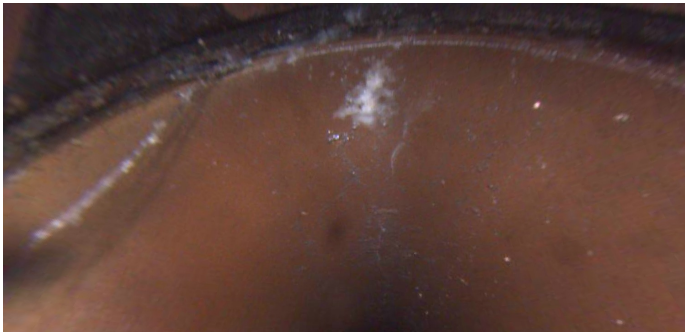
Code: **RFJ**
Description: **Roots Fine Joint**

Distance (ft): **103.6**
Structural Grade: **0**
O&M Grade: **1**
Clock Start/From: **11**
Clock To:
1st Value:
2nd Value:
Value Percent:
Continuous Index:
Within 8" of Joint: **YES**
Remarks:

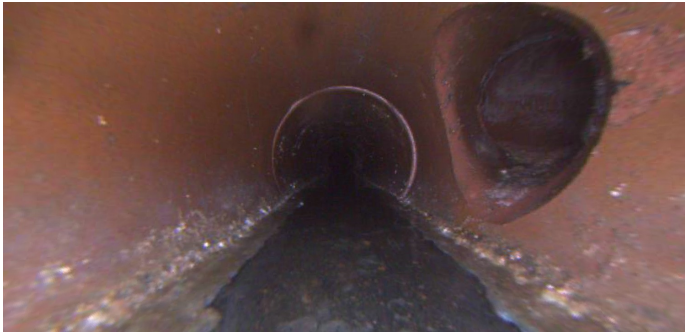
Code: **TF**
Description: **Tap Factory**

Distance (ft): **105.3**
Structural Grade: **0**
O&M Grade: **0**
Clock Start/From: **3**
Clock To:
1st Value: **4.000**
2nd Value:
Value Percent:
Continuous Index:
Within 8" of Joint:
Remarks:

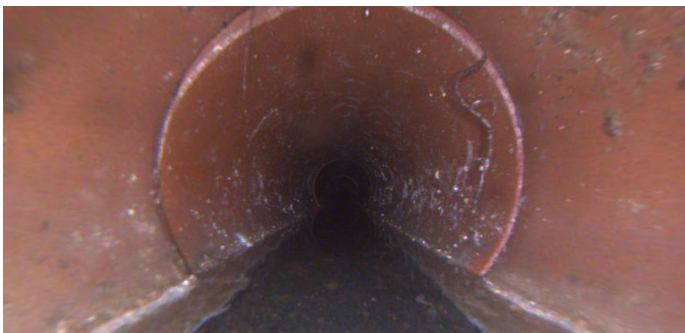
Code: **RFJ**
Description: **Roots Fine Joint**

Distance (ft): **109.2**
Structural Grade: **0**
O&M Grade: **1**
Clock Start/From: **8**
Clock To: **4**
1st Value:
2nd Value:
Value Percent:
Continuous Index:
Within 8" of Joint: **YES**
Remarks:

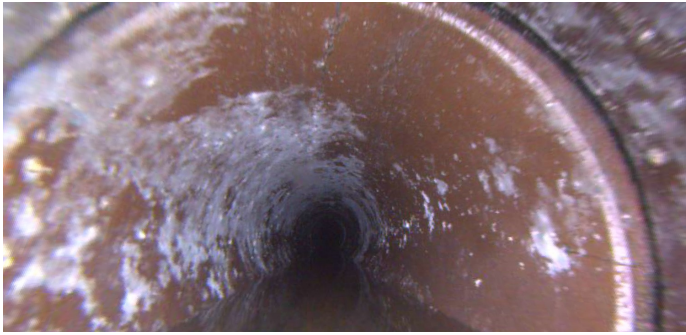
Code: **FH2**
Description: **Fracture Longitudinal Hinge, 2**

Distance (ft): **133.6**
Structural Grade: **4**
O&M Grade: **0**
Clock Start/From: **12**
Clock To: **3**
1st Value:
2nd Value:
Value Percent:
Continuous Index:
Within 8" of Joint: **YES**
Remarks:

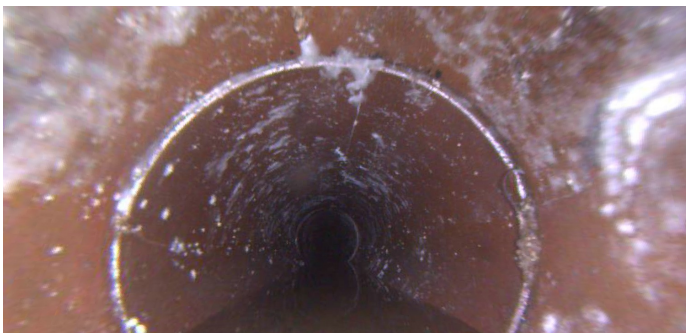
Code: **RFJ**
Description: **Roots Fine Joint**

Distance (ft): **136.4**
Structural Grade: **0**
O&M Grade: **1**
Clock Start/From: **8**
Clock To: **4**
1st Value:
2nd Value:
Value Percent:
Continuous Index:
Within 8" of Joint: **YES**
Remarks:

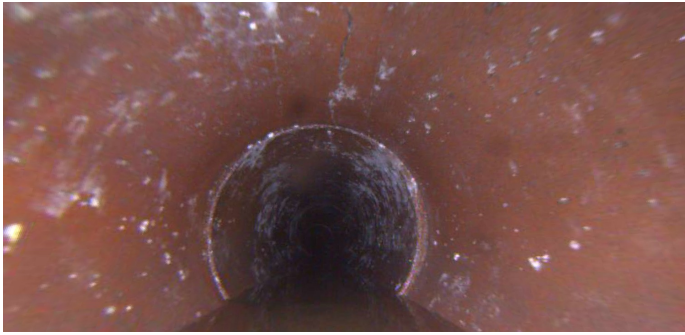
Code: **FL**
Description: **Fracture Longitudinal**

Distance (ft): **138.9**
Structural Grade: **3**
O&M Grade: **0**
Clock Start/From: **12**
Clock To:
1st Value:
2nd Value:
Value Percent:
Continuous Index:
Within 8" of Joint: **YES**
Remarks:

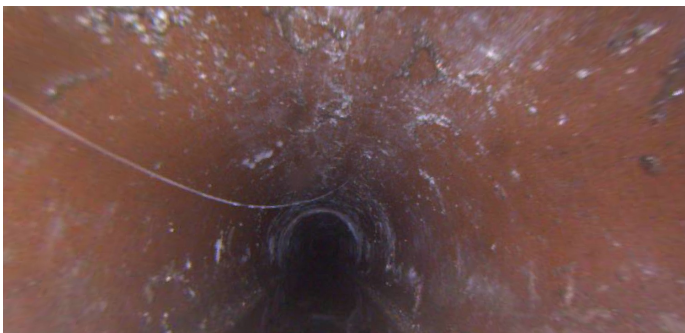
Code: **DAGS**
Description: **Deposits Attached Grease**

Distance (ft): **160.9**
Structural Grade: **0**
O&M Grade: **2**
Clock Start/From: **8**
Clock To: **4**
1st Value:
2nd Value:
Value Percent: **5.000**
Continuous Index: **S04**
Within 8" of Joint: **NO**
Remarks:

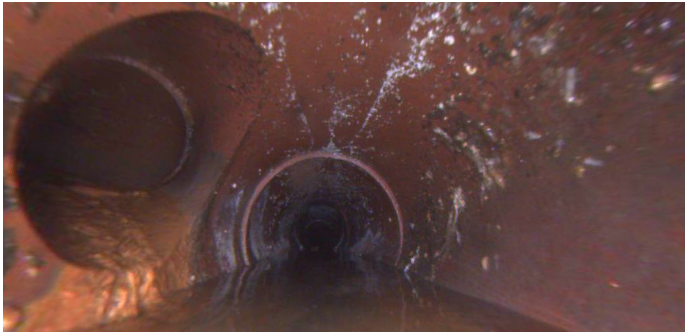
Code: **TFA**
Description: **Tap Factory Active**

Distance (ft): **168.5**
Structural Grade: **0**
O&M Grade: **0**
Clock Start/From: **9**
Clock To:
1st Value: **4.000**
2nd Value:
Value Percent:
Continuous Index:
Within 8" of Joint:
Remarks:

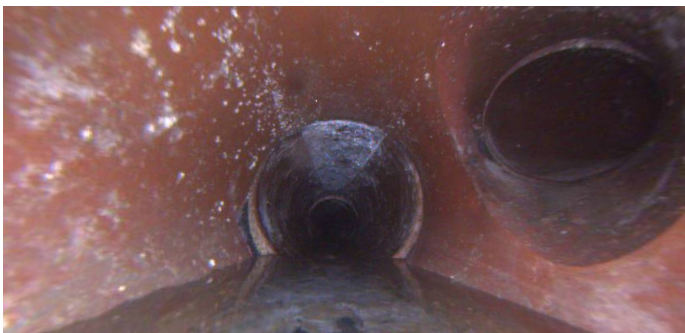
Code: **TFA**
Description: **Tap Factory Active**

Distance (ft): **171.7**
Structural Grade: **0**
O&M Grade: **0**
Clock Start/From: **3**
Clock To:
1st Value: **4.000**
2nd Value:
Value Percent:
Continuous Index:
Within 8" of Joint:
Remarks:

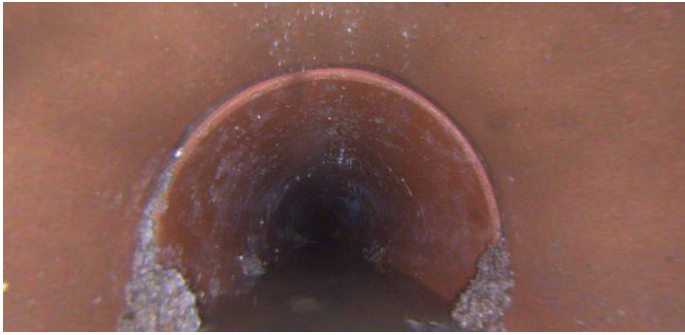
Code: **DAZ**
Description: **Deposits Attached Other**

Distance (ft): **178.4**
Structural Grade: **0**
O&M Grade: **2**
Clock Start/From: **8**
Clock To: **4**
1st Value:
2nd Value:
Value Percent: **5.000**
Continuous Index:
Within 8" of Joint: **YES**
Remarks:

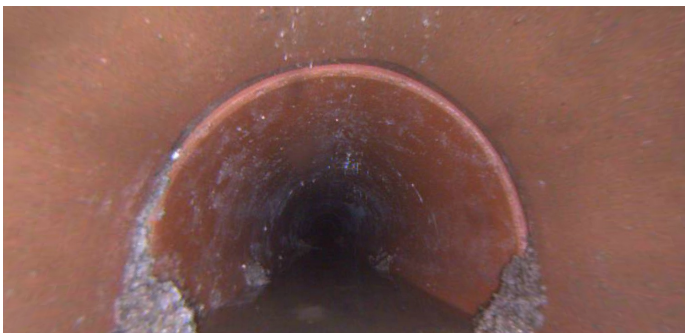
Code: **DAZ**
Description: **Deposits Attached Other**

Distance (ft): **178.4**
Structural Grade: **0**
O&M Grade: **2**
Clock Start/From: **8**
Clock To: **4**
1st Value:
2nd Value:
Value Percent: **5.000**
Continuous Index: **S05**
Within 8" of Joint: **YES**
Remarks:

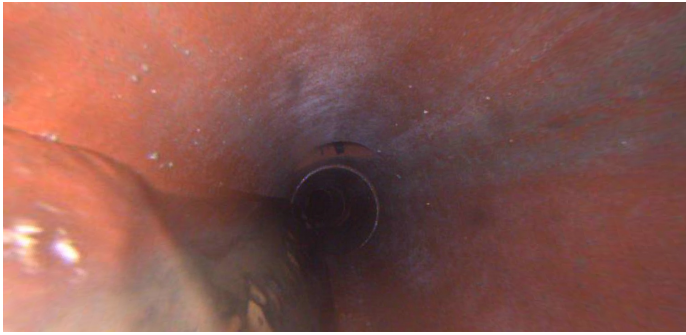
Code: **MSA**
Description: **Abandoned Survey**

Distance (ft): **194.7**
Structural Grade: **0**
O&M Grade: **0**
Clock Start/From:
Clock To:
1st Value:
2nd Value:
Value Percent:
Continuous Index:
Within 8" of Joint: **NO**
Remarks: **OVERTURNED**

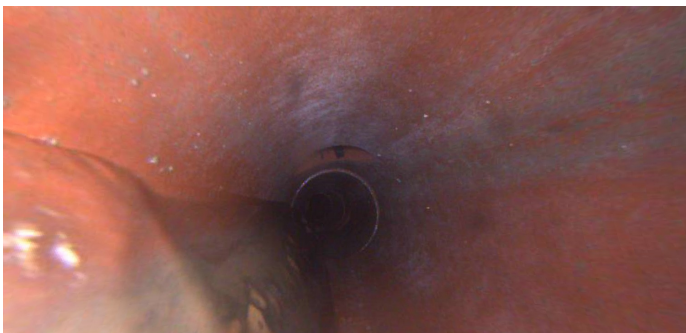
Code: **DAZ**
Description: **Deposits Attached Other**

Distance (ft): **194.7**
Structural Grade: **0**
O&M Grade: **2**
Clock Start/From: **8**
Clock To: **4**
1st Value:
2nd Value:
Value Percent: **5.000**
Continuous Index: **F05**
Within 8" of Joint: **YES**
Remarks:

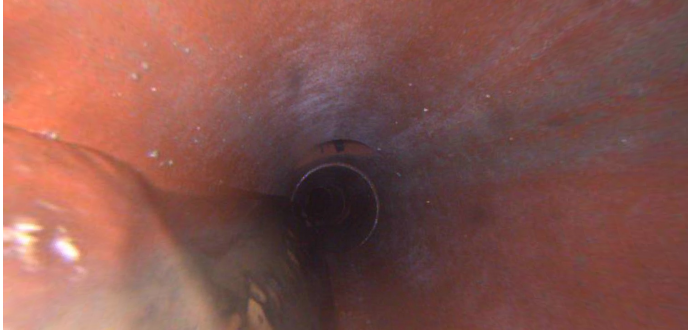
Code:	DAGS
Description:	Deposits Attached Grease
Distance (ft):	194.7
Structural Grade:	0
O&M Grade:	2
Clock Start/From:	8
Clock To:	4
1st Value:	
2nd Value:	
Value Percent:	5.000
Continuous Index:	F04
Within 8" of Joint:	NO
Remarks:
