Profile/Photo Observation Report

Date:	04/03/2018	Weather:		Coding:	PACP 6.0
Pipe Length (ft):	139.2	Owner:	NA	Pre Clean:	Not Known
P.O.#:		Surveyor:	Jen Costello	PSR:	P-903-029-013
Customer:		Clean Date:	01/01/1900	Shape:	C

Street:	Rand St.	Flow Control:	Not Controlled
City:	Hobart, IN	Year Renewed:	
Location:	Other	Tape/Media #:	
Purpose:	Not Known	Dia/Height:	12"
Use:	Sanitary	Material:	VCP
Drain Area:	NA	Lining:	
Category:	NA		
Comment:

Location Details:		Direction of Survey:	Upstream
US MH:	M-903-029	DS MH:	M-803-013
		Total Length Surveyed (ft):	8.8

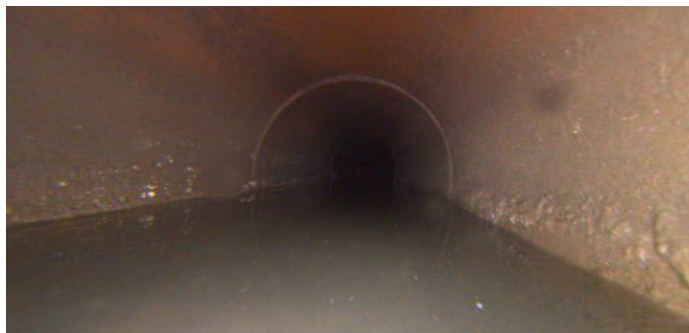
Code: **AMH**
 Description: **Manhole**

Distance (ft): **.0**
 Structural Grade: **0**
 O&M Grade: **0**
 Clock Start/From:
 Clock To:
 1st Value:
 2nd Value:
 Value Percent:
 Continuous Index:
 Within 8" of Joint: **NO**
 Remarks: **M-803-013**

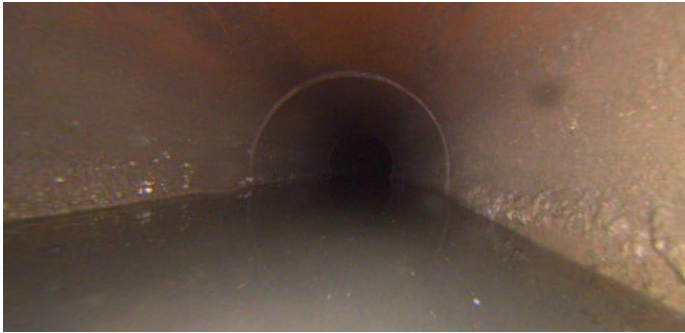
Code:	MWL
Description:	Water Level

Distance (ft):	.0
Structural Grade:	0
O&M Grade:	0
Clock Start/From:	
Clock To:	
1st Value:	
2nd Value:	
Value Percent:	40.000
Continuous Index:	
Within 8" of Joint:	NO
Remarks:

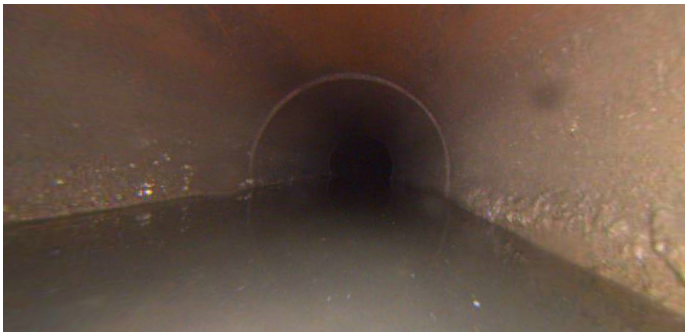
Code:	DAGS
Description:	Deposits Attached Grease

Distance (ft):	.0
Structural Grade:	0
O&M Grade:	2
Clock Start/From:	8
Clock To:	4
1st Value:	
2nd Value:	
Value Percent:	5.000
Continuous Index:	S01
Within 8" of Joint:	NO
Remarks:

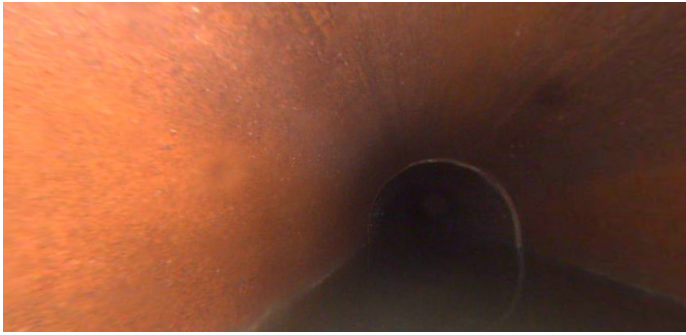
Code: **DAGS**
Description: **Deposits Attached Grease**

Distance (ft): **6.3**
Structural Grade: **0**
O&M Grade: **2**
Clock Start/From: **8**
Clock To: **4**
1st Value:
2nd Value:
Value Percent: **5.000**
Continuous Index: **F01**
Within 8" of Joint: **NO**
Remarks:

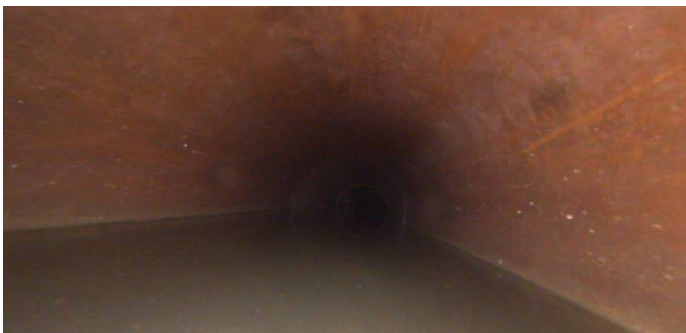
Code: **MSA**
Description: **Abandoned Survey**

Distance (ft): **8.8**
Structural Grade: **0**
O&M Grade: **0**
Clock Start/From:
Clock To:
1st Value:
2nd Value:
Value Percent:
Continuous Index:
Within 8" of Joint: **NO**
Remarks: **HIGH WATER**
