## Profile/Photo Observation Report

Street:	<b>E RAND ST &amp; N HOBART RD</b>	Flow Control:	<b>Not Controlled</b>
City:	<b>Hobart, IN</b>	Year Renewed:	
Location:	<b>Light Highway</b>	Tape/Media #:	
Purpose:	<b>Routine Assessment</b>	Dia/Height:	<b>12"</b>
Use:	<b>Sanitary</b>	Material:	<b>VCP</b>
Drain Area:	<b>NA</b>	Lining:	
Category:	<b>NA</b>		
Comment:

Location Details:		Direction of Survey:	<b>Upstream</b>
US MH:	<b>M-903-029</b>	DS MH:	<b>M-803-013</b>
		Total Length Surveyed (ft):	<b>17.6</b>

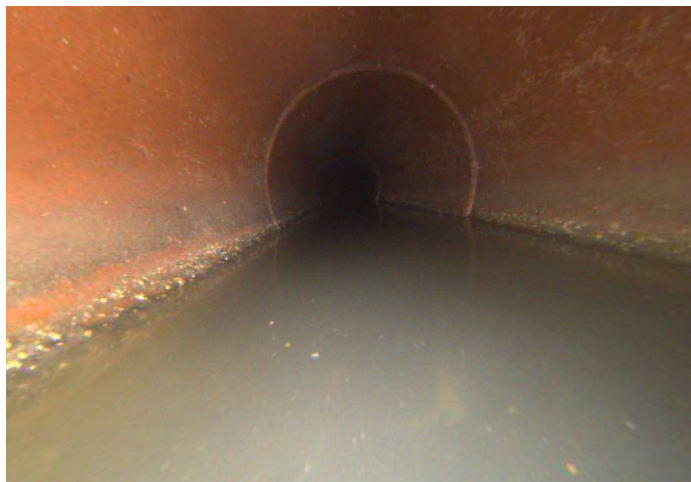
Code: **AMH**  
Description: **Manhole**

Distance (ft): **.0**  
Structural Grade: **0**  
O&M Grade: **0**  
Clock Start/From:  
Clock To:  
1st Value:  
2nd Value:  
Value Percent:  
Continuous Index:  
Within 8" of Joint: **NO**  
Remarks: **M-803-013**

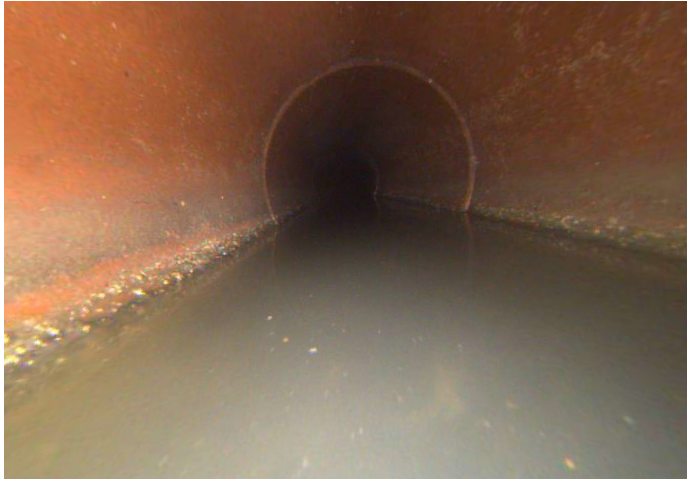
Code: **MWL**  
Description: **Water Level**

Distance (ft): **.0**  
Structural Grade: **0**  
O&M Grade: **0**  
Clock Start/From:  
Clock To:  
1st Value:  
2nd Value:  
Value Percent: **25.000**  
Continuous Index:  
Within 8" of Joint: **NO**  
Remarks:

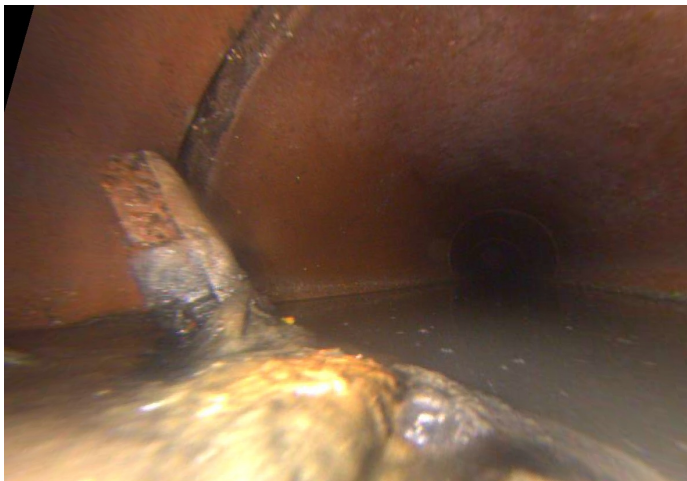
Code: **OBM**  
Description: **Obstacle Pipe Material**

Distance (ft): **16.7**  
Structural Grade: **0**  
O&M Grade: **3**  
Clock Start/From: **6**  
Clock To: **8**  
1st Value:  
2nd Value:  
Value Percent: **20.000**  
Continuous Index:  
Within 8" of Joint: **NO**  
Remarks:

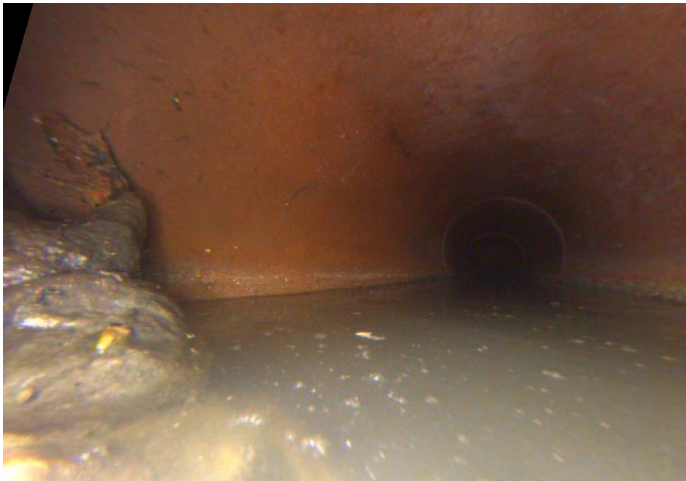
Code:	<b>MSA</b>
Description:	<b>Abandoned Survey</b>
Distance (ft):	<b>17.6</b>
Structural Grade:	<b>0</b>
O&M Grade:	<b>0</b>
Clock Start/From:	
Clock To:	
1st Value:	
2nd Value:	
Value Percent:	
Continuous Index:	
Within 8" of Joint:	<b>NO</b>
Remarks:	<b>OBM</b>
