Profile/Photo Observation Report

Date:	10/19/2021	Weather:		Coding:	PACP 6.0
Pipe Length (ft):		Owner:	Hobart, IN	Pre Clean:	Not Known
P.O.#:	886_1	Surveyor:	M. Pielacha	PSR:	P-903-031-030
Customer:	Hobart, IN	Clean Date:		Shape:	C

Street:	Off Rand Street	Flow Control:	
City:	Hobart, IN	Year Renewed:	
Location:	Alley	Tape/Media #:	886
Purpose:	Routine Assessment	Dia/Height:	12"
Use:	Sanitary	Material:	VCP
Drain Area:		Lining:	
Category:	NA		
Comment:

Location Details:		Direction of Survey:	Upstream
US MH:	M-903-30	DS MH:	M-903-31
		Total Length Surveyed (ft):	205.5

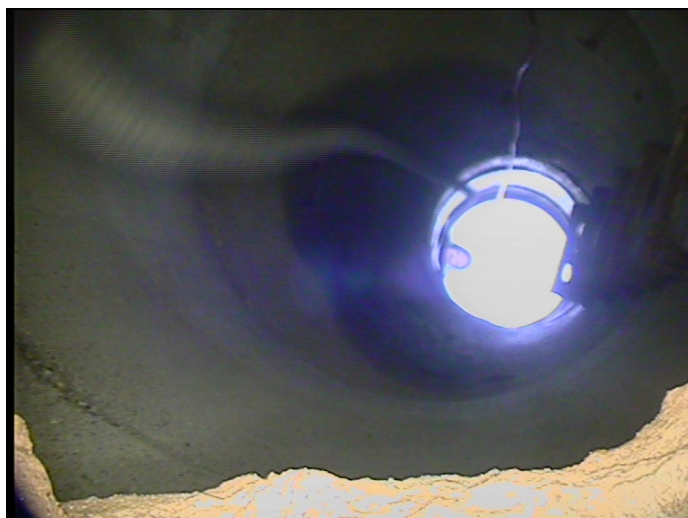
Code: **AMH**
 Description: **Manhole**

Distance (ft): **.0**
 Structural Grade: **0**
 O&M Grade: **0**
 Clock Start/From:
 Clock To:
 1st Value:
 2nd Value:
 Value Percent:
 Continuous Index:
 Within 8" of Joint: **NO**
 Remarks: **M-903-31**

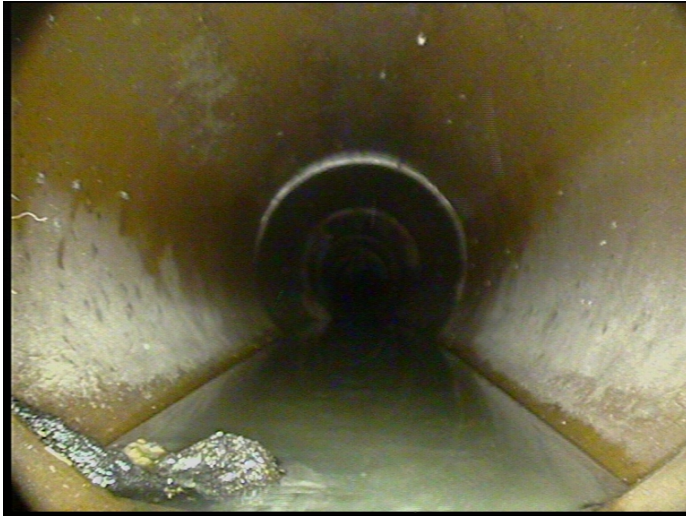
Code: **MWL**
Description: **Water Level**

Distance (ft): **.0**
Structural Grade: **0**
O&M Grade: **0**
Clock Start/From:
Clock To:
1st Value:
2nd Value:
Value Percent: **5.000**
Continuous Index:
Within 8" of Joint: **NO**
Remarks:

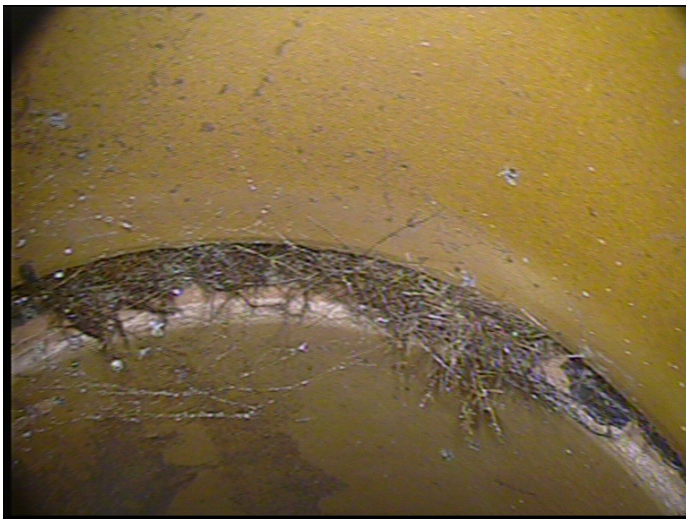
Code: **RFJ**
Description: **Roots Fine Joint**

Distance (ft): **7.3**
Structural Grade: **0**
O&M Grade: **1**
Clock Start/From: **7**
Clock To: **5**
1st Value:
2nd Value:
Value Percent:
Continuous Index:
Within 8" of Joint: **YES**
Remarks:

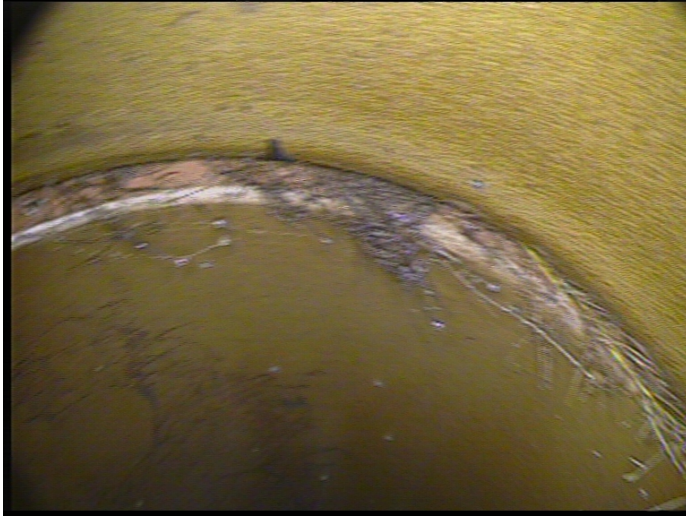
Code: **RFJ**
Description: **Roots Fine Joint**

Distance (ft): **10.4**
Structural Grade: **0**
O&M Grade: **1**
Clock Start/From: **7**
Clock To: **5**
1st Value:
2nd Value:
Value Percent:
Continuous Index:
Within 8" of Joint: **YES**
Remarks:

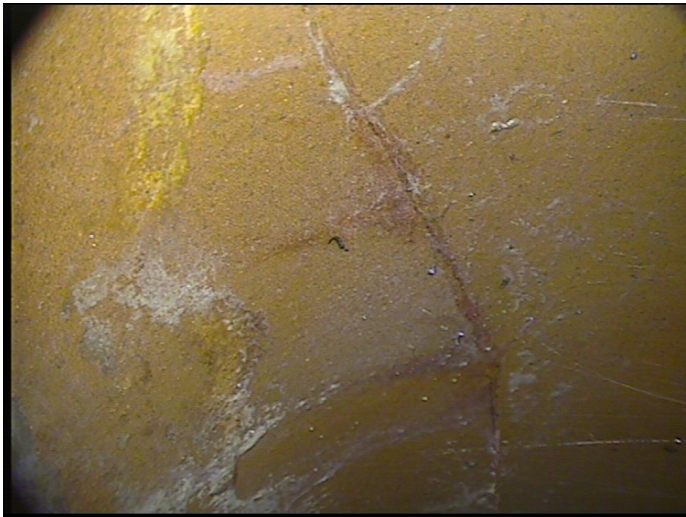
Code: **CL**
Description: **Crack Longitudinal**

Distance (ft): **43.9**
Structural Grade: **2**
O&M Grade: **0**
Clock Start/From: **9**
Clock To:
1st Value:
2nd Value:
Value Percent:
Continuous Index:
Within 8" of Joint: **YES**
Remarks:

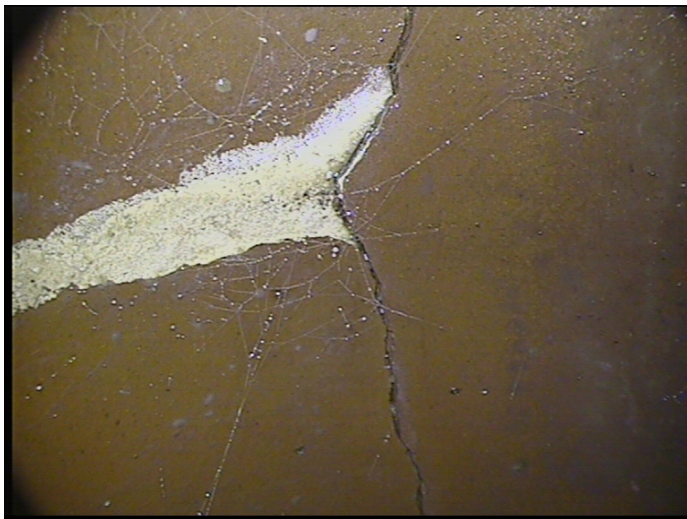
Code: **CL**
Description: **Crack Longitudinal**

Distance (ft): **47.8**
Structural Grade: **2**
O&M Grade: **0**
Clock Start/From: **10**
Clock To:
1st Value:
2nd Value:
Value Percent:
Continuous Index:
Within 8" of Joint: **YES**
Remarks:

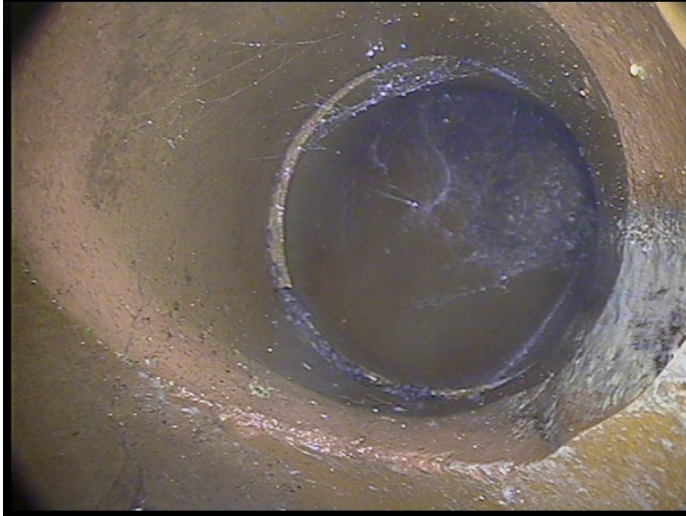
Code: **TF**
Description: **Tap Factory**

Distance (ft): **54.8**
Structural Grade: **0**
O&M Grade: **0**
Clock Start/From: **3**
Clock To:
1st Value: **4.000**
2nd Value:
Value Percent:
Continuous Index:
Within 8" of Joint: **NO**
Remarks:

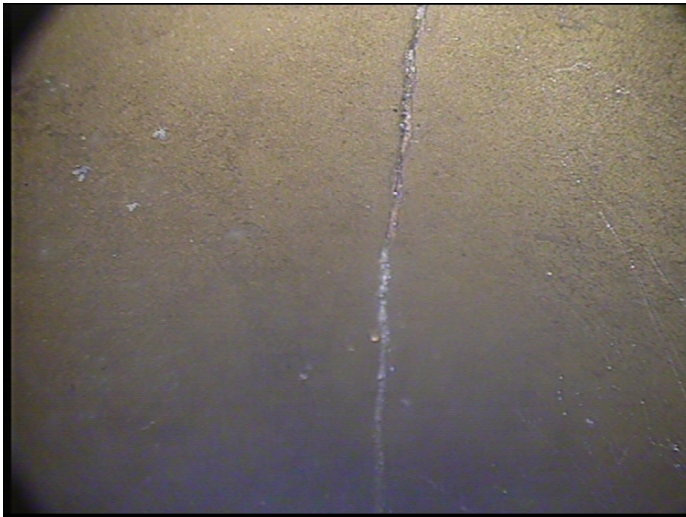
Code: **CL**
Description: **Crack Longitudinal**

Distance (ft): **61.9**
Structural Grade: **2**
O&M Grade: **0**
Clock Start/From: **12**
Clock To:
1st Value:
2nd Value:
Value Percent:
Continuous Index:
Within 8" of Joint: **YES**
Remarks:

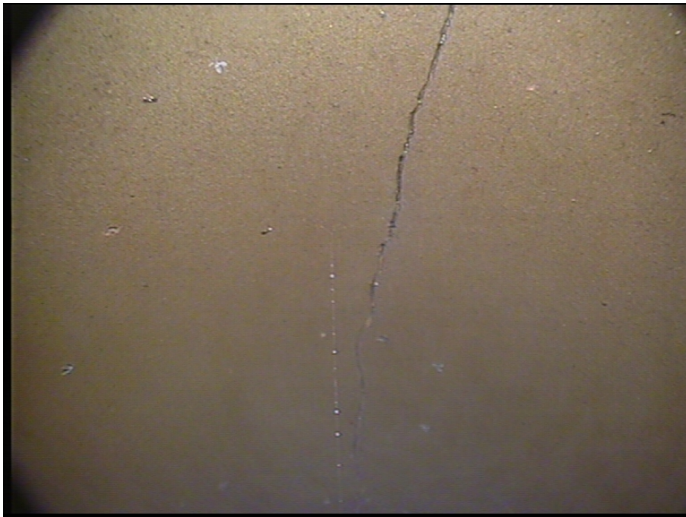
Code:	CL
Description:	Crack Longitudinal
Distance (ft):	71.9
Structural Grade:	2
O&M Grade:	0
Clock Start/From:	12
Clock To:	
1st Value:	
2nd Value:	
Value Percent:	
Continuous Index:	S01
Within 8" of Joint:	YES
Remarks:

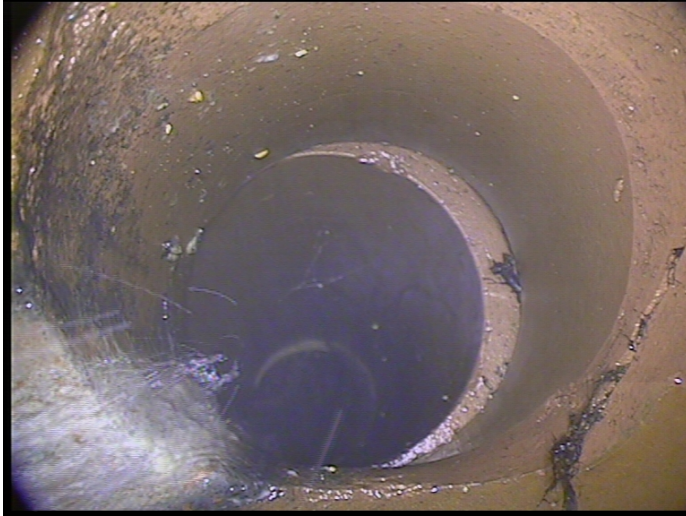
Code:	TFA
Description:	Tap Factory Active
Distance (ft):	81.8
Structural Grade:	0
O&M Grade:	0
Clock Start/From:	10
Clock To:	
1st Value:	4.000
2nd Value:	
Value Percent:	
Continuous Index:	
Within 8" of Joint:	NO
Remarks:

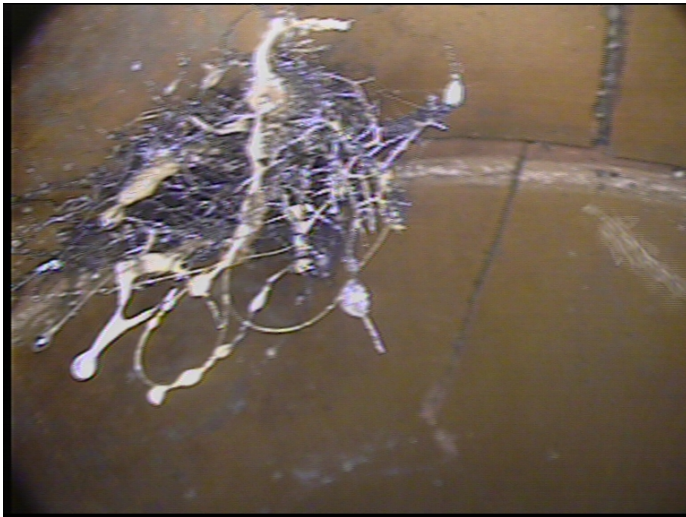
Code:	RMJ
Description:	Roots Medium Joint
Distance (ft):	82.4
Structural Grade:	0
O&M Grade:	3
Clock Start/From:	10
Clock To:	11
1st Value:	
2nd Value:	
Value Percent:	5.000
Continuous Index:	
Within 8" of Joint:	YES
Remarks:

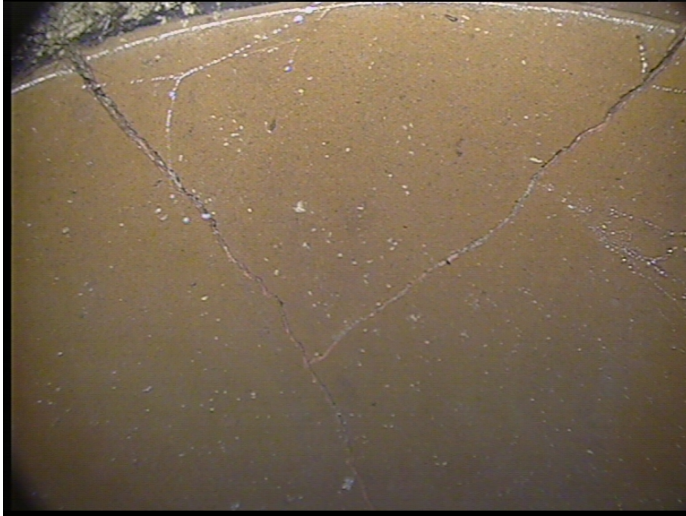
Code:	CM
Description:	Crack Multiple
Distance (ft):	94.5
Structural Grade:	3
O&M Grade:	0
Clock Start/From:	10
Clock To:	12
1st Value:	
2nd Value:	
Value Percent:	
Continuous Index:	
Within 8" of Joint:	YES
Remarks:

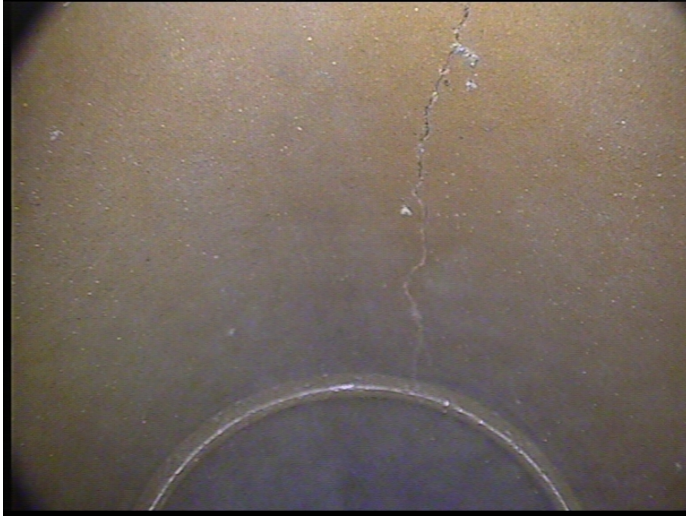
Code:	CL
Description:	Crack Longitudinal
Distance (ft):	126.2
Structural Grade:	2
O&M Grade:	0
Clock Start/From:	1
Clock To:	
1st Value:	
2nd Value:	
Value Percent:	
Continuous Index:	
Within 8" of Joint:	YES
Remarks:

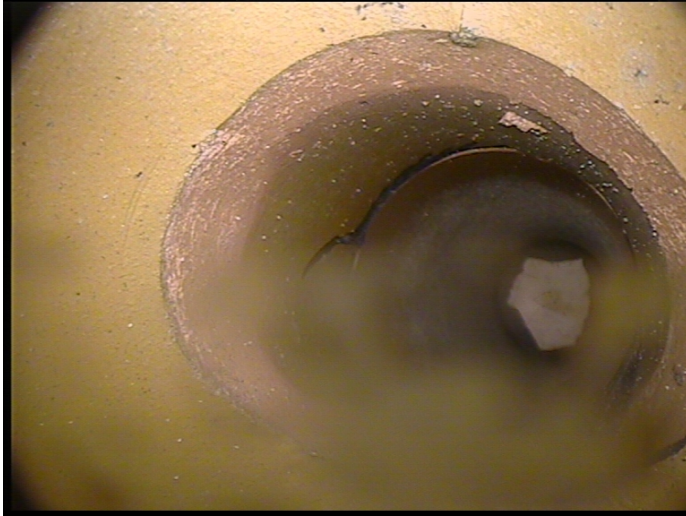
Code: **TF**
Description: **Tap Factory**

Distance (ft): **177.5**
Structural Grade: **0**
O&M Grade: **0**
Clock Start/From: **2**
Clock To:
1st Value: **4.000**
2nd Value:
Value Percent:
Continuous Index:
Within 8" of Joint: **NO**
Remarks:

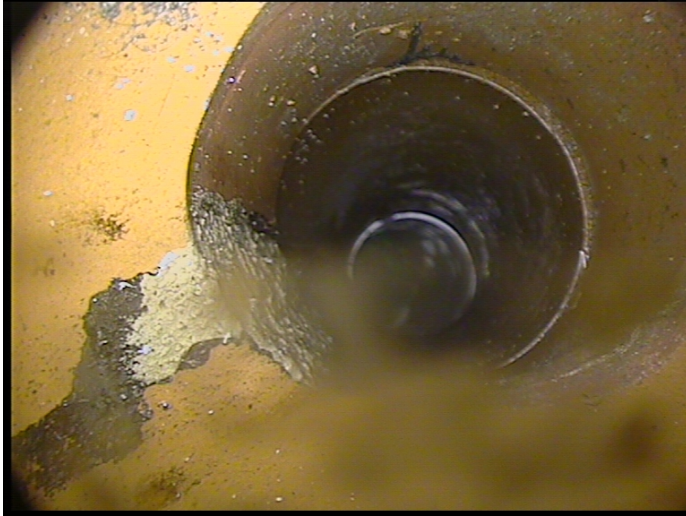
Code: **TF**
Description: **Tap Factory**

Distance (ft): **198.7**
Structural Grade: **0**
O&M Grade: **0**
Clock Start/From: **10**
Clock To:
1st Value: **4.000**
2nd Value:
Value Percent:
Continuous Index:
Within 8" of Joint: **NO**
Remarks:

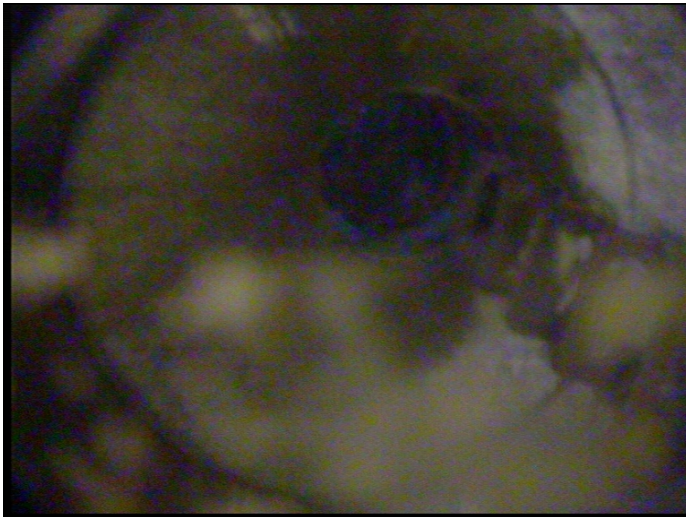
Code: **AMH**
Description: **Manhole**

Distance (ft): **205.5**
Structural Grade: **0**
O&M Grade: **0**
Clock Start/From:
Clock To:
1st Value:
2nd Value:
Value Percent:
Continuous Index:
Within 8" of Joint: **NO**
Remarks: **M-903-30**
