Profile/Photo Observation Report

Date:	05/05/2018	Weather:		Coding:	PACP 4.2
Pipe Length (ft):	227.9	Owner:	City of Hobart	Pre Clean:	No Pre-Cleaning
P.O.#:	2004	Surveyor:	SAN	PSR:	P-903-034-033
Customer:	Red Zone	Clean Date:		Shape:	C

Street:	703 N Hobart Rd	Flow Control:	Not Controlled
City:	Hobart In	Year Renewed:	
Location:	Main Highway - Urban	Tape/Media #:	Deliverable 1
Purpose:	Routine Assessment	Dia/Height:	12"
Use:	Sanitary	Material:	VCP
Drain Area:	Northeast	Lining:	
Category:	NA		
Comment:	450-1		
Location Details:	Edge of street	Direction of Survey:	Upstream
US MH:	M-903-034	DS MH:	M-903-033
		Total Length Surveyed (ft):	227.9

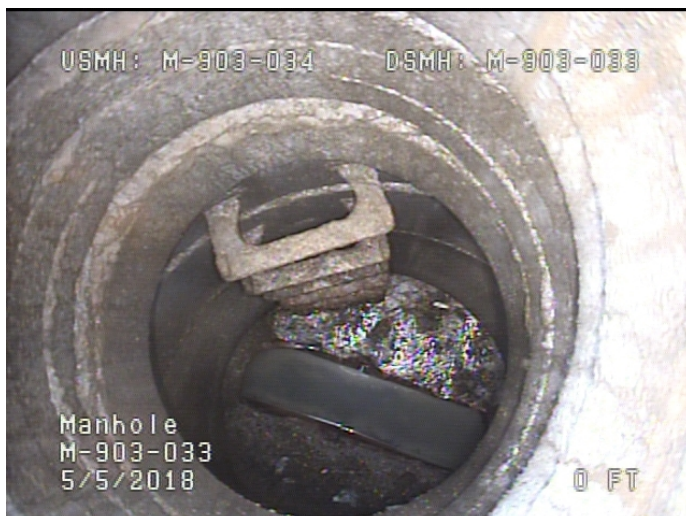
Code: **AMH**
 Description: **Manhole**

Distance (ft): **.0**
 Structural Grade: **0**
 O&M Grade: **0**
 Clock Start/From:
 Clock To:
 1st Value:
 2nd Value:
 Value Percent:
 Continuous Index:
 Within 8" of Joint: **NO**
 Remarks: **M-903-033**

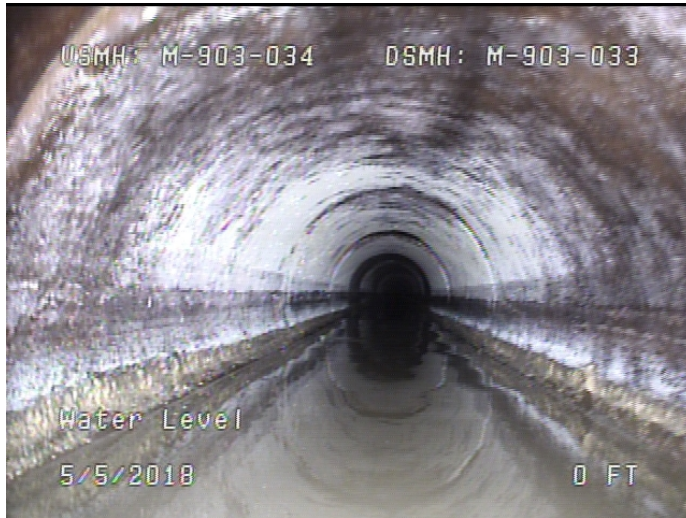
Code: **MWL**
 Description: **Water Level**

Distance (ft): **.0**
 Structural Grade: **0**
 O&M Grade: **0**
 Clock Start/From:
 Clock To:
 1st Value:
 2nd Value:
 Value Percent: **15.000**
 Continuous Index:
 Within 8" of Joint: **NO**
 Remarks:

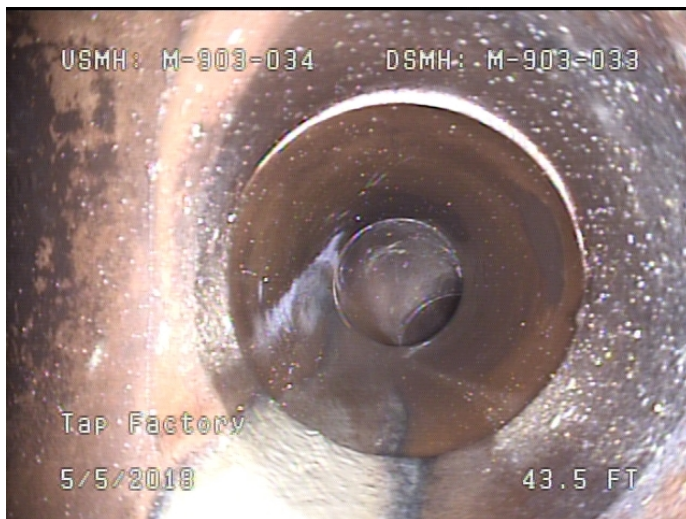
Code: **TF**
 Description: **Tap Factory**

Distance (ft): **43.5**
 Structural Grade: **0**
 O&M Grade: **0**
 Clock Start/From: **2**
 Clock To:
 1st Value: **4.000**
 2nd Value:
 Value Percent:
 Continuous Index:
 Within 8" of Joint: **NO**
 Remarks:

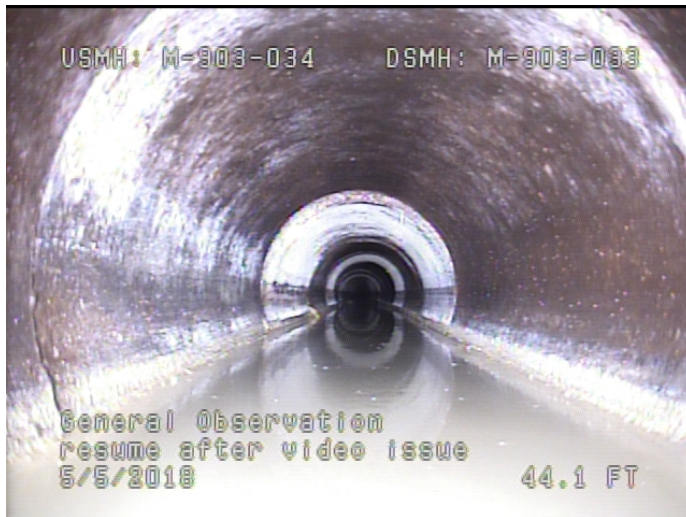
Code:	MGO
Description:	General Observation
Distance (ft):	44.1
Structural Grade:	0
O&M Grade:	0
Clock Start/From:	
Clock To:	
1st Value:	
2nd Value:	
Value Percent:	
Continuous Index:	
Within 8" of Joint:	NO
Remarks:	resume after video issue

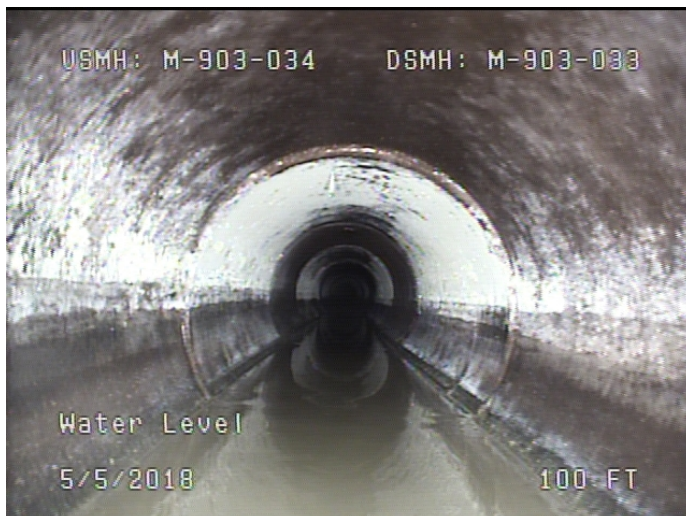
Code:	MWL
Description:	Water Level
Distance (ft):	100.0
Structural Grade:	0
O&M Grade:	0
Clock Start/From:	
Clock To:	
1st Value:	
2nd Value:	
Value Percent:	10.000
Continuous Index:	
Within 8" of Joint:	NO
Remarks:

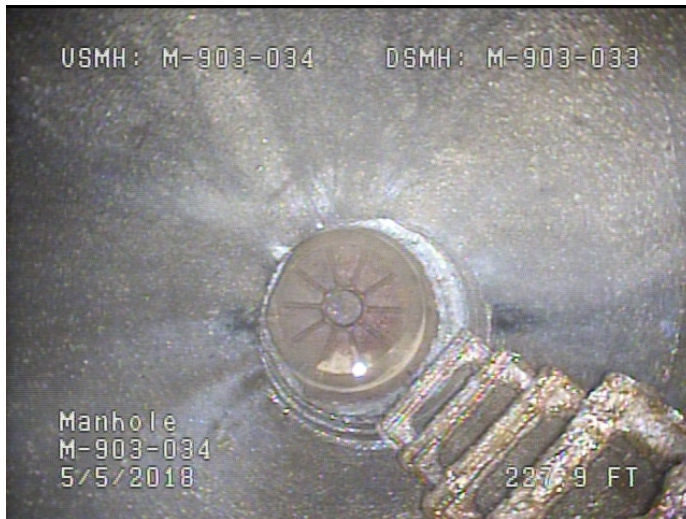
Code:	AMH
Description:	Manhole
Distance (ft):	227.9
Structural Grade:	0
O&M Grade:	0
Clock Start/From:	
Clock To:	
1st Value:	
2nd Value:	
Value Percent:	
Continuous Index:	
Within 8" of Joint:	NO
Remarks:	M-903-034
