## Profile/Photo Observation Report

Street:	<b>N HOBART RD</b>	Flow Control:	<b>Not Controlled</b>
City:	<b>Hobart, IN</b>	Year Renewed:	
Location:	<b>Other</b>	Tape/Media #:	
Purpose:	<b>Not Known</b>	Dia/Height:	<b>10"</b>
Use:	<b>Sanitary</b>	Material:	<b>VCP</b>
Drain Area:	<b>NA</b>	Lining:	
Category:	<b>NA</b>		
Comment:

Location Details:		Direction of Survey:	<b>Upstream</b>
US MH:	<b>M-903-034</b>	DS MH:	<b>M-903-050</b>
		Total Length Surveyed (ft):	<b>53.2</b>

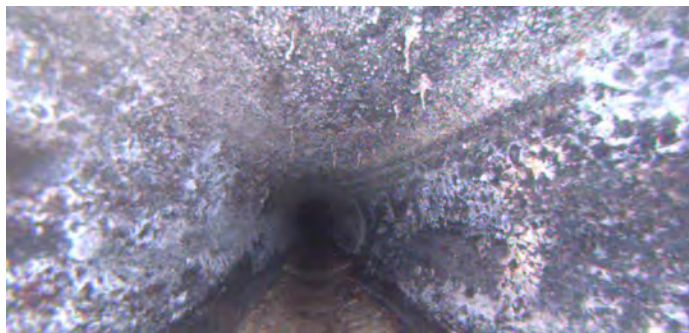
Code: **DAGS**  
Description: **Deposits Attached Grease**

Distance (ft): **.0**  
Structural Grade: **0**  
O&M Grade: **2**  
Clock Start/From: **7**  
Clock To: **5**  
1st Value:  
2nd Value:  
Value Percent: **10.000**  
Continuous Index: **S01**  
Within 8" of Joint: **NO**  
Remarks:

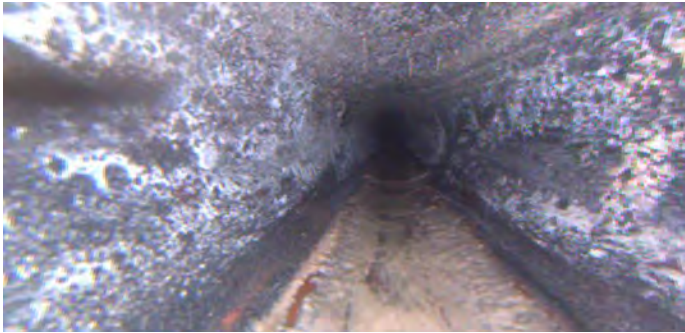
Code:	<b>AMH</b>
Description:	<b>Manhole</b>

Distance (ft):	<b>.0</b>
Structural Grade:	<b>0</b>
O&M Grade:	<b>0</b>
Clock Start/From:	
Clock To:	
1st Value:	
2nd Value:	
Value Percent:	
Continuous Index:	
Within 8" of Joint:	<b>NO</b>
Remarks:	<b>M-903-050</b>

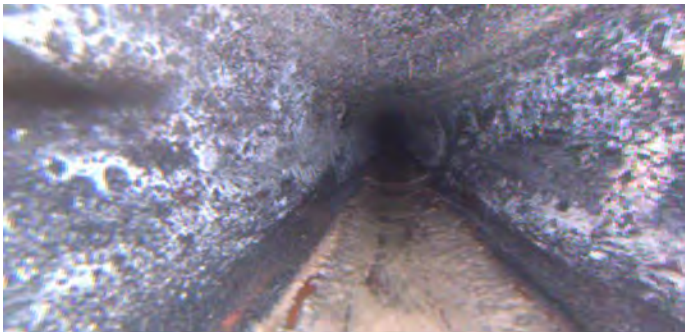
Code:	<b>MWL</b>
Description:	<b>Water Level</b>

Distance (ft):	<b>.0</b>
Structural Grade:	<b>0</b>
O&M Grade:	<b>0</b>
Clock Start/From:	
Clock To:	
1st Value:	
2nd Value:	
Value Percent:	<b>5.000</b>
Continuous Index:	
Within 8" of Joint:	<b>NO</b>
Remarks:

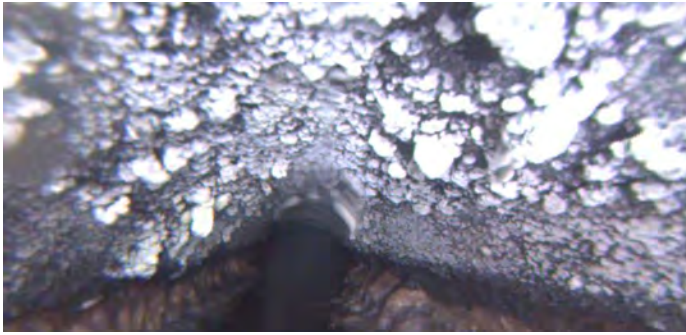
Code: **DAGS**  
Description: **Deposits Attached Grease**

Distance (ft): **53.2**  
Structural Grade: **0**  
O&M Grade: **2**  
Clock Start/From: **7**  
Clock To: **5**  
1st Value:  
2nd Value:  
Value Percent: **10.000**  
Continuous Index: **F01**  
Within 8" of Joint: **NO**  
Remarks:

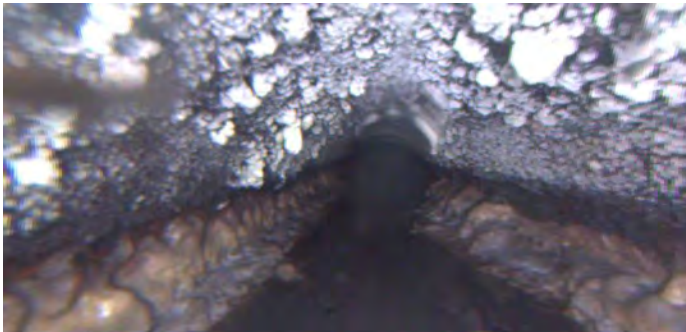
Code: **MSA**  
Description: **Abandoned Survey**

Distance (ft): **53.2**  
Structural Grade: **0**  
O&M Grade: **0**  
Clock Start/From:  
Clock To:  
1st Value:  
2nd Value:  
Value Percent:  
Continuous Index:  
Within 8" of Joint: **NO**  
Remarks: **encrustation**
