Profile/Photo Observation Report

Street:	n hobart rd	Flow Control:	Not Controlled
City:	Hobart, IN	Year Renewed:	
Location:	Other	Tape/Media #:	
Purpose:	Not Known	Dia/Height:	10"
Use:	Sanitary	Material:	VCP
Drain Area:	NA	Lining:	
Category:	NA		
Comment:

Location Details:		Direction of Survey:	Upstream
US MH:	M-903-034	DS MH:	M-903-050
		Total Length Surveyed (ft):	53.2

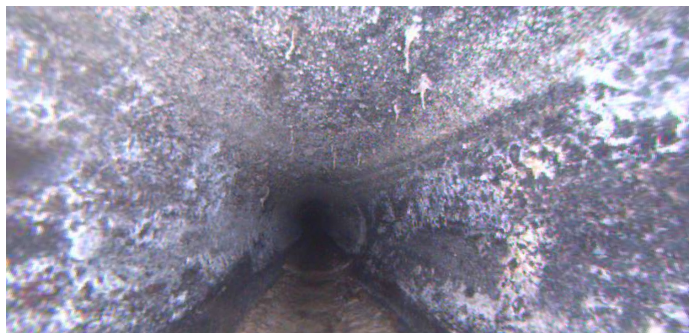
Code: **DAGS**
Description: **Deposits Attached Grease**

Distance (ft): **.0**
Structural Grade: **0**
O&M Grade: **2**
Clock Start/From: **7**
Clock To: **5**
1st Value:
2nd Value:
Value Percent: **10.000**
Continuous Index: **S01**
Within 8" of Joint: **NO**
Remarks:

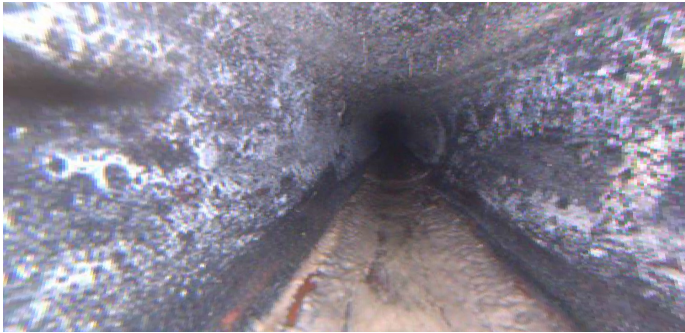
Code:	AMH
Description:	Manhole

Distance (ft):	.0
Structural Grade:	0
O&M Grade:	0
Clock Start/From:	
Clock To:	
1st Value:	
2nd Value:	
Value Percent:	
Continuous Index:	
Within 8" of Joint:	NO
Remarks:	M-903-050

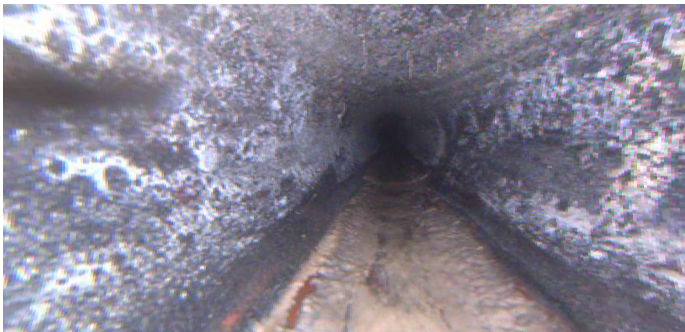
Code:	MWL
Description:	Water Level

Distance (ft):	.0
Structural Grade:	0
O&M Grade:	0
Clock Start/From:	
Clock To:	
1st Value:	
2nd Value:	
Value Percent:	5.000
Continuous Index:	
Within 8" of Joint:	NO
Remarks:

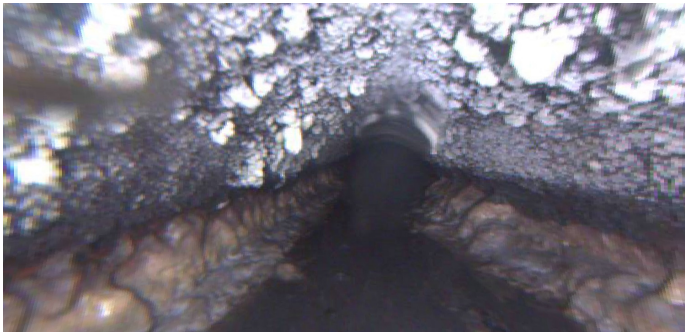
Code: **MSA**
Description: **Abandoned Survey**

Distance (ft): **53.2**
Structural Grade: **0**
O&M Grade: **0**
Clock Start/From:
Clock To:
1st Value:
2nd Value:
Value Percent:
Continuous Index:
Within 8" of Joint: **NO**
Remarks: **encrustation**
