## Profile/Photo Observation Report

Street:	<b>N HOBART RD</b>	Flow Control:	<b>Not Controlled</b>
City:	<b>Hobart, IN</b>	Year Renewed:	
Location:	<b>Other</b>	Tape/Media #:	
Purpose:	<b>Not Known</b>	Dia/Height:	<b>10"</b>
Use:	<b>Sanitary</b>	Material:	<b>PVC</b>
Drain Area:	<b>NA</b>	Lining:	
Category:	<b>NA</b>		
Comment:

Location Details:		Direction of Survey:	<b>Downstream</b>
US MH:	<b>M-903-034</b>	DS MH:	<b>M-903-050</b>
		Total Length Surveyed (ft):	<b>36.2</b>

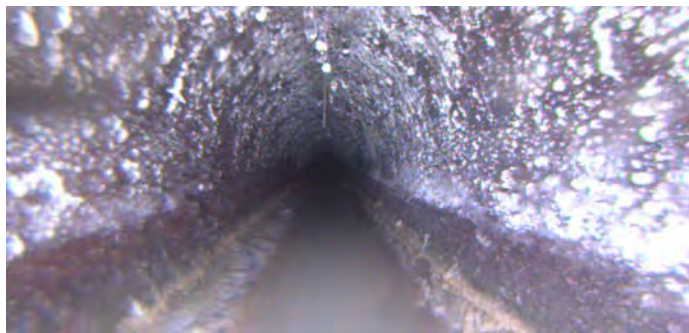
Code: **DAGS**  
Description: **Deposits Attached Grease**

Distance (ft): **.0**  
Structural Grade: **0**  
O&M Grade: **2**  
Clock Start/From: **8**  
Clock To: **4**  
1st Value:  
2nd Value:  
Value Percent: **5.000**  
Continuous Index: **S01**  
Within 8" of Joint: **NO**  
Remarks:

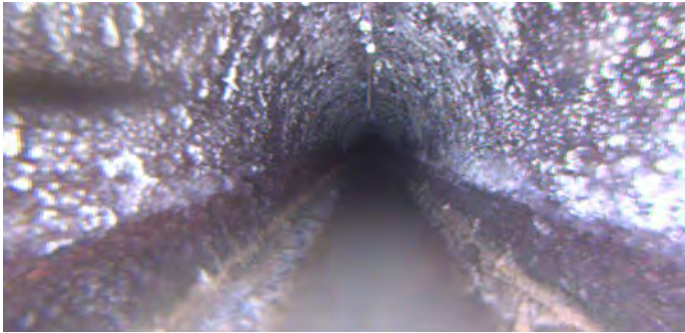
Code:	<b>AMH</b>
Description:	<b>Manhole</b>

Distance (ft):	<b>.0</b>
Structural Grade:	<b>0</b>
O&M Grade:	<b>0</b>
Clock Start/From:	
Clock To:	
1st Value:	
2nd Value:	
Value Percent:	
Continuous Index:	
Within 8" of Joint:	<b>NO</b>
Remarks:	<b>M-903-034</b>

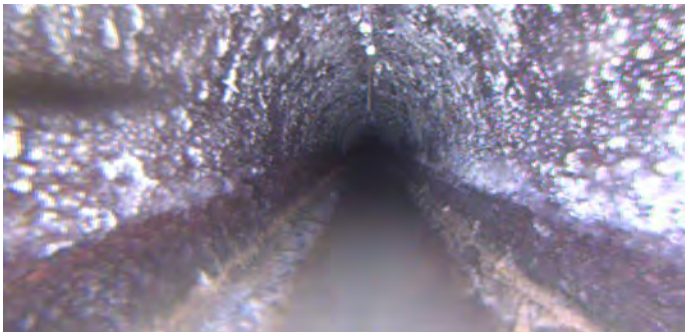
Code:	<b>MWL</b>
Description:	<b>Water Level</b>

Distance (ft):	<b>.0</b>
Structural Grade:	<b>0</b>
O&M Grade:	<b>0</b>
Clock Start/From:	
Clock To:	
1st Value:	
2nd Value:	
Value Percent:	<b>5.000</b>
Continuous Index:	
Within 8" of Joint:	<b>NO</b>
Remarks:

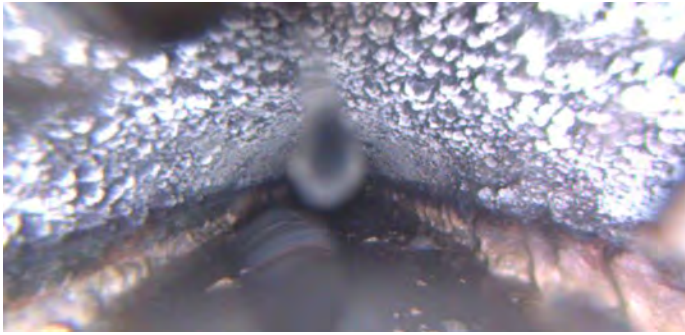
Code: **DAGS**  
Description: **Deposits Attached Grease**

Distance (ft): **36.2**  
Structural Grade: **0**  
O&M Grade: **2**  
Clock Start/From: **8**  
Clock To: **4**  
1st Value:  
2nd Value:  
Value Percent: **5.000**  
Continuous Index: **F01**  
Within 8" of Joint: **NO**  
Remarks:

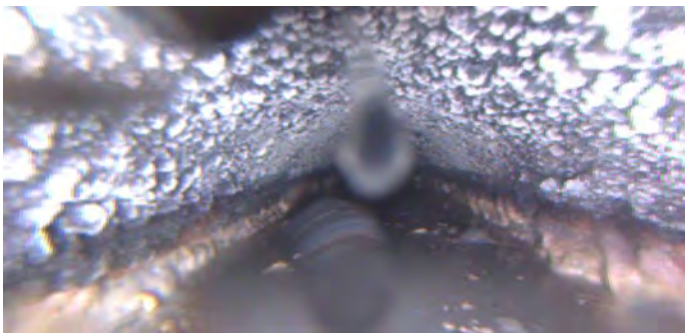
Code: **MSA**  
Description: **Abandoned Survey**

Distance (ft): **36.2**  
Structural Grade: **0**  
O&M Grade: **0**  
Clock Start/From:  
Clock To:  
1st Value:  
2nd Value:  
Value Percent:  
Continuous Index:  
Within 8" of Joint: **NO**  
Remarks: **encrustation**
