Profile/Photo Observation Report

Street:	37th ave	Flow Control:	Not Controlled
City:	Hobart, IN	Year Renewed:	
Location:	Other	Tape/Media #:	
Purpose:	Not Known	Dia/Height:	10"
Use:	Sanitary	Material:	VCP
Drain Area:	NA	Lining:	
Category:	NA		
Comment:

Location Details:		Direction of Survey:	Upstream
US MH:	M-903-037	DS MH:	M-903-038
		Total Length Surveyed (ft):	131.5

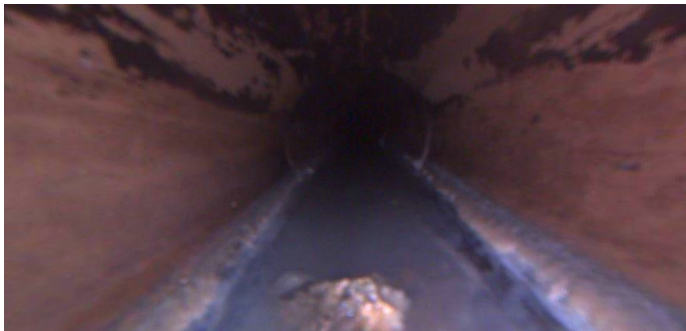
Code: **AMH**
Description: **Manhole**

Distance (ft): **.0**
Structural Grade: **0**
O&M Grade: **0**
Clock Start/From:
Clock To:
1st Value:
2nd Value:
Value Percent:
Continuous Index:
Within 8" of Joint: **NO**
Remarks: **M-903-038**

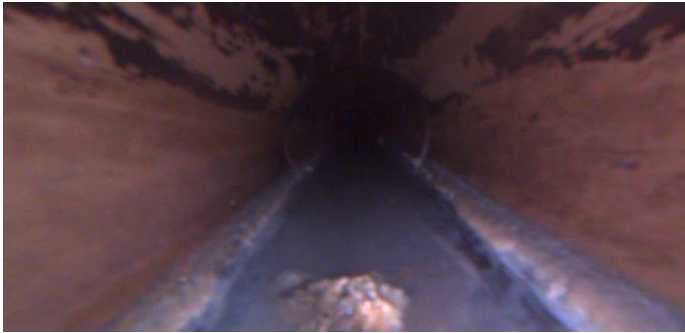
Code:	MWL
Description:	Water Level

Distance (ft):	.0
Structural Grade:	0
O&M Grade:	0
Clock Start/From:	
Clock To:	
1st Value:	
2nd Value:	
Value Percent:	5.000
Continuous Index:	
Within 8" of Joint:	NO
Remarks:

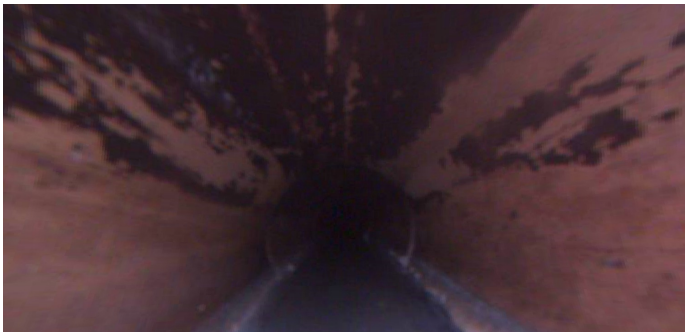
Code:	FM
Description:	Fracture Multiple

Distance (ft):	.0
Structural Grade:	4
O&M Grade:	0
Clock Start/From:	7
Clock To:	5
1st Value:	
2nd Value:	
Value Percent:	
Continuous Index:	S01
Within 8" of Joint:	
Remarks:

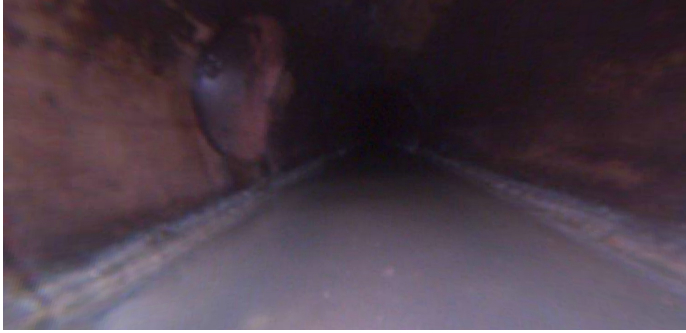
Code: **TF**
Description: **Tap Factory**

Distance (ft): **5.9**
Structural Grade: **0**
O&M Grade: **0**
Clock Start/From: **9**
Clock To:
1st Value: **4.000**
2nd Value:
Value Percent:
Continuous Index:
Within 8" of Joint:
Remarks:

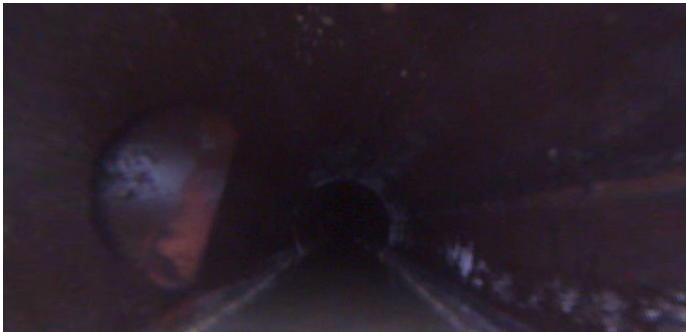
Code: **TF**
Description: **Tap Factory**

Distance (ft): **47.9**
Structural Grade: **0**
O&M Grade: **0**
Clock Start/From: **9**
Clock To:
1st Value: **4.000**
2nd Value:
Value Percent:
Continuous Index:
Within 8" of Joint:
Remarks:

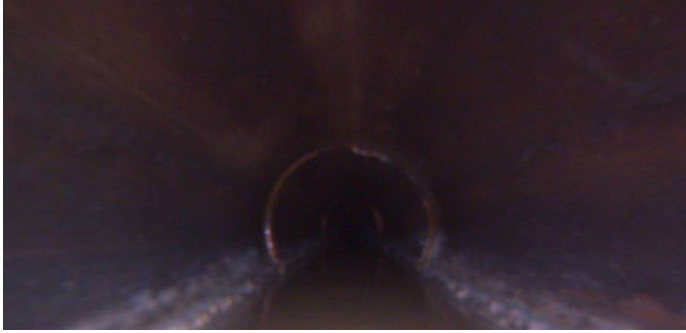
Code: **DAE**
Description: **Deposits Attached Encrustation**

Distance (ft): **87.8**
Structural Grade: **0**
O&M Grade: **2**
Clock Start/From: **7**
Clock To: **5**
1st Value:
2nd Value:
Value Percent: **5.000**
Continuous Index: **S02**
Within 8" of Joint: **YES**
Remarks:

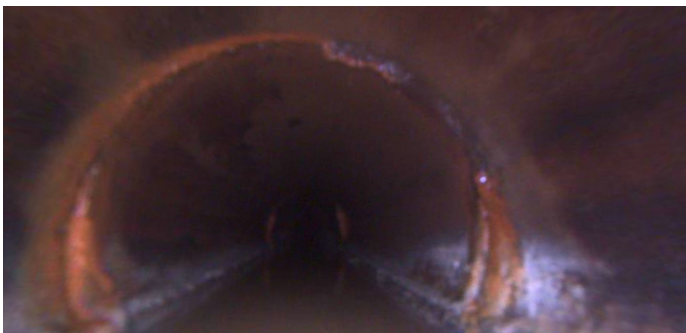
Code: **IW**
Description: **Infil Weeper**

Distance (ft): **88.8**
Structural Grade: **0**
O&M Grade: **2**
Clock Start/From: **8**
Clock To: **4**
1st Value:
2nd Value:
Value Percent:
Continuous Index:
Within 8" of Joint: **YES**
Remarks:

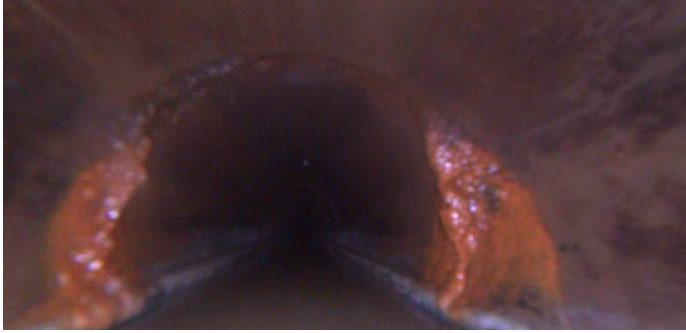
Code: **IW**
Description: **Infil Weeper**

Distance (ft): **91.7**
Structural Grade: **0**
O&M Grade: **2**
Clock Start/From: **8**
Clock To: **4**
1st Value:
2nd Value:
Value Percent:
Continuous Index:
Within 8" of Joint: **YES**
Remarks:

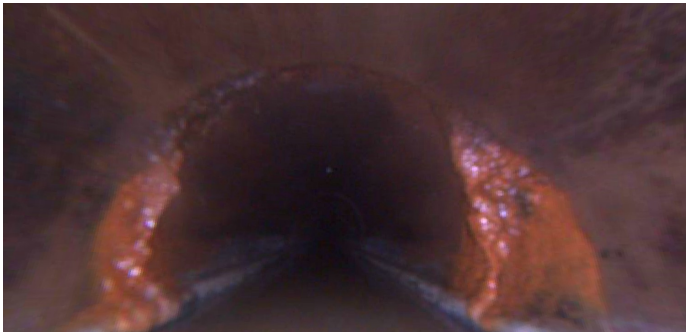
Code: **DAE**
Description: **Deposits Attached Encrustation**

Distance (ft): **91.7**
Structural Grade: **0**
O&M Grade: **2**
Clock Start/From: **7**
Clock To: **5**
1st Value:
2nd Value:
Value Percent: **5.000**
Continuous Index: **F02**
Within 8" of Joint: **YES**
Remarks:

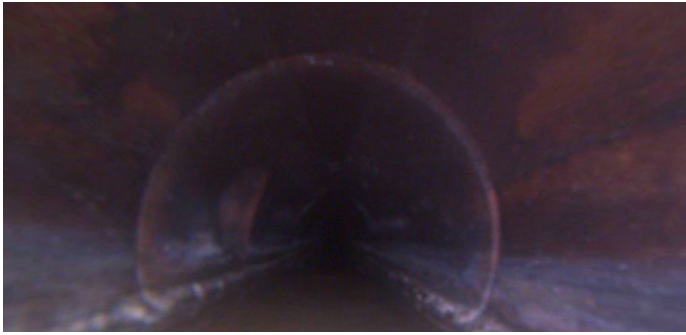
Code: **TF**
Description: **Tap Factory**

Distance (ft): **94.7**
Structural Grade: **0**
O&M Grade: **0**
Clock Start/From: **9**
Clock To:
1st Value: **4.000**
2nd Value:
Value Percent:
Continuous Index:
Within 8" of Joint:
Remarks:

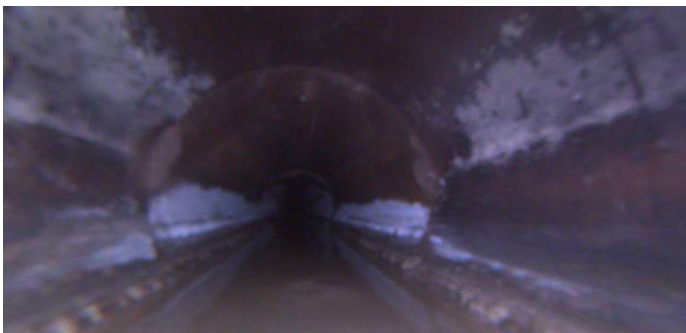
Code: **RFJ**
Description: **Roots Fine Joint**

Distance (ft): **109.2**
Structural Grade: **0**
O&M Grade: **1**
Clock Start/From: **9**
Clock To: **3**
1st Value:
2nd Value:
Value Percent:
Continuous Index:
Within 8" of Joint: **YES**
Remarks:

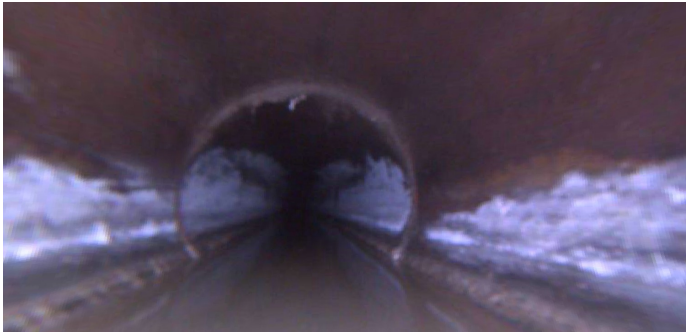
Code: **RFJ**
Description: **Roots Fine Joint**

Distance (ft): **112.1**
Structural Grade: **0**
O&M Grade: **1**
Clock Start/From: **9**
Clock To: **5**
1st Value:
2nd Value:
Value Percent:
Continuous Index:
Within 8" of Joint: **YES**
Remarks:

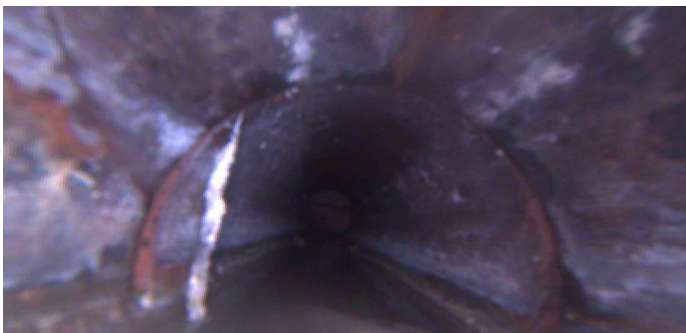
Code: **RFJ**
Description: **Roots Fine Joint**

Distance (ft): **124.5**
Structural Grade: **0**
O&M Grade: **1**
Clock Start/From: **11**
Clock To:
1st Value:
2nd Value:
Value Percent:
Continuous Index:
Within 8" of Joint: **YES**
Remarks:

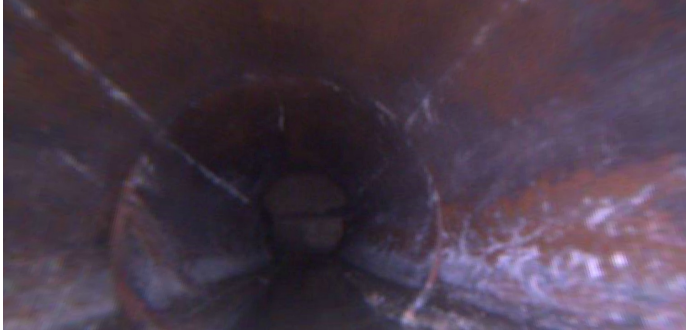
Code: **RFJ**
Description: **Roots Fine Joint**

Distance (ft): **127.3**
Structural Grade: **0**
O&M Grade: **1**
Clock Start/From: **12**
Clock To:
1st Value:
2nd Value:
Value Percent:
Continuous Index:
Within 8" of Joint: **YES**
Remarks:

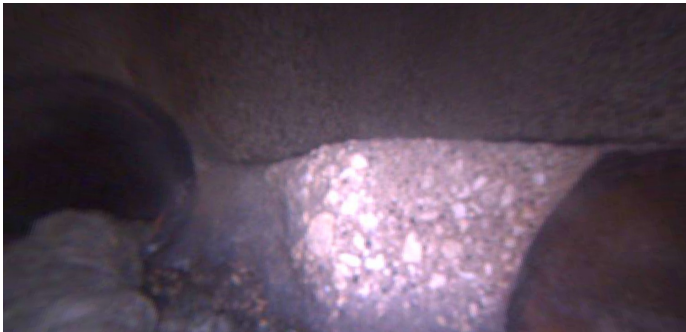
Code: **FM**
Description: **Fracture Multiple**

Distance (ft): **131.5**
Structural Grade: **4**
O&M Grade: **0**
Clock Start/From: **7**
Clock To: **5**
1st Value:
2nd Value:
Value Percent:
Continuous Index: **F01**
Within 8" of Joint:
Remarks:

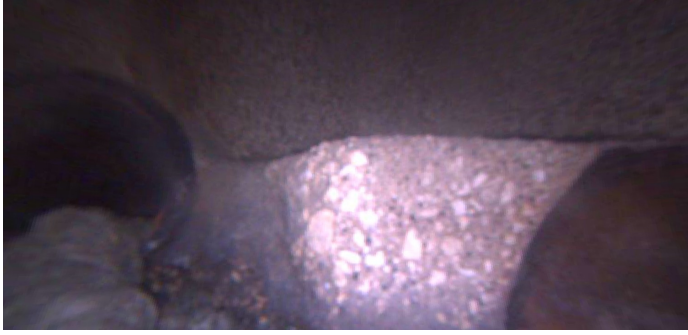
Code:	AMH
Description:	Manhole
Distance (ft):	131.5
Structural Grade:	0
O&M Grade:	0
Clock Start/From:	
Clock To:	
1st Value:	
2nd Value:	
Value Percent:	
Continuous Index:	
Within 8" of Joint:	NO
Remarks:	M-903-037
