Profile/Photo Observation Report

Street:	OFF E 38TH PL	Flow Control:	Not Controlled
City:	Hobart, IN	Year Renewed:	
Location:	Other	Tape/Media #:	
Purpose:	Not Known	Dia/Height:	10"
Use:	Sanitary	Material:	VCP
Drain Area:	NA	Lining:	
Category:	NA		
Comment:

Location Details:		Direction of Survey:	Downstream
US MH:	M-903-037	DS MH:	M-903-053
		Total Length Surveyed (ft):	60.0

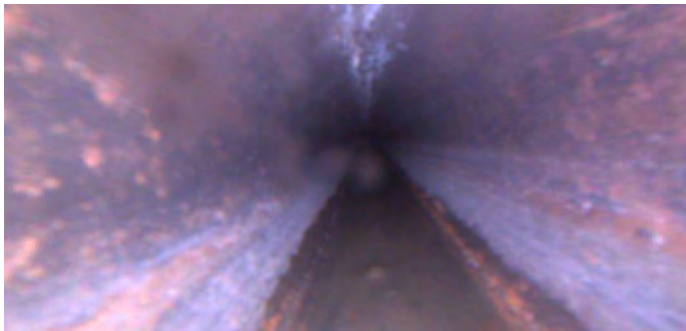
Code: **AMH**
Description: **Manhole**

Distance (ft): **.0**
Structural Grade: **0**
O&M Grade: **0**
Clock Start/From:
Clock To:
1st Value:
2nd Value:
Value Percent:
Continuous Index:
Within 8" of Joint: **NO**
Remarks: **M-903-037**

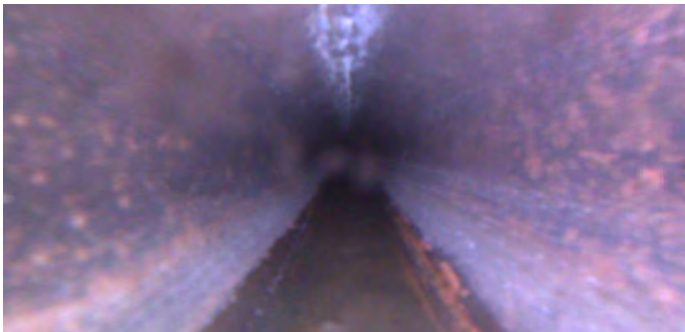
Code:	DAZ
Description:	Deposits Attached Other

Distance (ft):	1.4
Structural Grade:	0
O&M Grade:	2
Clock Start/From:	7
Clock To:	5
1st Value:	
2nd Value:	
Value Percent:	5.000
Continuous Index:	S01
Within 8" of Joint:	YES
Remarks:	WANDER
