Profile/Photo Observation Report

Street:	OFF E 38TH PL	Flow Control:	Not Controlled
City:	Hobart, IN	Year Renewed:	
Location:	Other	Tape/Media #:	
Purpose:	Not Known	Dia/Height:	10"
Use:	Sanitary	Material:	PVC
Drain Area:	NA	Lining:	
Category:	NA		
Comment:

Location Details:		Direction of Survey:	Downstream
US MH:	M-903-038	DS MH:	M-903-055
		Total Length Surveyed (ft):	91.4

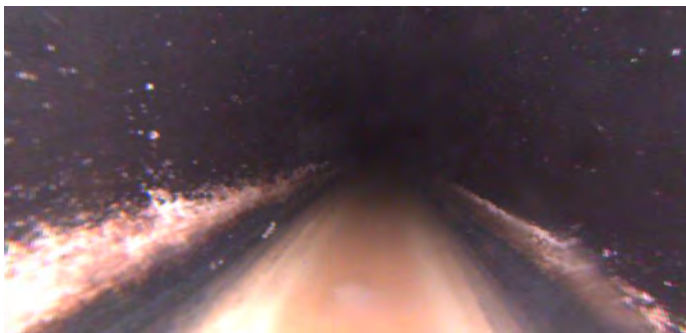
Code: **AMH**
Description: **Manhole**

Distance (ft): **.0**
Structural Grade: **0**
O&M Grade: **0**
Clock Start/From:
Clock To:
1st Value:
2nd Value:
Value Percent:
Continuous Index:
Within 8" of Joint: **NO**
Remarks: **M-903-038**

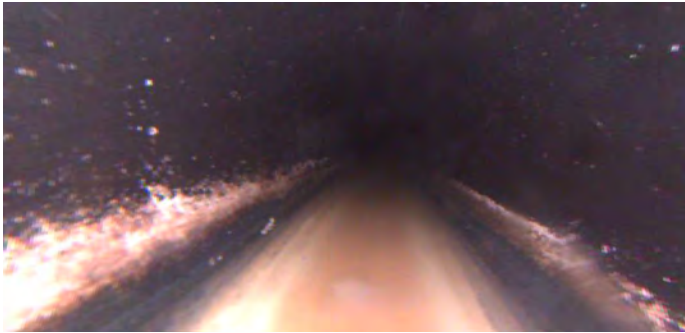
Code:	MWL
Description:	Water Level

Distance (ft):	.0
Structural Grade:	0
O&M Grade:	0
Clock Start/From:	
Clock To:	
1st Value:	
2nd Value:	
Value Percent:	5.000
Continuous Index:	
Within 8" of Joint:	NO
Remarks:

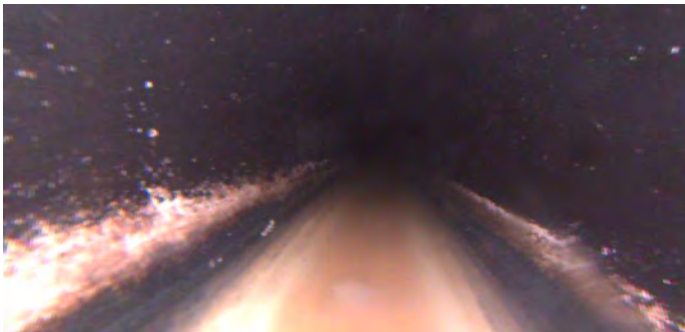
Code:	DAZ
Description:	Deposits Attached Other

Distance (ft):	.0
Structural Grade:	0
O&M Grade:	2
Clock Start/From:	7
Clock To:	5
1st Value:	
2nd Value:	
Value Percent:	5.000
Continuous Index:	S01
Within 8" of Joint:	YES
Remarks:	WANDER

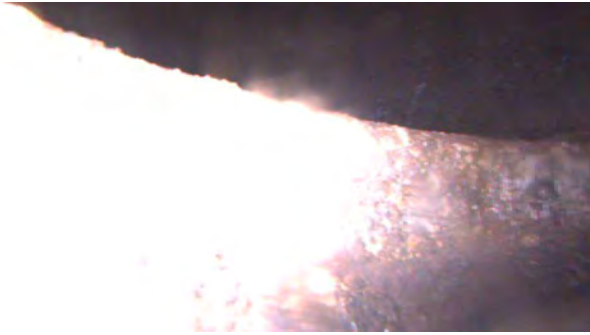
Code: **AMH**
Description: **Manhole**

Distance (ft): **91.4**
Structural Grade: **0**
O&M Grade: **0**
Clock Start/From:
Clock To:
1st Value:
2nd Value:
Value Percent:
Continuous Index:
Within 8" of Joint: **NO**
Remarks: **M-903-055**

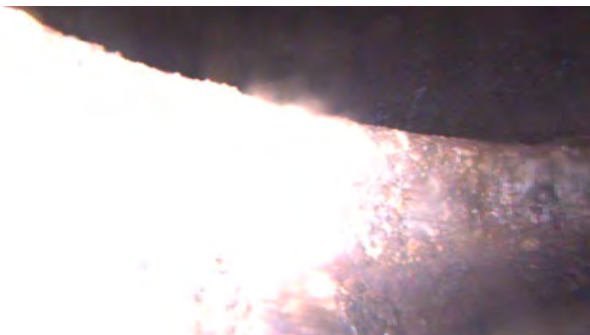
Code: **DAZ**
Description: **Deposits Attached Other**

Distance (ft): **91.4**
Structural Grade: **0**
O&M Grade: **2**
Clock Start/From: **7**
Clock To: **5**
1st Value:
2nd Value:
Value Percent: **5.000**
Continuous Index: **F01**
Within 8" of Joint: **YES**
Remarks: **WANDER**
