Profile/Photo Observation Report

Street:	37th ave	Flow Control:	Not Controlled
City:	Hobart, IN	Year Renewed:	
Location:	Other	Tape/Media #:	
Purpose:	Not Known	Dia/Height:	10"
Use:	Sanitary	Material:	PVC
Drain Area:	NA	Lining:	
Category:	NA		
Comment:

Location Details:		Direction of Survey:	Downstream
US MH:	M-903-038	DS MH:	M-903-055
		Total Length Surveyed (ft):	91.4

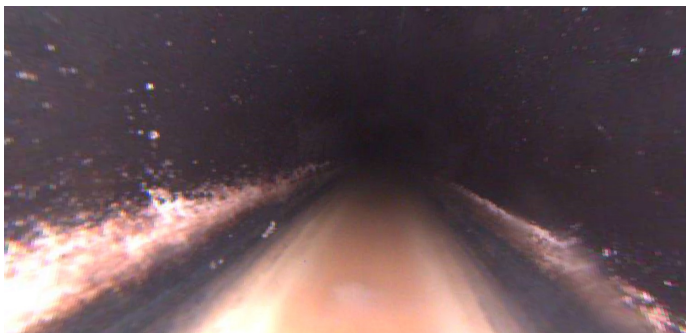
Code: **AMH**
Description: **Manhole**

Distance (ft): **.0**
Structural Grade: **0**
O&M Grade: **0**
Clock Start/From:
Clock To:
1st Value:
2nd Value:
Value Percent:
Continuous Index:
Within 8" of Joint: **NO**
Remarks: **M-903-038**

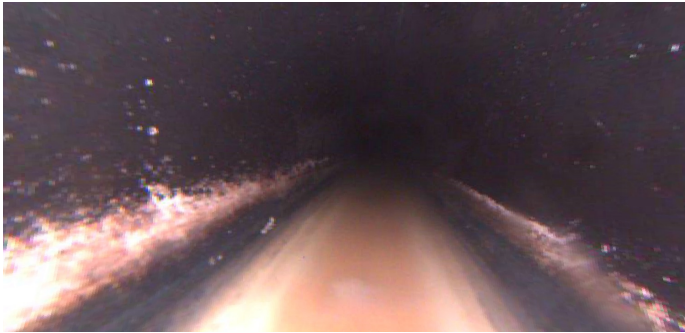
Code:	MWL
Description:	Water Level

Distance (ft):	.0
Structural Grade:	0
O&M Grade:	0
Clock Start/From:	
Clock To:	
1st Value:	
2nd Value:	
Value Percent:	5.000
Continuous Index:	
Within 8" of Joint:	NO
Remarks:

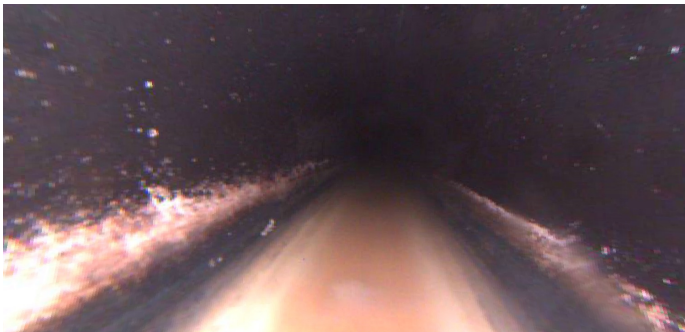
Code:	DAZ
Description:	Deposits Attached Other

Distance (ft):	.0
Structural Grade:	0
O&M Grade:	2
Clock Start/From:	7
Clock To:	5
1st Value:	
2nd Value:	
Value Percent:	5.000
Continuous Index:	S01
Within 8" of Joint:	YES
Remarks:	WANDER

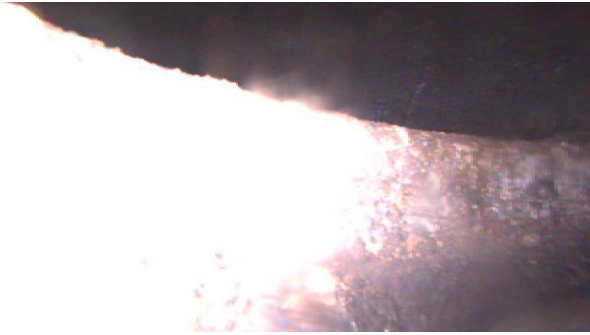
Code: **AMH**
Description: **Manhole**

Distance (ft): **91.4**
Structural Grade: **0**
O&M Grade: **0**
Clock Start/From:
Clock To:
1st Value:
2nd Value:
Value Percent:
Continuous Index:
Within 8" of Joint: **NO**
Remarks: **M-903-055**

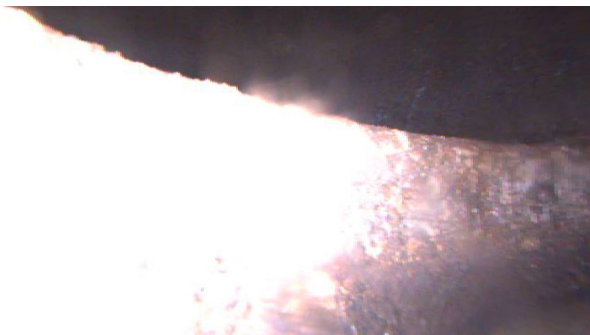
Code: **DAZ**
Description: **Deposits Attached Other**

Distance (ft): **91.4**
Structural Grade: **0**
O&M Grade: **2**
Clock Start/From: **7**
Clock To: **5**
1st Value:
2nd Value:
Value Percent: **5.000**
Continuous Index: **F01**
Within 8" of Joint: **YES**
Remarks: **WANDER**
