Profile/Photo Observation Report

Date:	03/20/2018	Weather:		Coding:	PACP 6.0
Pipe Length (ft):	88.7	Owner:	NA	Pre Clean:	Not Known
P.O.#:		Surveyor:	Selasie Honu	PSR:	P-903-0SL-041
Customer:		Clean Date:	01/01/1900	Shape:	C

Street:	38th pl	Flow Control:	Not Controlled
City:	Hobart, IN	Year Renewed:	
Location:	Other	Tape/Media #:	
Purpose:	Not Known	Dia/Height:	10"
Use:	Sanitary	Material:	VCP
Drain Area:	NA	Lining:	
Category:	NA		
Comment:

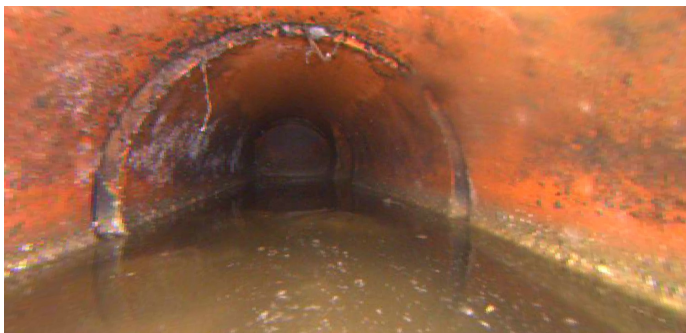
Code: **AMH**
Description: **Manhole**

Distance (ft): **.0**
Structural Grade: **0**
O&M Grade: **0**
Clock Start/From:
Clock To:
1st Value:
2nd Value:
Value Percent:
Continuous Index:
Within 8" of Joint: **NO**
Remarks: **M-903-041**

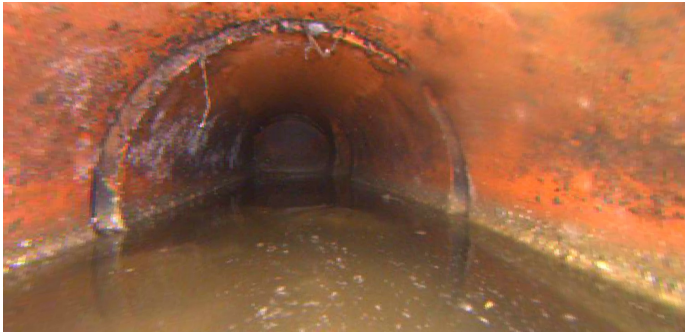
Code:	MWL
Description:	Water Level

Distance (ft):	.0
Structural Grade:	0
O&M Grade:	0
Clock Start/From:	
Clock To:	
1st Value:	
2nd Value:	
Value Percent:	5.000
Continuous Index:	
Within 8" of Joint:	NO
Remarks:

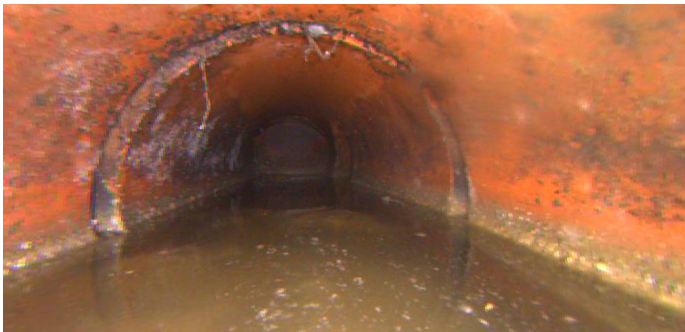
Code:	RFJ
Description:	Roots Fine Joint

Distance (ft):	.0
Structural Grade:	0
O&M Grade:	1
Clock Start/From:	11
Clock To:	1
1st Value:	
2nd Value:	
Value Percent:	
Continuous Index:	
Within 8" of Joint:	YES
Remarks:

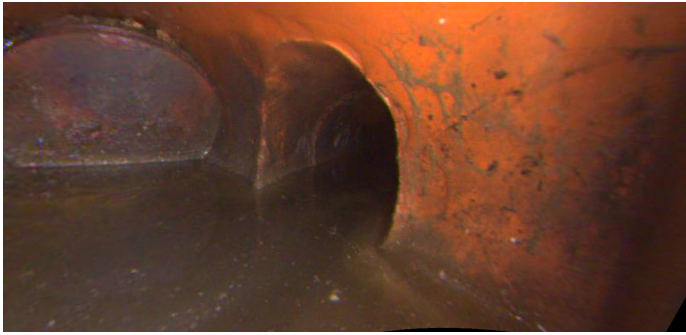
Code: **TFA**
Description: **Tap Factory Active**

Distance (ft): **2.1**
Structural Grade: **0**
O&M Grade: **0**
Clock Start/From: **3**
Clock To:
1st Value: **4.000**
2nd Value:
Value Percent:
Continuous Index:
Within 8" of Joint:
Remarks:

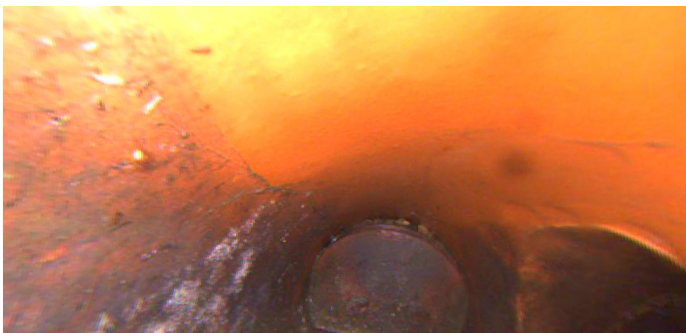
Code: **FM**
Description: **Fracture Multiple**

Distance (ft): **2.1**
Structural Grade: **4**
O&M Grade: **0**
Clock Start/From: **9**
Clock To: **2**
1st Value:
2nd Value:
Value Percent:
Continuous Index:
Within 8" of Joint:
Remarks:
