Profile/Photo Observation Report

Street:	E 38TH PL	Flow Control:	Not Controlled
City:	Hobart, IN	Year Renewed:	
Location:	Other	Tape/Media #:	
Purpose:	Not Known	Dia/Height:	10"
Use:	Sanitary	Material:	VCP
Drain Area:	NA	Lining:	
Category:	NA		
Comment:

Location Details:		Direction of Survey:	Downstream
US MH:	M-903-042	DS MH:	M-903-043
		Total Length Surveyed (ft):	292.6

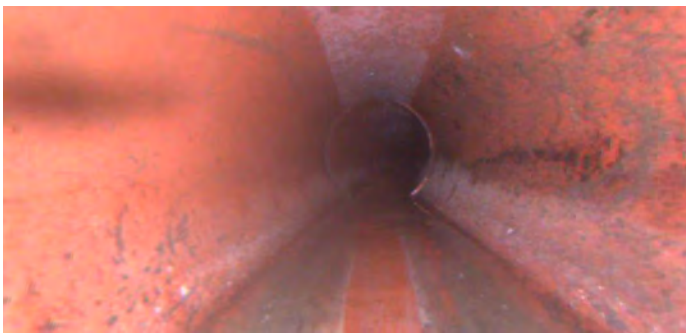
Code: **MWL**
Description: **Water Level**

Distance (ft): **.0**
Structural Grade: **0**
O&M Grade: **0**
Clock Start/From:
Clock To:
1st Value:
2nd Value:
Value Percent: **5.000**
Continuous Index:
Within 8" of Joint: **NO**
Remarks:

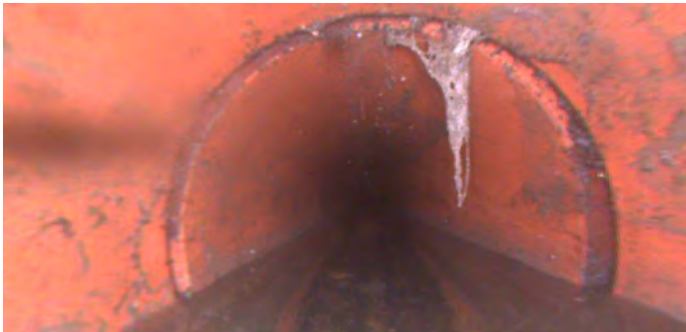
Code: **RFJ**
Description: **Roots Fine Joint**

Distance (ft): **24.0**
Structural Grade: **0**
O&M Grade: **1**
Clock Start/From: **12**
Clock To: **1**
1st Value:
2nd Value:
Value Percent:
Continuous Index:
Within 8" of Joint: **YES**
Remarks:

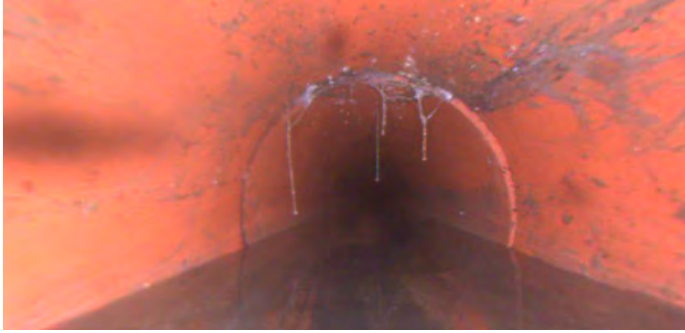
Code: **RFJ**
Description: **Roots Fine Joint**

Distance (ft): **29.4**
Structural Grade: **0**
O&M Grade: **1**
Clock Start/From: **11**
Clock To: **1**
1st Value:
2nd Value:
Value Percent:
Continuous Index:
Within 8" of Joint: **YES**
Remarks:

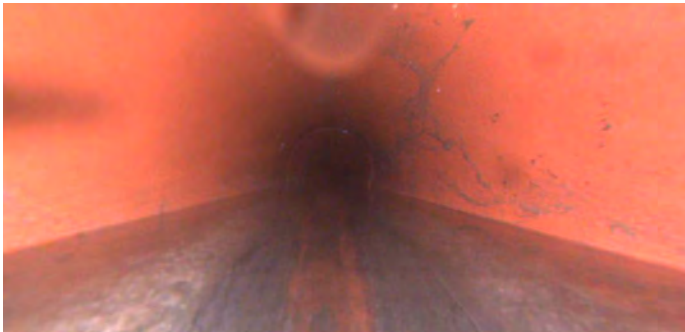
Code: **MWL**
Description: **Water Level**

Distance (ft): **39.3**
Structural Grade: **0**
O&M Grade: **0**
Clock Start/From:
Clock To:
1st Value:
2nd Value:
Value Percent: **40.000**
Continuous Index:
Within 8" of Joint: **NO**
Remarks:

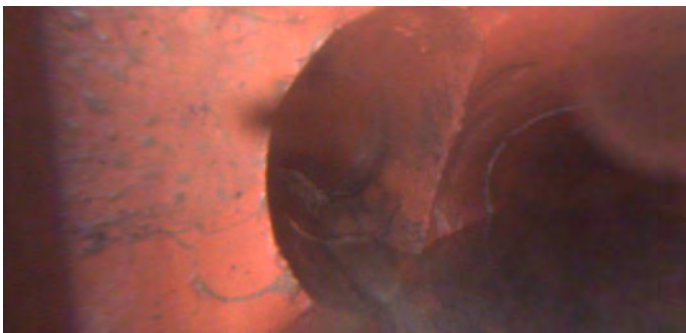
Code: **TF**
Description: **Tap Factory**

Distance (ft): **50.2**
Structural Grade: **0**
O&M Grade: **0**
Clock Start/From: **9**
Clock To:
1st Value: **6.000**
2nd Value:
Value Percent:
Continuous Index:
Within 8" of Joint:
Remarks:

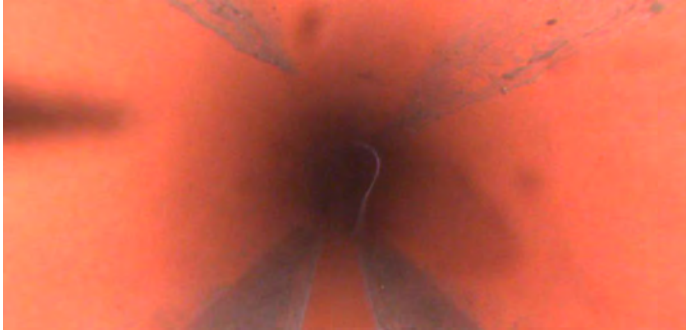
Code: **MWL**
Description: **Water Level**

Distance (ft): **83.2**
Structural Grade: **0**
O&M Grade: **0**
Clock Start/From:
Clock To:
1st Value:
2nd Value:
Value Percent: **5.000**
Continuous Index:
Within 8" of Joint: **NO**
Remarks:

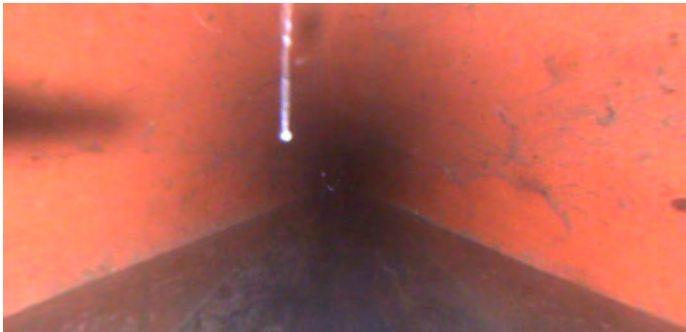
Code: **MWL**
Description: **Water Level**

Distance (ft): **102.6**
Structural Grade: **0**
O&M Grade: **0**
Clock Start/From:
Clock To:
1st Value:
2nd Value:
Value Percent: **40.000**
Continuous Index:
Within 8" of Joint: **NO**
Remarks:

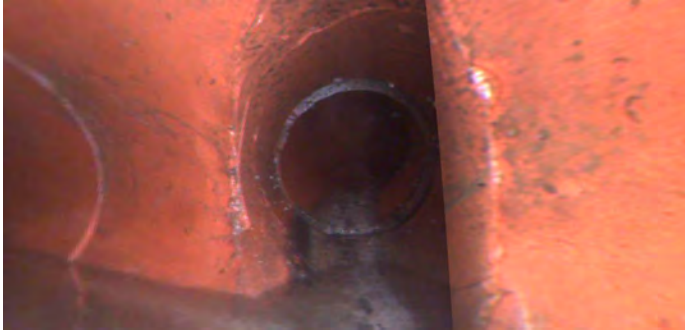
Code: **TF**
Description: **Tap Factory**

Distance (ft): **120.9**
Structural Grade: **0**
O&M Grade: **0**
Clock Start/From: **9**
Clock To:
1st Value: **6.000**
2nd Value:
Value Percent:
Continuous Index:
Within 8" of Joint:
Remarks:

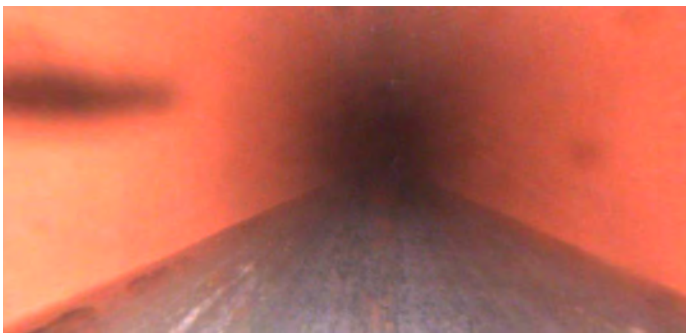
Code: **MWL**
Description: **Water Level**

Distance (ft): **152.7**
Structural Grade: **0**
O&M Grade: **0**
Clock Start/From:
Clock To:
1st Value:
2nd Value:
Value Percent: **20.000**
Continuous Index:
Within 8" of Joint: **NO**
Remarks:

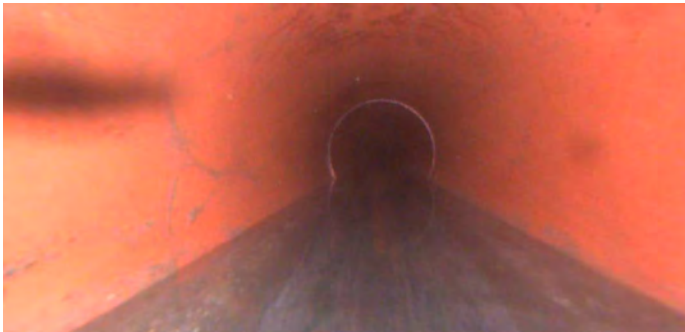
Code: **MWL**
Description: **Water Level**

Distance (ft): **167.5**
Structural Grade: **0**
O&M Grade: **0**
Clock Start/From:
Clock To:
1st Value:
2nd Value:
Value Percent: **20.000**
Continuous Index:
Within 8" of Joint: **NO**
Remarks:

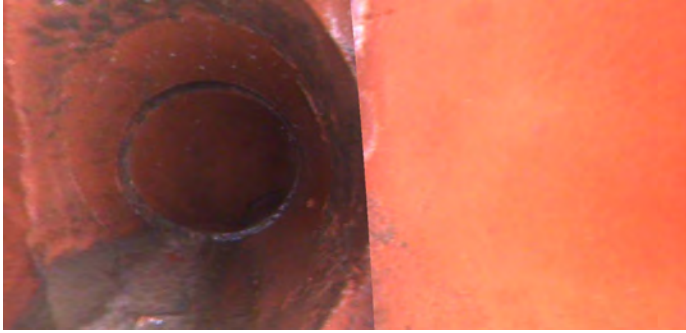
Code: **TF**
Description: **Tap Factory**

Distance (ft): **259.5**
Structural Grade: **0**
O&M Grade: **0**
Clock Start/From: **2**
Clock To:
1st Value: **6.000**
2nd Value:
Value Percent:
Continuous Index:
Within 8" of Joint:
Remarks:

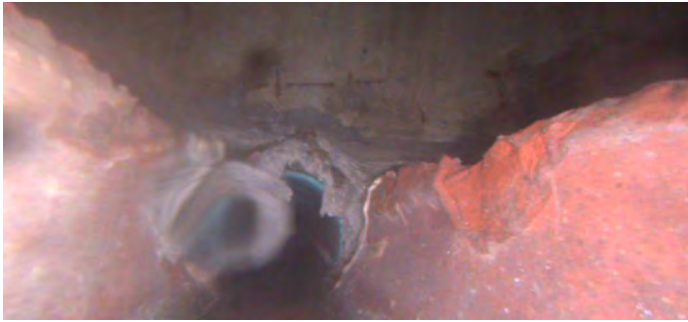
Code:	AMH
Description:	Manhole
Distance (ft):	292.6
Structural Grade:	0
O&M Grade:	0
Clock Start/From:	
Clock To:	
1st Value:	
2nd Value:	
Value Percent:	
Continuous Index:	
Within 8" of Joint:	NO
Remarks:	M-903-043
