Profile/Photo Observation Report

Street:	COOKE ST	Flow Control:	Not Controlled
City:	Hobart, IN	Year Renewed:	
Location:	Other	Tape/Media #:	
Purpose:	Not Known	Dia/Height:	10"
Use:	Sanitary	Material:	VCP
Drain Area:	NA	Lining:	
Category:	NA		
Comment:

Location Details:		Direction of Survey:	Downstream
US MH:	M-903-045	DS MH:	M-903-044
		Total Length Surveyed (ft):	235.9

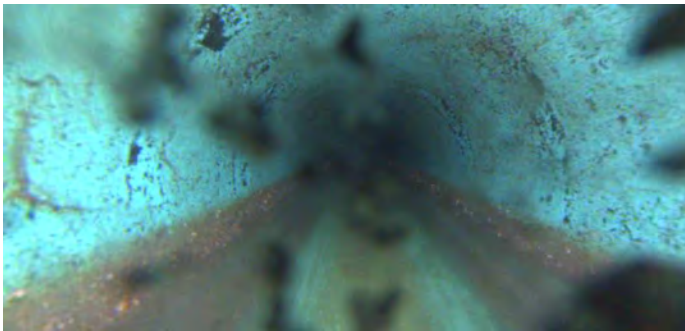
Code: **AMH**
Description: **Manhole**

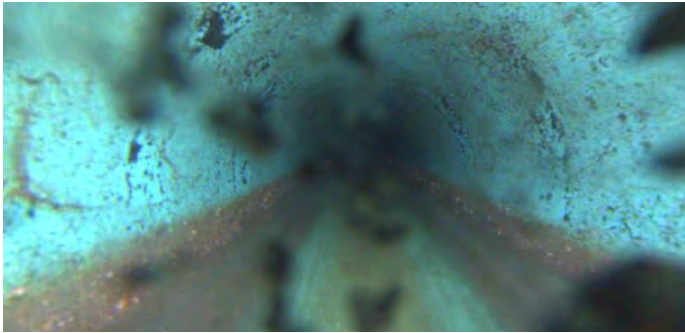
Code:	MWL
Description:	Water Level

Distance (ft):	.0
Structural Grade:	0
O&M Grade:	0
Clock Start/From:	
Clock To:	
1st Value:	
2nd Value:	
Value Percent:	5.000
Continuous Index:	
Within 8" of Joint:	NO
Remarks:

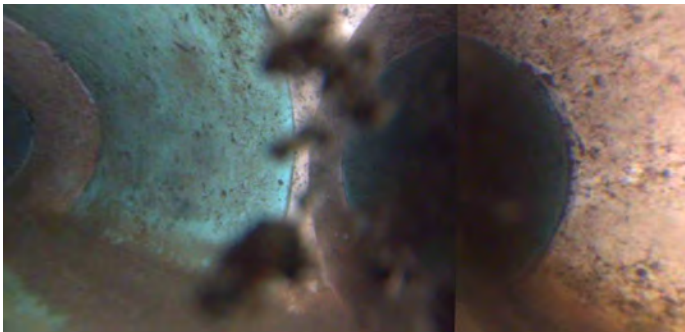
Code:	TFA
Description:	Tap Factory Active

Distance (ft):	40.6
Structural Grade:	0
O&M Grade:	0
Clock Start/From:	3
Clock To:	
1st Value:	4.000
2nd Value:	
Value Percent:	
Continuous Index:	
Within 8" of Joint:	
Remarks:

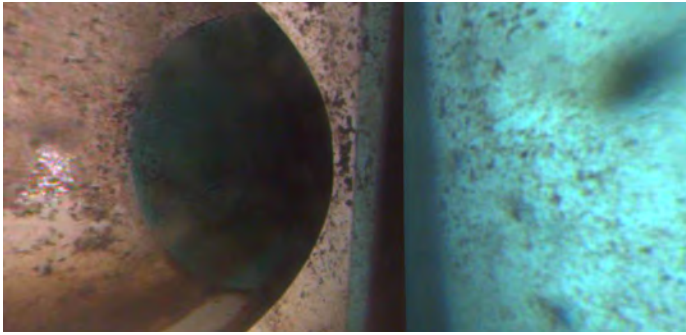
Code: **TFA**
Description: **Tap Factory Active**

Distance (ft): **42.3**
Structural Grade: **0**
O&M Grade: **0**
Clock Start/From: **9**
Clock To:
1st Value: **4.000**
2nd Value:
Value Percent:
Continuous Index:
Within 8" of Joint:
Remarks:

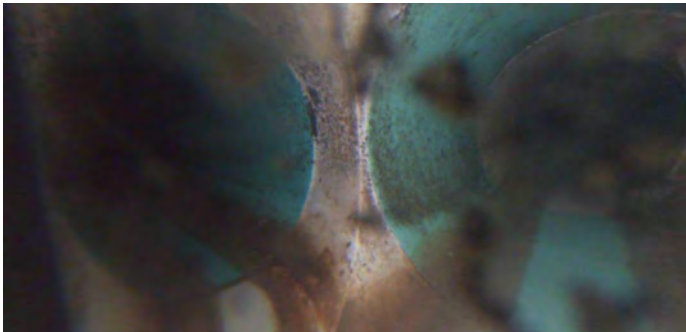
Code: **TFA**
Description: **Tap Factory Active**

Distance (ft): **110.7**
Structural Grade: **0**
O&M Grade: **0**
Clock Start/From: **9**
Clock To:
1st Value: **4.000**
2nd Value:
Value Percent:
Continuous Index:
Within 8" of Joint:
Remarks:

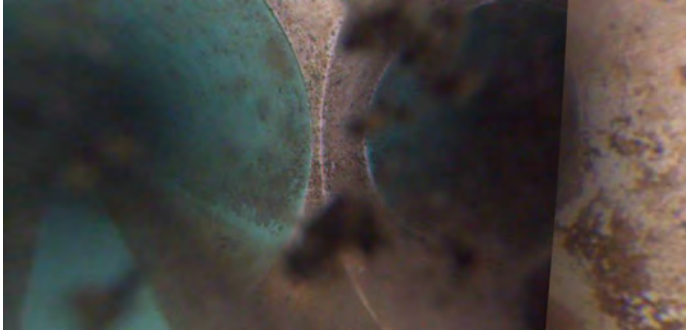
Code: **TF**
Description: **Tap Factory**

Distance (ft): **112.1**
Structural Grade: **0**
O&M Grade: **0**
Clock Start/From: **3**
Clock To:
1st Value: **4.000**
2nd Value:
Value Percent:
Continuous Index:
Within 8" of Joint:
Remarks:

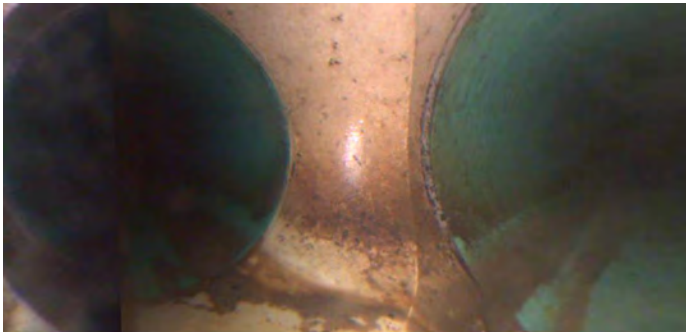
Code: **TF**
Description: **Tap Factory**

Distance (ft): **195.2**
Structural Grade: **0**
O&M Grade: **0**
Clock Start/From: **3**
Clock To:
1st Value: **4.000**
2nd Value:
Value Percent:
Continuous Index:
Within 8" of Joint:
Remarks:

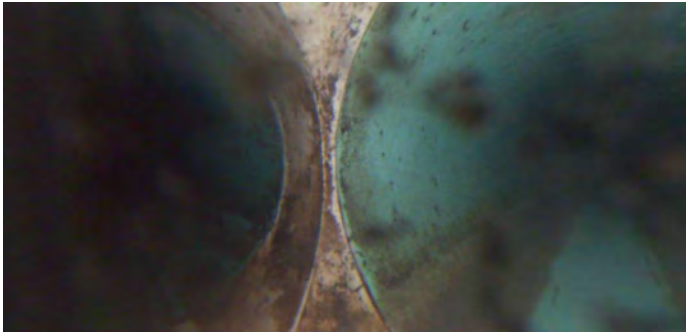
Code: **TF**
Description: **Tap Factory**

Distance (ft): **196.5**
Structural Grade: **0**
O&M Grade: **0**
Clock Start/From: **9**
Clock To:
1st Value: **4.000**
2nd Value:
Value Percent:
Continuous Index:
Within 8" of Joint:
Remarks:

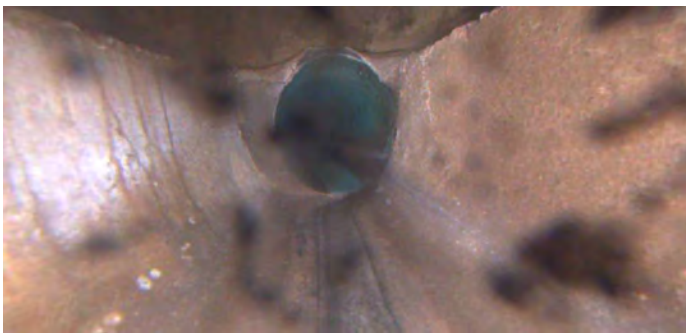
Code: **AMH**
Description: **Manhole**

Distance (ft): **235.9**
Structural Grade: **0**
O&M Grade: **0**
Clock Start/From:
Clock To:
1st Value:
2nd Value:
Value Percent:
Continuous Index:
Within 8" of Joint: **NO**
Remarks: **M-903-044**
