Profile/Photo Observation Report

Street:	brandit st	Flow Control:	Not Controlled
City:	Hobart, IN	Year Renewed:	
Location:	Other	Tape/Media #:	
Purpose:	Not Known	Dia/Height:	10"
Use:	Sanitary	Material:	VCP
Drain Area:	NA	Lining:	
Category:	NA		
Comment:

Location Details:		Direction of Survey:	Downstream
US MH:	M-903-045	DS MH:	M-903-044
		Total Length Surveyed (ft):	235.9

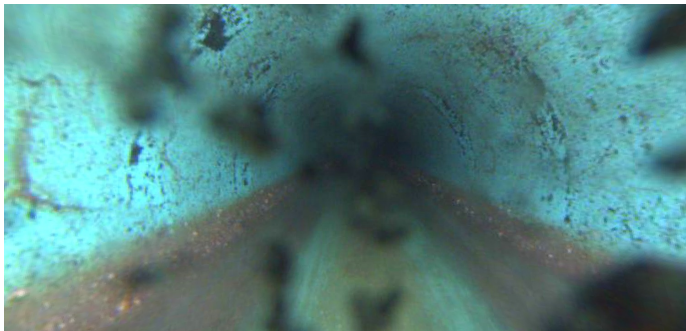
Code: **AMH**
Description: **Manhole**

Distance (ft): **.0**
Structural Grade: **0**
O&M Grade: **0**
Clock Start/From:
Clock To:
1st Value:
2nd Value:
Value Percent:
Continuous Index:
Within 8" of Joint: **NO**
Remarks: **M-903-045**

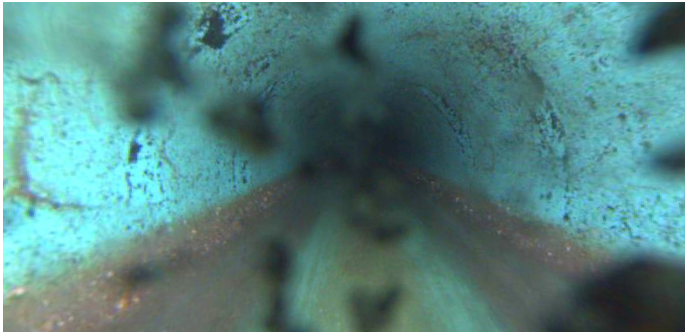
Code:	MWL
Description:	Water Level

Distance (ft):	.0
Structural Grade:	0
O&M Grade:	0
Clock Start/From:	
Clock To:	
1st Value:	
2nd Value:	
Value Percent:	5.000
Continuous Index:	
Within 8" of Joint:	NO
Remarks:

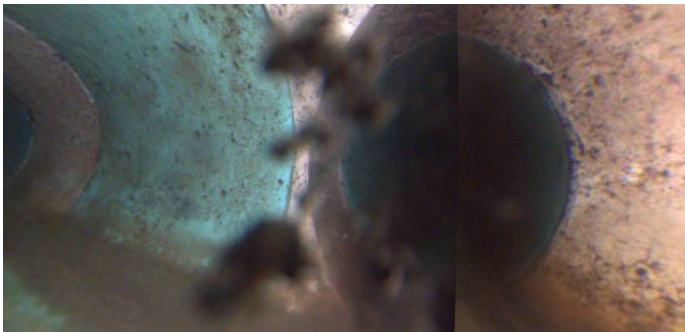
Code:	TFA
Description:	Tap Factory Active

Distance (ft):	40.6
Structural Grade:	0
O&M Grade:	0
Clock Start/From:	3
Clock To:	
1st Value:	4.000
2nd Value:	
Value Percent:	
Continuous Index:	
Within 8" of Joint:	
Remarks:

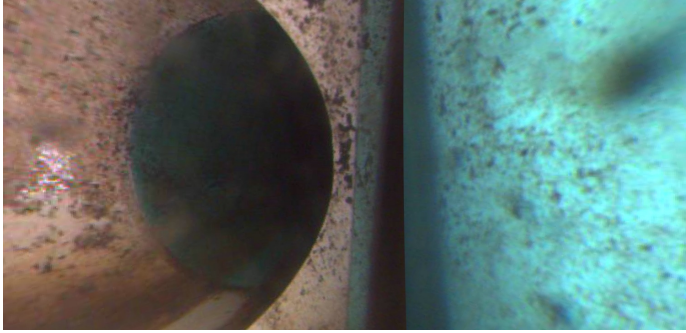
Code: **TFA**
Description: **Tap Factory Active**

Distance (ft): **42.3**
Structural Grade: **0**
O&M Grade: **0**
Clock Start/From: **9**
Clock To:
1st Value: **4.000**
2nd Value:
Value Percent:
Continuous Index:
Within 8" of Joint:
Remarks:

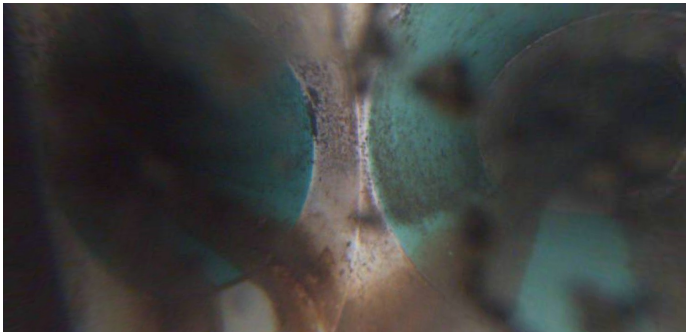
Code: **TFA**
Description: **Tap Factory Active**

Distance (ft): **110.7**
Structural Grade: **0**
O&M Grade: **0**
Clock Start/From: **9**
Clock To:
1st Value: **4.000**
2nd Value:
Value Percent:
Continuous Index:
Within 8" of Joint:
Remarks:

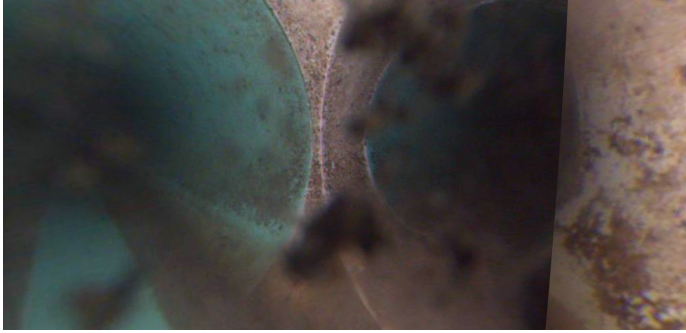
Code: **TF**
Description: **Tap Factory**

Distance (ft): **112.1**
Structural Grade: **0**
O&M Grade: **0**
Clock Start/From: **3**
Clock To:
1st Value: **4.000**
2nd Value:
Value Percent:
Continuous Index:
Within 8" of Joint:
Remarks:

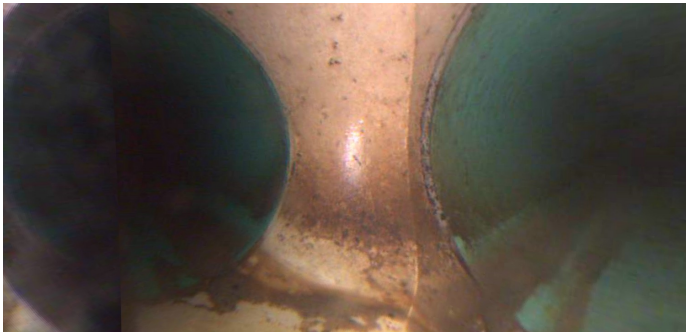
Code: **TF**
Description: **Tap Factory**

Distance (ft): **195.2**
Structural Grade: **0**
O&M Grade: **0**
Clock Start/From: **3**
Clock To:
1st Value: **4.000**
2nd Value:
Value Percent:
Continuous Index:
Within 8" of Joint:
Remarks:

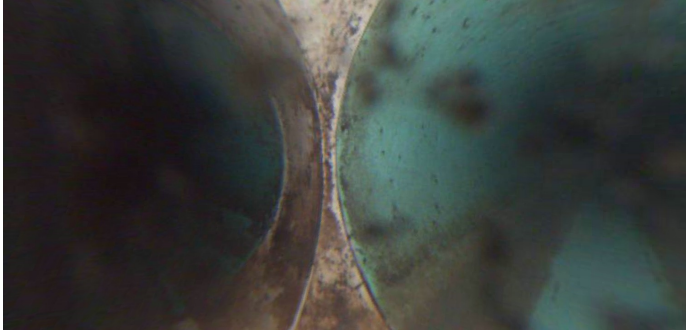
Code: **TF**
Description: **Tap Factory**

Distance (ft): **196.5**
Structural Grade: **0**
O&M Grade: **0**
Clock Start/From: **9**
Clock To:
1st Value: **4.000**
2nd Value:
Value Percent:
Continuous Index:
Within 8" of Joint:
Remarks:

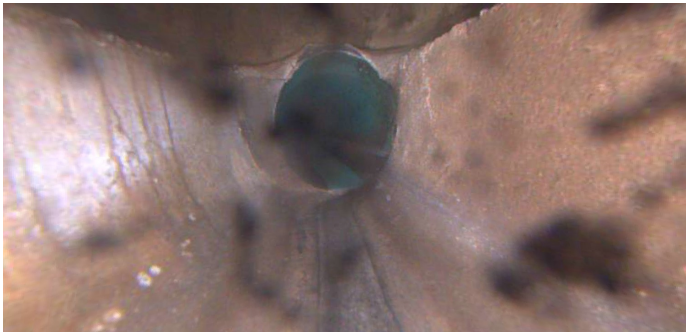
Code: **AMH**
Description: **Manhole**

Distance (ft): **235.9**
Structural Grade: **0**
O&M Grade: **0**
Clock Start/From:
Clock To:
1st Value:
2nd Value:
Value Percent:
Continuous Index:
Within 8" of Joint: **NO**
Remarks: **M-903-044**
