## Profile/Photo Observation Report

Street:	<b>COOKE ST</b>	Flow Control:	<b>Not Controlled</b>
City:	<b>Hobart, IN</b>	Year Renewed:	
Location:	<b>Other</b>	Tape/Media #:	
Purpose:	<b>Not Known</b>	Dia/Height:	<b>10"</b>
Use:	<b>Sanitary</b>	Material:	<b>PVC</b>
Drain Area:	<b>NA</b>	Lining:	
Category:	<b>NA</b>		
Comment:

Location Details:		Direction of Survey:	<b>Upstream</b>
US MH:	<b>M-903-046</b>	DS MH:	<b>M-903-045</b>
		Total Length Surveyed (ft):	<b>238.8</b>

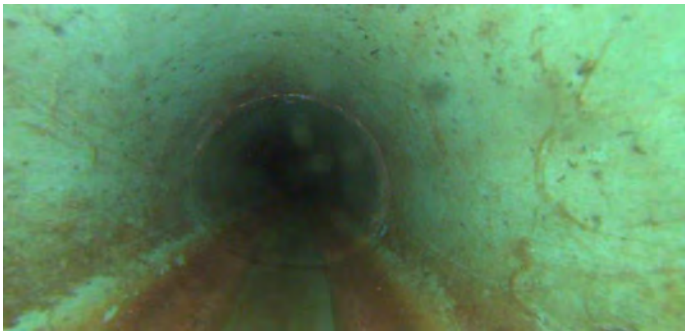
Code: **AMH**  
Description: **Manhole**

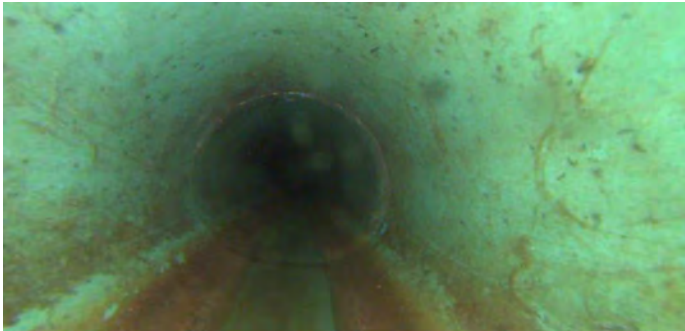
Code:	<b>MWL</b>
Description:	<b>Water Level</b>

Distance (ft):	<b>.0</b>
Structural Grade:	<b>0</b>
O&M Grade:	<b>0</b>
Clock Start/From:	
Clock To:	
1st Value:	
2nd Value:	
Value Percent:	<b>5.000</b>
Continuous Index:	
Within 8" of Joint:	<b>NO</b>
Remarks:

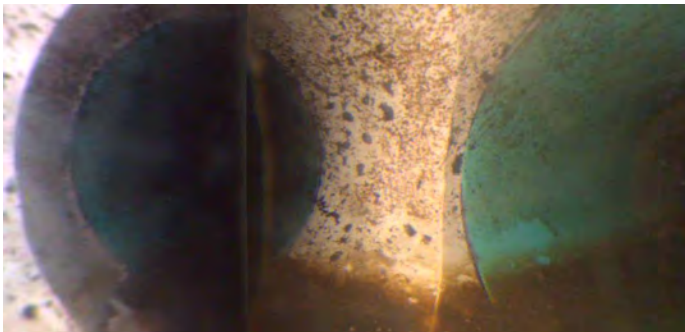
Code:	<b>TF</b>
Description:	<b>Tap Factory</b>

Distance (ft):	<b>42.7</b>
Structural Grade:	<b>0</b>
O&M Grade:	<b>0</b>
Clock Start/From:	<b>9</b>
Clock To:	
1st Value:	<b>4.000</b>
2nd Value:	
Value Percent:	
Continuous Index:	
Within 8" of Joint:	
Remarks:

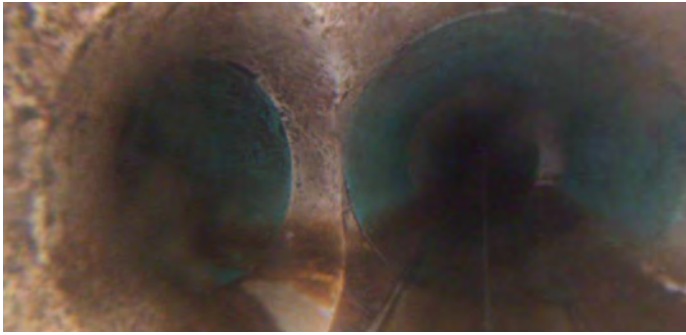
Code: **TF**  
Description: **Tap Factory**

Distance (ft): **44.7**  
Structural Grade: **0**  
O&M Grade: **0**  
Clock Start/From: **3**  
Clock To:  
1st Value: **4.000**  
2nd Value:  
Value Percent:  
Continuous Index:  
Within 8" of Joint:  
Remarks:

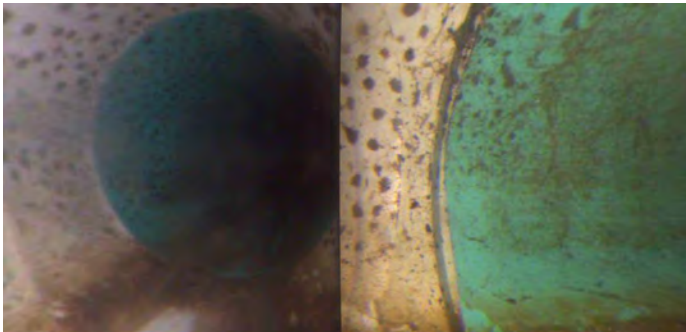
Code: **TF**  
Description: **Tap Factory**

Distance (ft): **112.8**  
Structural Grade: **0**  
O&M Grade: **0**  
Clock Start/From: **9**  
Clock To:  
1st Value: **4.000**  
2nd Value:  
Value Percent:  
Continuous Index:  
Within 8" of Joint:  
Remarks:

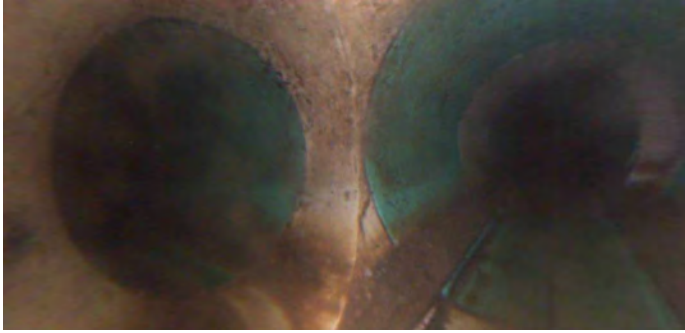
Code: **TF**  
Description: **Tap Factory**

Distance (ft): **114.4**  
Structural Grade: **0**  
O&M Grade: **0**  
Clock Start/From: **3**  
Clock To:  
1st Value: **4.000**  
2nd Value:  
Value Percent:  
Continuous Index:  
Within 8" of Joint:  
Remarks:

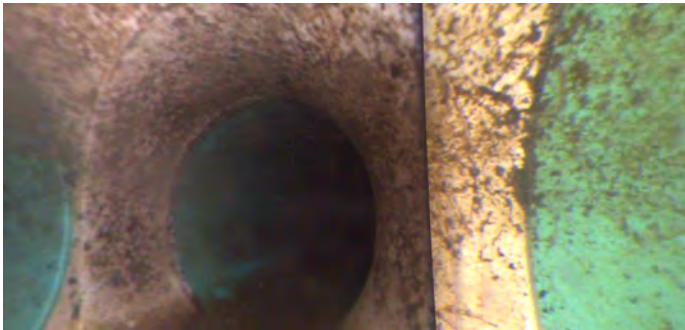
Code: **TFA**  
Description: **Tap Factory Active**

Distance (ft): **196.3**  
Structural Grade: **0**  
O&M Grade: **0**  
Clock Start/From: **9**  
Clock To:  
1st Value: **4.000**  
2nd Value:  
Value Percent:  
Continuous Index:  
Within 8" of Joint:  
Remarks:

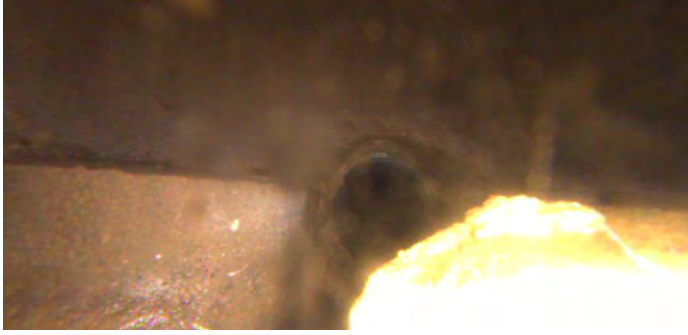
Code:	AMH
Description:	Manhole
Distance (ft):	238.8
Structural Grade:	0
O&M Grade:	0
Clock Start/From:	
Clock To:	
1st Value:	
2nd Value:	
Value Percent:	
Continuous Index:	
Within 8" of Joint:	NO
Remarks:	M-903-046
