## Profile/Photo Observation Report

Street:	<b>brandit st</b>	Flow Control:	<b>Not Controlled</b>
City:	<b>Hobart, IN</b>	Year Renewed:	
Location:	<b>Other</b>	Tape/Media #:	
Purpose:	<b>Not Known</b>	Dia/Height:	<b>10"</b>
Use:	<b>Sanitary</b>	Material:	<b>PVC</b>
Drain Area:	<b>NA</b>	Lining:	
Category:	<b>NA</b>		
Comment:

Location Details:		Direction of Survey:	<b>Upstream</b>
US MH:	<b>M-903-046</b>	DS MH:	<b>M-903-045</b>
		Total Length Surveyed (ft):	<b>238.8</b>

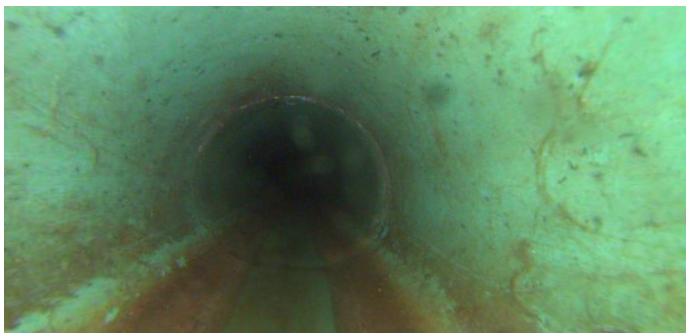
Code: **AMH**  
Description: **Manhole**

Distance (ft): **.0**  
Structural Grade: **0**  
O&M Grade: **0**  
Clock Start/From:  
Clock To:  
1st Value:  
2nd Value:  
Value Percent:  
Continuous Index:  
Within 8" of Joint: **NO**  
Remarks: **M-903-045**

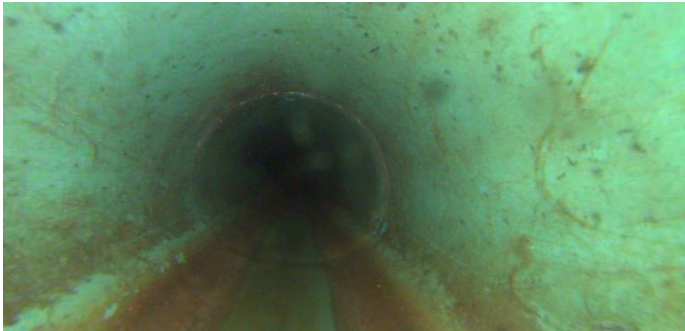
Code:	<b>MWL</b>
Description:	<b>Water Level</b>

Distance (ft):	<b>.0</b>
Structural Grade:	<b>0</b>
O&M Grade:	<b>0</b>
Clock Start/From:	
Clock To:	
1st Value:	
2nd Value:	
Value Percent:	<b>5.000</b>
Continuous Index:	
Within 8" of Joint:	<b>NO</b>
Remarks:

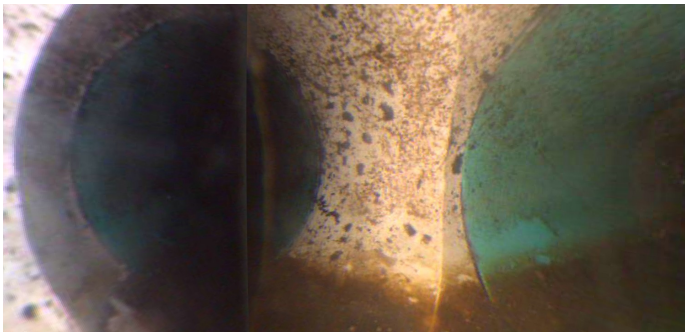
Code:	<b>TF</b>
Description:	<b>Tap Factory</b>

Distance (ft):	<b>42.7</b>
Structural Grade:	<b>0</b>
O&M Grade:	<b>0</b>
Clock Start/From:	<b>9</b>
Clock To:	
1st Value:	<b>4.000</b>
2nd Value:	
Value Percent:	
Continuous Index:	
Within 8" of Joint:	
Remarks:

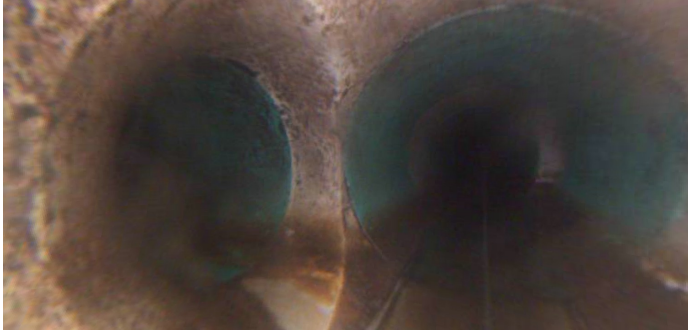
Code: **TF**  
Description: **Tap Factory**

Distance (ft): **44.7**  
Structural Grade: **0**  
O&M Grade: **0**  
Clock Start/From: **3**  
Clock To:  
1st Value: **4.000**  
2nd Value:  
Value Percent:  
Continuous Index:  
Within 8" of Joint:  
Remarks:

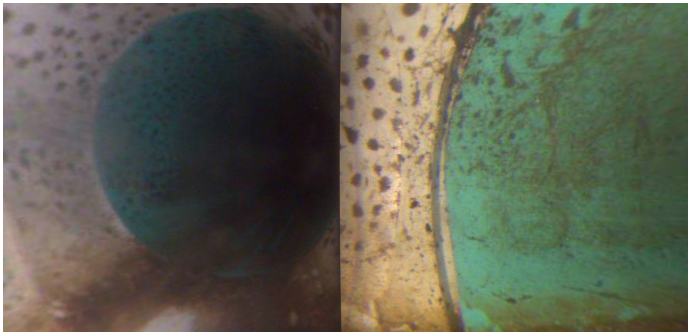
Code: **TF**  
Description: **Tap Factory**

Distance (ft): **112.8**  
Structural Grade: **0**  
O&M Grade: **0**  
Clock Start/From: **9**  
Clock To:  
1st Value: **4.000**  
2nd Value:  
Value Percent:  
Continuous Index:  
Within 8" of Joint:  
Remarks:

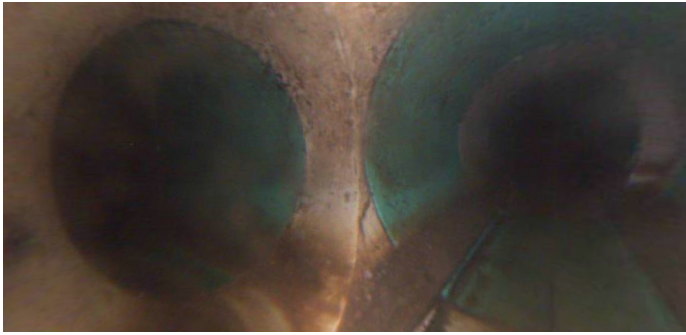
Code: **TF**  
Description: **Tap Factory**

Distance (ft): **114.4**  
Structural Grade: **0**  
O&M Grade: **0**  
Clock Start/From: **3**  
Clock To:  
1st Value: **4.000**  
2nd Value:  
Value Percent:  
Continuous Index:  
Within 8" of Joint:  
Remarks:

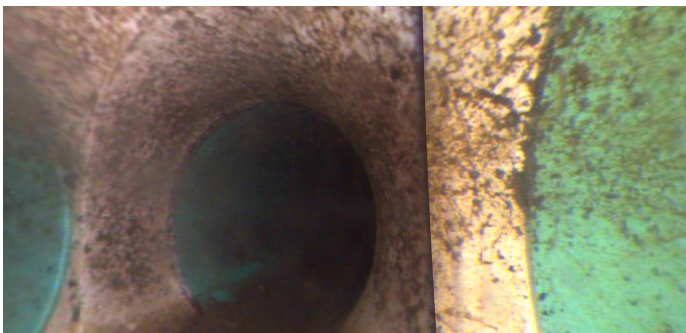
Code: **TFA**  
Description: **Tap Factory Active**

Distance (ft): **196.3**  
Structural Grade: **0**  
O&M Grade: **0**  
Clock Start/From: **9**  
Clock To:  
1st Value: **4.000**  
2nd Value:  
Value Percent:  
Continuous Index:  
Within 8" of Joint:  
Remarks:

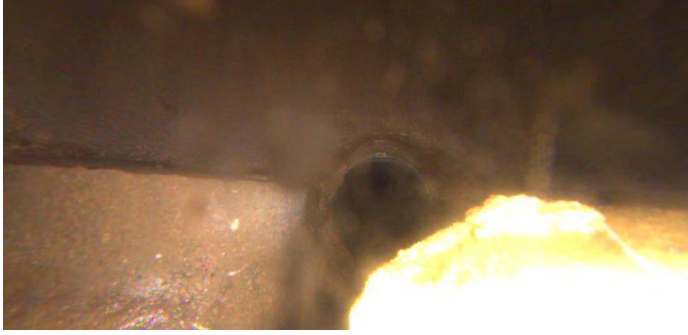
Code:	AMH
Description:	Manhole
Distance (ft):	238.8
Structural Grade:	0
O&M Grade:	0
Clock Start/From:	
Clock To:	
1st Value:	
2nd Value:	
Value Percent:	
Continuous Index:	
Within 8" of Joint:	NO
Remarks:	M-903-046
