## Profile/Photo Observation Report

Street:	<b>COOKE ST</b>	Flow Control:	<b>Not Controlled</b>
City:	<b>Hobart, IN</b>	Year Renewed:	
Location:	<b>Other</b>	Tape/Media #:	
Purpose:	<b>Not Known</b>	Dia/Height:	<b>10"</b>
Use:	<b>Sanitary</b>	Material:	<b>PVC</b>
Drain Area:	<b>NA</b>	Lining:	
Category:	<b>NA</b>		
Comment:

Location Details:		Direction of Survey:	<b>Downstream</b>
US MH:	<b>M-903-047</b>	DS MH:	<b>M-903-046</b>
		Total Length Surveyed (ft):	<b>122.8</b>

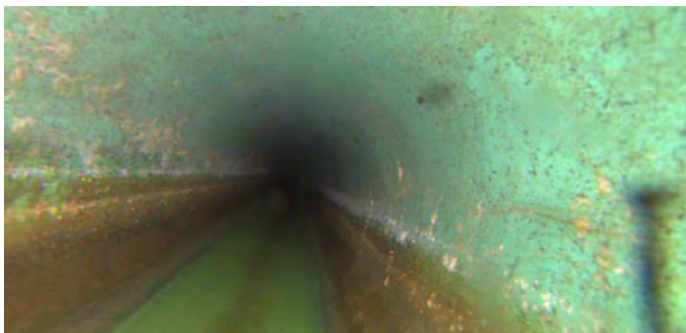
Code: **AMH**  
Description: **Manhole**

Distance (ft): **.0**  
Structural Grade: **0**  
O&M Grade: **0**  
Clock Start/From:  
Clock To:  
1st Value:  
2nd Value:  
Value Percent:  
Continuous Index:  
Within 8" of Joint: **NO**  
Remarks: **M-903-047**

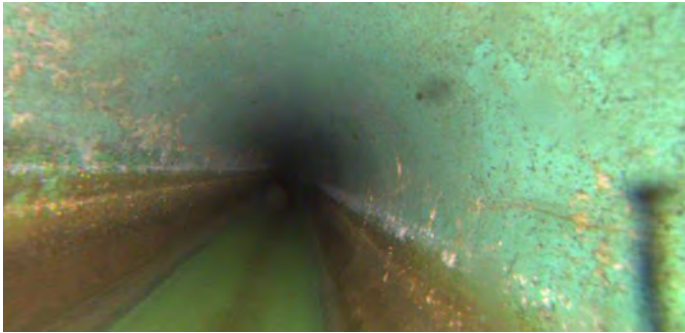
Code:	<b>MWL</b>
Description:	<b>Water Level</b>

Distance (ft):	<b>.0</b>
Structural Grade:	<b>0</b>
O&M Grade:	<b>0</b>
Clock Start/From:	
Clock To:	
1st Value:	
2nd Value:	
Value Percent:	<b>5.000</b>
Continuous Index:	
Within 8" of Joint:	<b>NO</b>
Remarks:

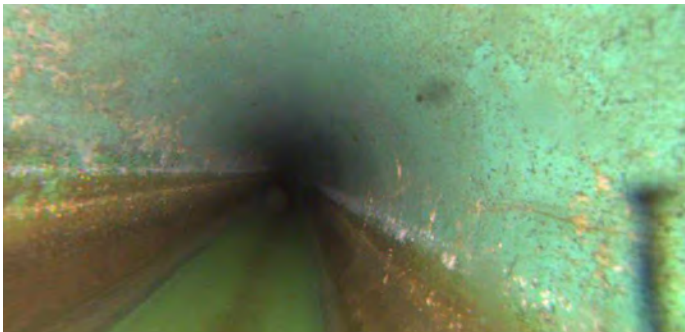
Code:	<b>DAGS</b>
Description:	<b>Deposits Attached Grease</b>

Distance (ft):	<b>.0</b>
Structural Grade:	<b>0</b>
O&M Grade:	<b>2</b>
Clock Start/From:	<b>8</b>
Clock To:	<b>4</b>
1st Value:	
2nd Value:	
Value Percent:	<b>5.000</b>
Continuous Index:	<b>S01</b>
Within 8" of Joint:	<b>NO</b>
Remarks:

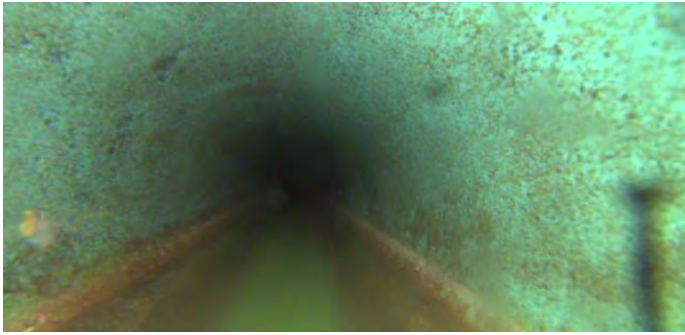
Code: **DAGS**  
Description: **Deposits Attached Grease**

Distance (ft): **30.5**  
Structural Grade: **0**  
O&M Grade: **2**  
Clock Start/From: **8**  
Clock To: **4**  
1st Value:  
2nd Value:  
Value Percent: **5.000**  
Continuous Index: **F01**  
Within 8" of Joint: **NO**  
Remarks:

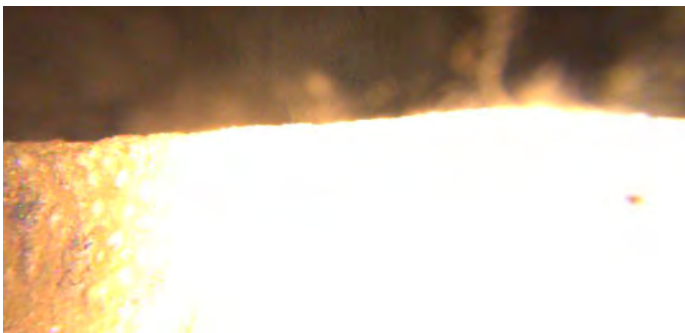
Code: **AMH**  
Description: **Manhole**

Distance (ft): **122.8**  
Structural Grade: **0**  
O&M Grade: **0**  
Clock Start/From:  
Clock To:  
1st Value:  
2nd Value:  
Value Percent:  
Continuous Index:  
Within 8" of Joint: **NO**  
Remarks: **M-903-046**
