Profile/Photo Observation Report

Street:	brandit st	Flow Control:	Not Controlled
City:	Hobart, IN	Year Renewed:	
Location:	Other	Tape/Media #:	
Purpose:	Not Known	Dia/Height:	10"
Use:	Sanitary	Material:	PVC
Drain Area:	NA	Lining:	
Category:	NA		
Comment:

Location Details:		Direction of Survey:	Downstream
US MH:	M-903-047	DS MH:	M-903-046
		Total Length Surveyed (ft):	122.8

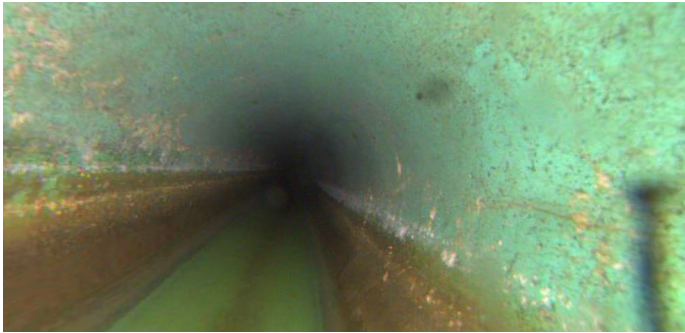
Code:	MWL
Description:	Water Level

Distance (ft):	.0
Structural Grade:	0
O&M Grade:	0
Clock Start/From:	
Clock To:	
1st Value:	
2nd Value:	
Value Percent:	5.000
Continuous Index:	
Within 8" of Joint:	NO
Remarks:

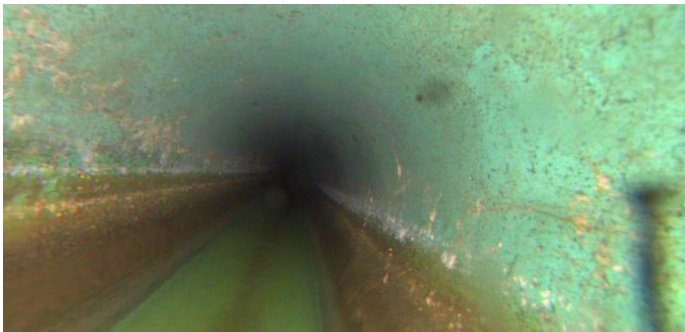
Code:	DAGS
Description:	Deposits Attached Grease

Distance (ft):	.0
Structural Grade:	0
O&M Grade:	2
Clock Start/From:	8
Clock To:	4
1st Value:	
2nd Value:	
Value Percent:	5.000
Continuous Index:	S01
Within 8" of Joint:	NO
Remarks:

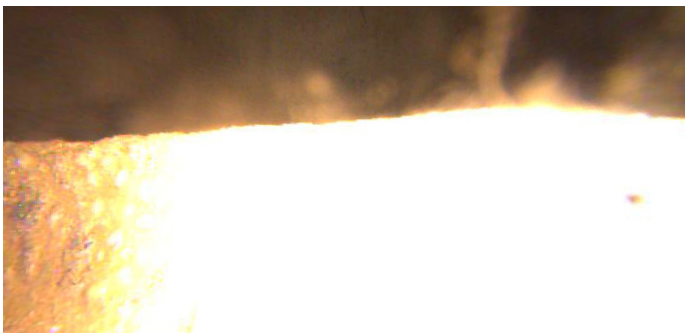
Code: **AMH**
Description: **Manhole**

Distance (ft): **122.8**
Structural Grade: **0**
O&M Grade: **0**
Clock Start/From:
Clock To:
1st Value:
2nd Value:
Value Percent:
Continuous Index:
Within 8" of Joint: **NO**
Remarks: **M-903-046**
