Profile/Photo Observation Report

Date:	03/30/2018	Weather:		Coding:	PACP 6.0
Pipe Length (ft):	35.2	Owner:	NA	Pre Clean:	Not Known
P.O.#:		Surveyor:	Jen Costello	PSR:	P-903-047-048
Customer:		Clean Date:	01/01/1900	Shape:	C

Street:	OFF COOKE ST	Flow Control:	Not Controlled
City:	Hobart, IN	Year Renewed:	
Location:	Other	Tape/Media #:	
Purpose:	Not Known	Dia/Height:	10"
Use:	Sanitary	Material:	PVC
Drain Area:	NA	Lining:	
Category:	NA		
Comment:

Location Details:		Direction of Survey:	Upstream
US MH:	M-903-048	DS MH:	M-903-047
		Total Length Surveyed (ft):	35.9

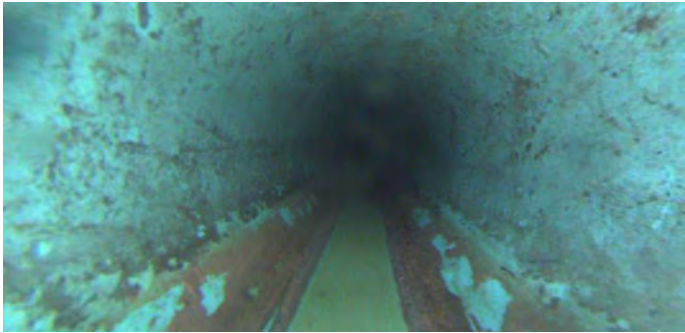
Code:	MWL
Description:	Water Level

Distance (ft):	.0
Structural Grade:	0
O&M Grade:	0
Clock Start/From:	
Clock To:	
1st Value:	
2nd Value:	
Value Percent:	5.000
Continuous Index:	
Within 8" of Joint:	NO
Remarks:

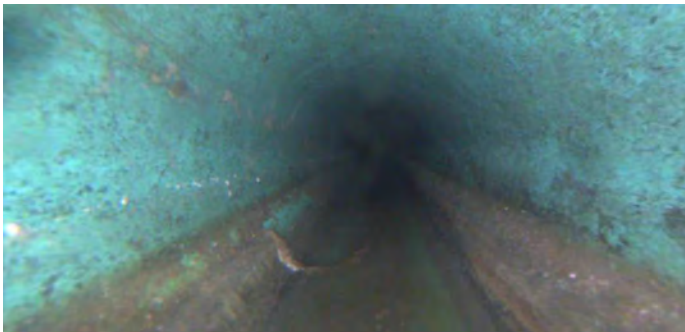
Code:	DAGS
Description:	Deposits Attached Grease

Distance (ft):	25.5
Structural Grade:	0
O&M Grade:	2
Clock Start/From:	7
Clock To:	5
1st Value:	
2nd Value:	
Value Percent:	5.000
Continuous Index:	S01
Within 8" of Joint:	NO
Remarks:

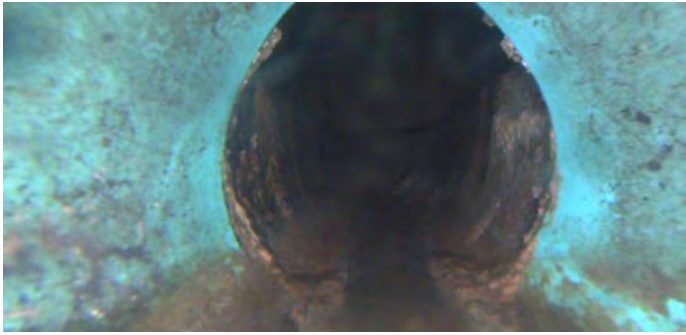
Code: **DAGS**
Description: **Deposits Attached Grease**

Distance (ft): **33.6**
Structural Grade: **0**
O&M Grade: **2**
Clock Start/From: **7**
Clock To: **5**
1st Value:
2nd Value:
Value Percent: **5.000**
Continuous Index: **F01**
Within 8" of Joint: **NO**
Remarks:

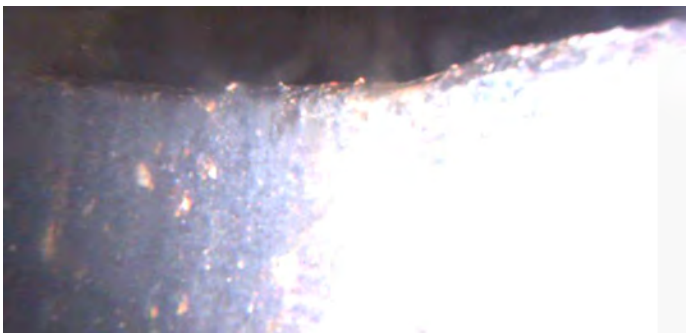
Code: **AMH**
Description: **Manhole**

Distance (ft): **35.9**
Structural Grade: **0**
O&M Grade: **0**
Clock Start/From:
Clock To:
1st Value:
2nd Value:
Value Percent:
Continuous Index:
Within 8" of Joint: **NO**
Remarks: **M-903-048**
