Profile/Photo Observation Report

Street:	brandit st	Flow Control:	Not Controlled
City:	Hobart, IN	Year Renewed:	
Location:	Other	Tape/Media #:	
Purpose:	Not Known	Dia/Height:	10"
Use:	Sanitary	Material:	PVC
Drain Area:	NA	Lining:	
Category:	NA		
Comment:

Location Details:		Direction of Survey:	Upstream
US MH:	M-903-048	DS MH:	M-903-047
		Total Length Surveyed (ft):	35.9

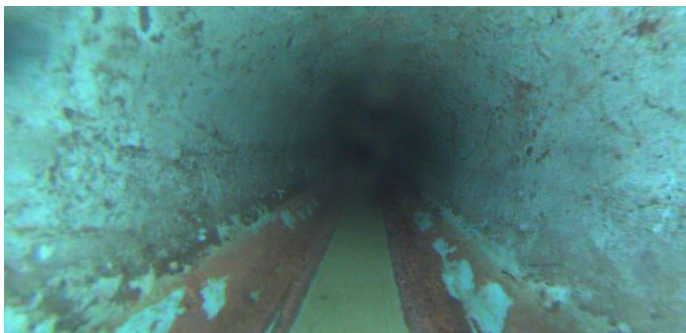
Code: **AMH**
Description: **Manhole**

Distance (ft): **.0**
Structural Grade: **0**
O&M Grade: **0**
Clock Start/From:
Clock To:
1st Value:
2nd Value:
Value Percent:
Continuous Index:
Within 8" of Joint: **NO**
Remarks: **M-903-047**

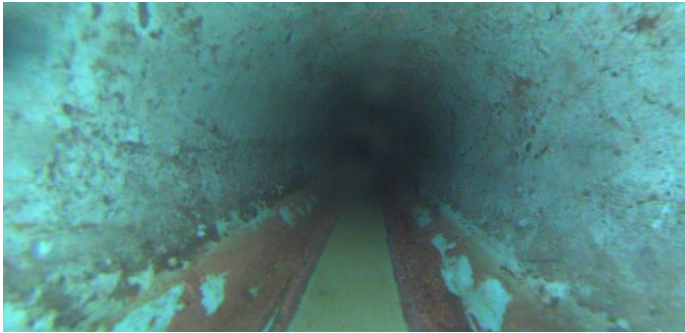
Code:	MWL
Description:	Water Level

Distance (ft):	.0
Structural Grade:	0
O&M Grade:	0
Clock Start/From:	
Clock To:	
1st Value:	
2nd Value:	
Value Percent:	5.000
Continuous Index:	
Within 8" of Joint:	NO
Remarks:

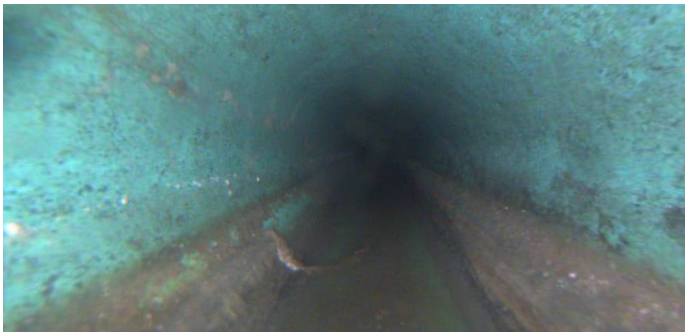
Code:	DAGS
Description:	Deposits Attached Grease

Distance (ft):	25.5
Structural Grade:	0
O&M Grade:	2
Clock Start/From:	7
Clock To:	5
1st Value:	
2nd Value:	
Value Percent:	5.000
Continuous Index:	S01
Within 8" of Joint:	NO
Remarks:

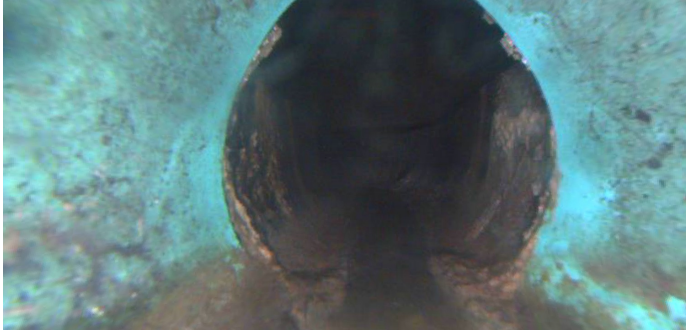
Code: **DAGS**
Description: **Deposits Attached Grease**

Distance (ft): **33.6**
Structural Grade: **0**
O&M Grade: **2**
Clock Start/From: **7**
Clock To: **5**
1st Value:
2nd Value:
Value Percent: **5.000**
Continuous Index: **F01**
Within 8" of Joint: **NO**
Remarks:

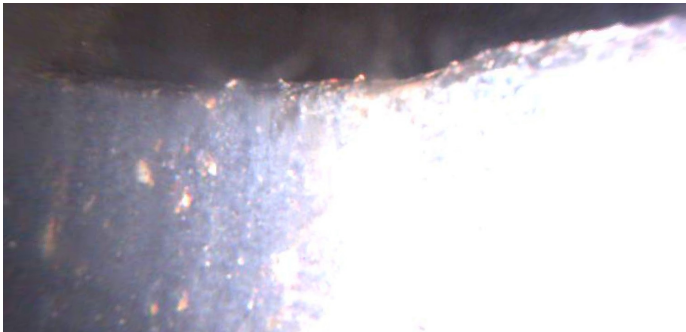
Code: **AMH**
Description: **Manhole**

Distance (ft): **35.9**
Structural Grade: **0**
O&M Grade: **0**
Clock Start/From:
Clock To:
1st Value:
2nd Value:
Value Percent:
Continuous Index:
Within 8" of Joint: **NO**
Remarks: **M-903-048**
