Profile/Photo Observation Report

Street:	COOKE ST & BRANDT ST	Flow Control:	Not Controlled
City:	Hobart, IN	Year Renewed:	
Location:	Other	Tape/Media #:	
Purpose:	Not Known	Dia/Height:	10"
Use:	Sanitary	Material:	PVC
Drain Area:	NA	Lining:	
Category:	NA		
Comment:

Location Details:		Direction of Survey:	Downstream
US MH:	M-903-049	DS MH:	M-903-046
		Total Length Surveyed (ft):	221.8

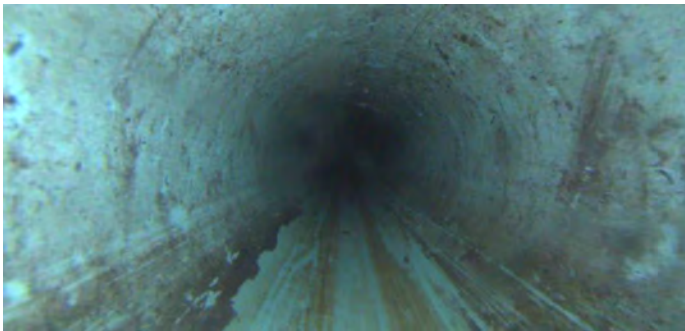
Code: **AMH**
Description: **Manhole**

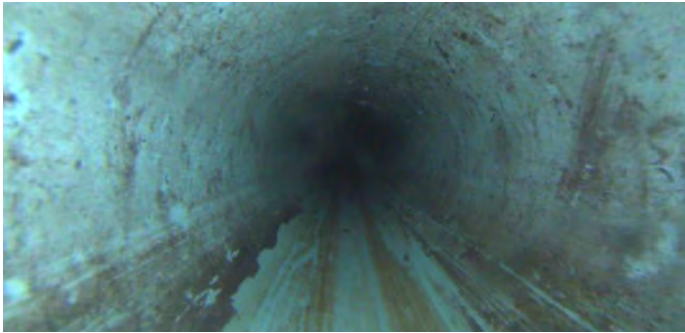
Code:	MWL
Description:	Water Level

Distance (ft):	.0
Structural Grade:	0
O&M Grade:	0
Clock Start/From:	
Clock To:	
1st Value:	
2nd Value:	
Value Percent:	5.000
Continuous Index:	
Within 8" of Joint:	NO
Remarks:

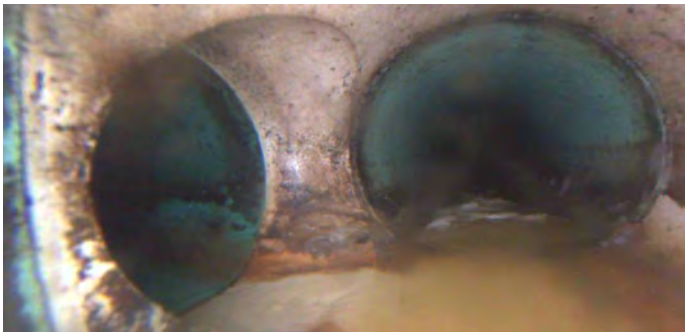
Code:	TFA
Description:	Tap Factory Active

Distance (ft):	26.3
Structural Grade:	0
O&M Grade:	0
Clock Start/From:	9
Clock To:	
1st Value:	4.000
2nd Value:	
Value Percent:	
Continuous Index:	
Within 8" of Joint:	
Remarks:

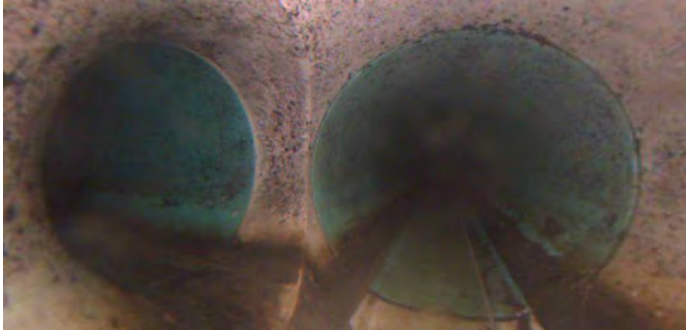
Code: **TFA**
Description: **Tap Factory Active**

Distance (ft): **96.2**
Structural Grade: **0**
O&M Grade: **0**
Clock Start/From: **3**
Clock To:
1st Value: **4.000**
2nd Value:
Value Percent:
Continuous Index:
Within 8" of Joint:
Remarks:

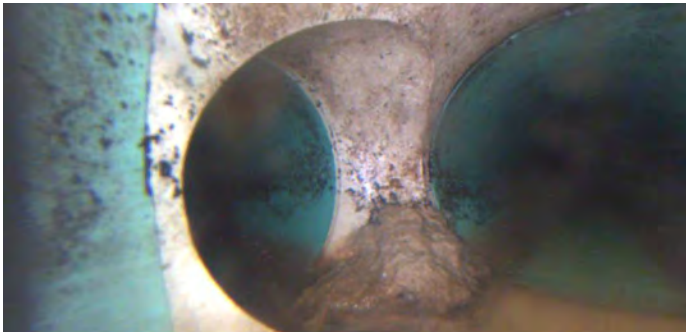
Code: **TFA**
Description: **Tap Factory Active**

Distance (ft): **109.7**
Structural Grade: **0**
O&M Grade: **0**
Clock Start/From: **9**
Clock To:
1st Value: **4.000**
2nd Value:
Value Percent:
Continuous Index:
Within 8" of Joint:
Remarks:

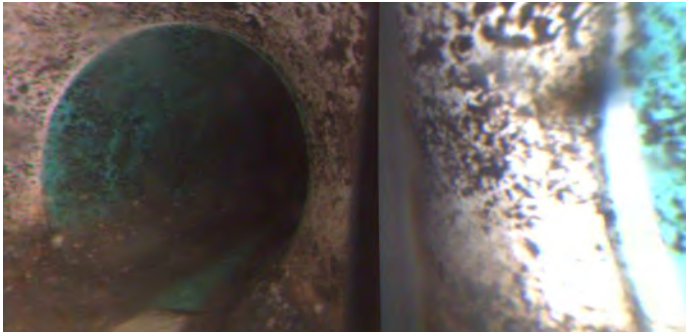
Code: **TFA**
Description: **Tap Factory Active**

Distance (ft): **179.0**
Structural Grade: **0**
O&M Grade: **0**
Clock Start/From: **9**
Clock To:
1st Value: **4.000**
2nd Value:
Value Percent:
Continuous Index:
Within 8" of Joint:
Remarks:

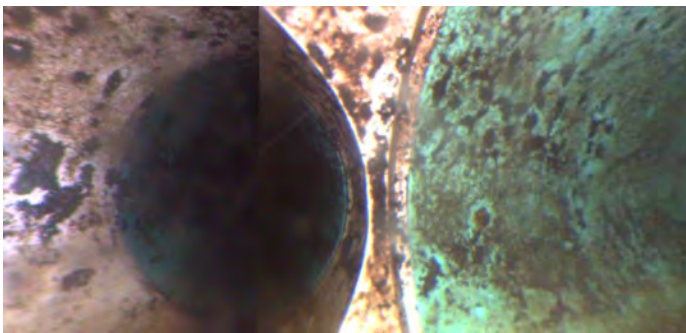
Code: **TF**
Description: **Tap Factory**

Distance (ft): **180.1**
Structural Grade: **0**
O&M Grade: **0**
Clock Start/From: **3**
Clock To:
1st Value: **4.000**
2nd Value:
Value Percent:
Continuous Index:
Within 8" of Joint:
Remarks:

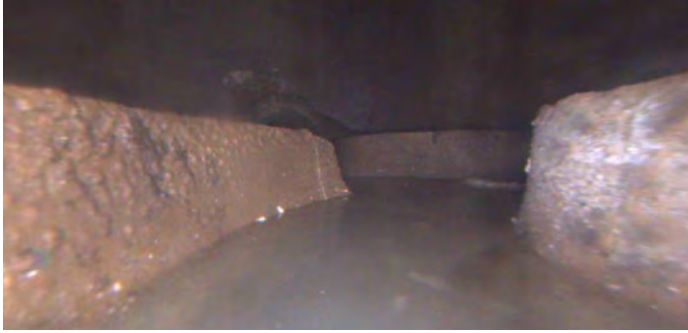
Code:	AMH
Description:	Manhole
Distance (ft):	221.8
Structural Grade:	0
O&M Grade:	0
Clock Start/From:	
Clock To:	
1st Value:	
2nd Value:	
Value Percent:	
Continuous Index:	
Within 8" of Joint:	NO
Remarks:	M-903-046
