Profile/Photo Observation Report

Street:	brandit st	Flow Control:	Not Controlled
City:	Hobart, IN	Year Renewed:	
Location:	Other	Tape/Media #:	
Purpose:	Not Known	Dia/Height:	10"
Use:	Sanitary	Material:	PVC
Drain Area:	NA	Lining:	
Category:	NA		
Comment:

Location Details:		Direction of Survey:	Downstream
US MH:	M-903-049	DS MH:	M-903-046
		Total Length Surveyed (ft):	221.8

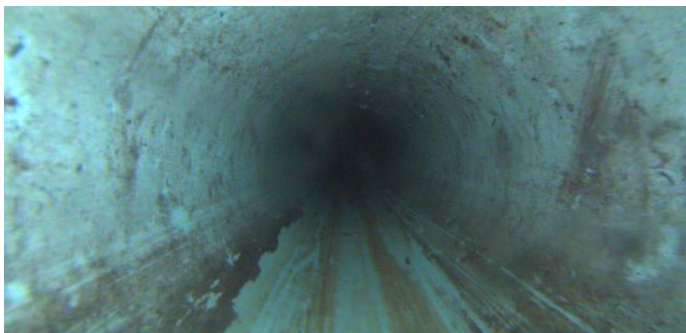
Code: **AMH**
Description: **Manhole**

Distance (ft): **.0**
Structural Grade: **0**
O&M Grade: **0**
Clock Start/From:
Clock To:
1st Value:
2nd Value:
Value Percent:
Continuous Index:
Within 8" of Joint: **NO**
Remarks: **M-903-049**

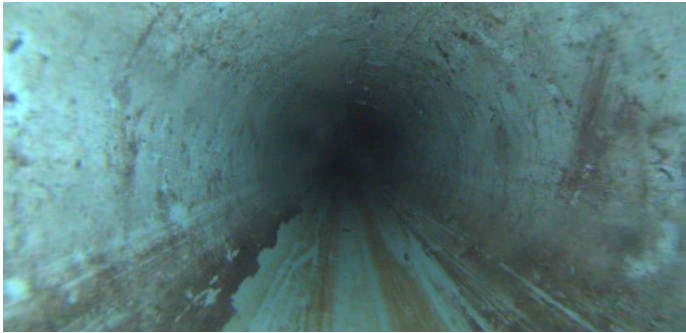
Code: **MWL**
Description: **Water Level**

Distance (ft): **.0**
Structural Grade: **0**
O&M Grade: **0**
Clock Start/From:
Clock To:
1st Value:
2nd Value:
Value Percent: **5.000**
Continuous Index:
Within 8" of Joint: **NO**
Remarks:

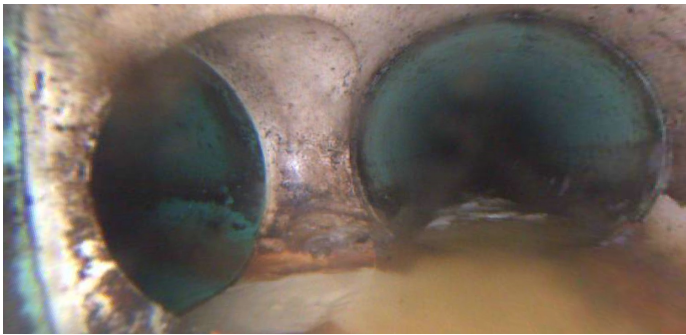
Code: **TFA**
Description: **Tap Factory Active**

Distance (ft): **26.3**
Structural Grade: **0**
O&M Grade: **0**
Clock Start/From: **9**
Clock To:
1st Value: **4.000**
2nd Value:
Value Percent:
Continuous Index:
Within 8" of Joint:
Remarks:

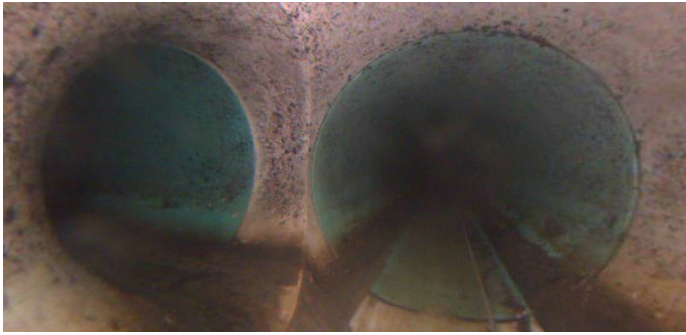
Code: **TFA**
Description: **Tap Factory Active**

Distance (ft): **96.2**
Structural Grade: **0**
O&M Grade: **0**
Clock Start/From: **3**
Clock To:
1st Value: **4.000**
2nd Value:
Value Percent:
Continuous Index:
Within 8" of Joint:
Remarks:

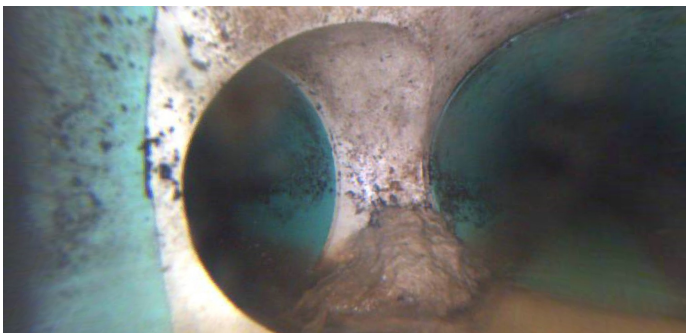
Code: **TFA**
Description: **Tap Factory Active**

Distance (ft): **109.7**
Structural Grade: **0**
O&M Grade: **0**
Clock Start/From: **9**
Clock To:
1st Value: **4.000**
2nd Value:
Value Percent:
Continuous Index:
Within 8" of Joint:
Remarks:

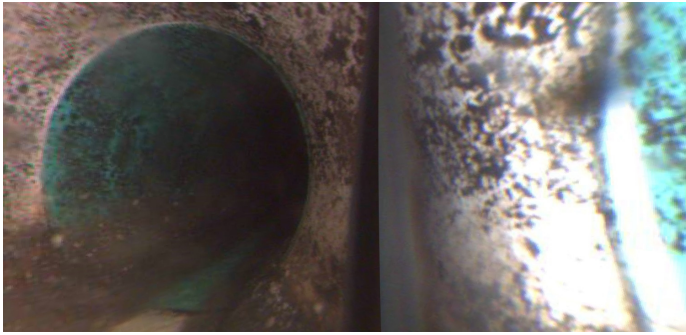
Code: **TFA**
Description: **Tap Factory Active**

Distance (ft): **179.0**
Structural Grade: **0**
O&M Grade: **0**
Clock Start/From: **9**
Clock To:
1st Value: **4.000**
2nd Value:
Value Percent:
Continuous Index:
Within 8" of Joint:
Remarks:

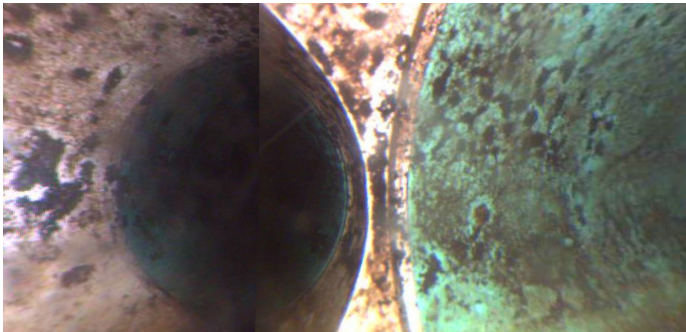
Code: **TF**
Description: **Tap Factory**

Distance (ft): **180.1**
Structural Grade: **0**
O&M Grade: **0**
Clock Start/From: **3**
Clock To:
1st Value: **4.000**
2nd Value:
Value Percent:
Continuous Index:
Within 8" of Joint:
Remarks:

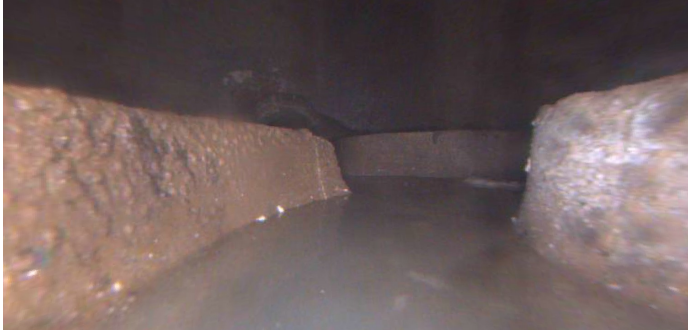
Code:	AMH
Description:	Manhole
Distance (ft):	221.8
Structural Grade:	0
O&M Grade:	0
Clock Start/From:	
Clock To:	
1st Value:	
2nd Value:	
Value Percent:	
Continuous Index:	
Within 8" of Joint:	NO
Remarks:	M-903-046
