Profile/Photo Observation Report

Date:	03/20/2018	Weather:		Coding:	PACP 6.0
Pipe Length (ft):	31.4	Owner:	NA	Pre Clean:	Not Known
P.O.#:		Surveyor:	JUSTIN GONZALES	PSR:	P-903-UNK-051
Customer:		Clean Date:	01/01/1900	Shape:	C

Street:	OFF E 38TH PL	Flow Control:	Not Controlled
City:	Hobart, IN	Year Renewed:	
Location:	Other	Tape/Media #:	
Purpose:	Not Known	Dia/Height:	10"
Use:	Sanitary	Material:	PVC
Drain Area:	NA	Lining:	
Category:	NA		
Comment:

Location Details:		Direction of Survey:	Downstream
US MH:	M-903-051	DS MH:	M-903-051
		Total Length Surveyed (ft):	237.3

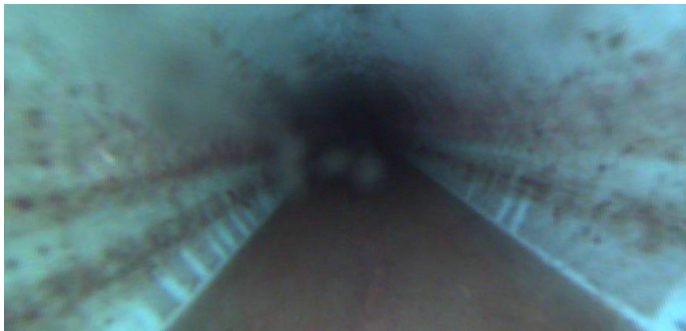
Code: **AMH**
Description: **Manhole**

Distance (ft): **.0**
Structural Grade: **0**
O&M Grade: **0**
Clock Start/From:
Clock To:
1st Value:
2nd Value:
Value Percent:
Continuous Index:
Within 8" of Joint: **NO**
Remarks: **M-903-051**

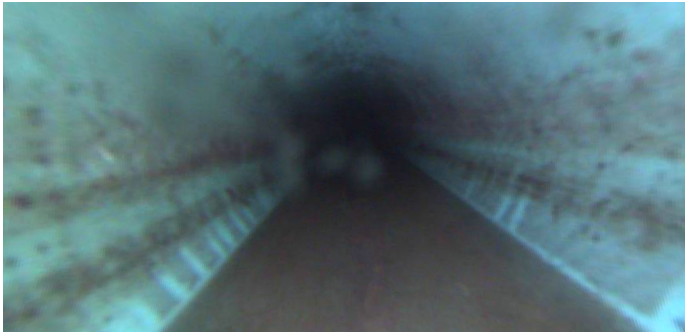
Code:	MWL
Description:	Water Level

Distance (ft):	.0
Structural Grade:	0
O&M Grade:	0
Clock Start/From:	
Clock To:	
1st Value:	
2nd Value:	
Value Percent:	10.000
Continuous Index:	
Within 8" of Joint:	NO
Remarks:

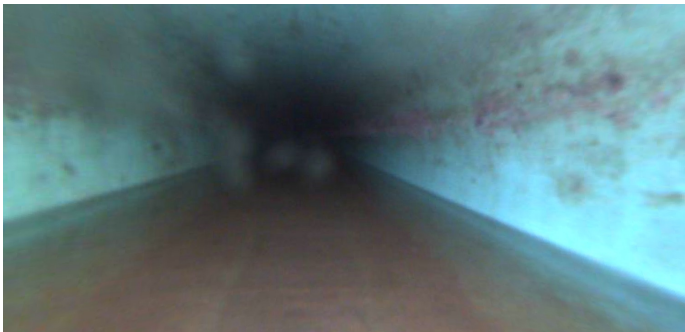
Code:	MWL
Description:	Water Level

Distance (ft):	111.3
Structural Grade:	0
O&M Grade:	0
Clock Start/From:	
Clock To:	
1st Value:	
2nd Value:	
Value Percent:	40.000
Continuous Index:	
Within 8" of Joint:	NO
Remarks:

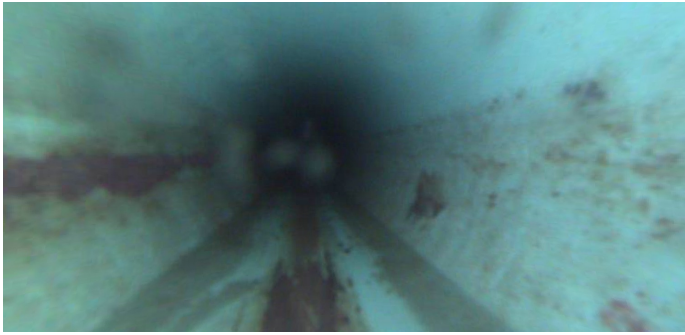
Code: **MWL**
Description: **Water Level**

Distance (ft): **118.2**
Structural Grade: **0**
O&M Grade: **0**
Clock Start/From:
Clock To:
1st Value:
2nd Value:
Value Percent: **5.000**
Continuous Index:
Within 8" of Joint: **NO**
Remarks:

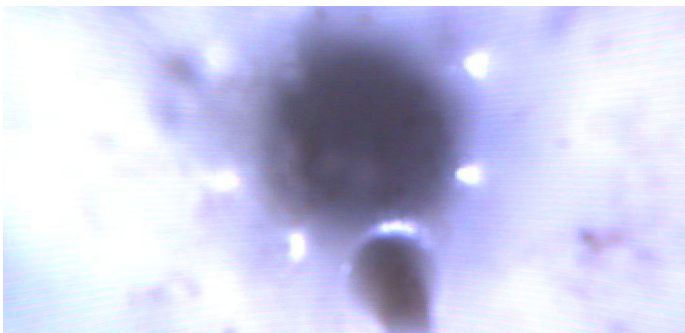
Code: **AEP**
Description: **End of Pipe**

Distance (ft): **237.3**
Structural Grade: **0**
O&M Grade: **0**
Clock Start/From:
Clock To:
1st Value:
2nd Value:
Value Percent:
Continuous Index:
Within 8" of Joint: **NO**
Remarks: **M-903-051; REACHED DS
STRUCTURE**
