Profile/Photo Observation Report

Street:	37th ave	Flow Control:	Not Controlled
City:	Hobart, IN	Year Renewed:	
Location:	Other	Tape/Media #:	
Purpose:	Not Known	Dia/Height:	10"
Use:	Sanitary	Material:	PVC
Drain Area:	NA	Lining:	
Category:	NA		
Comment:

Location Details:		Direction of Survey:	Downstream
US MH:	M-903-051	DS MH:	M-903-051
		Total Length Surveyed (ft):	237.3

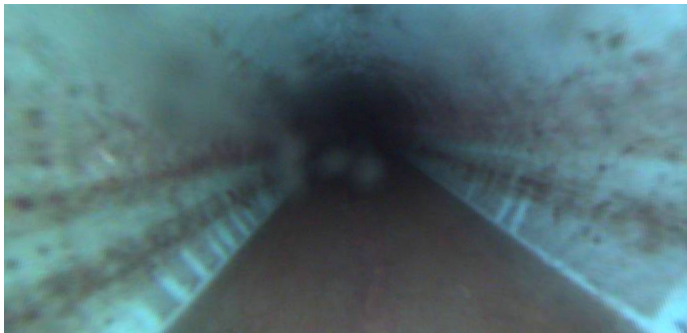
Code: **AMH**
Description: **Manhole**

Distance (ft): **.0**
Structural Grade: **0**
O&M Grade: **0**
Clock Start/From:
Clock To:
1st Value:
2nd Value:
Value Percent:
Continuous Index:
Within 8" of Joint: **NO**
Remarks: **M-903-051**

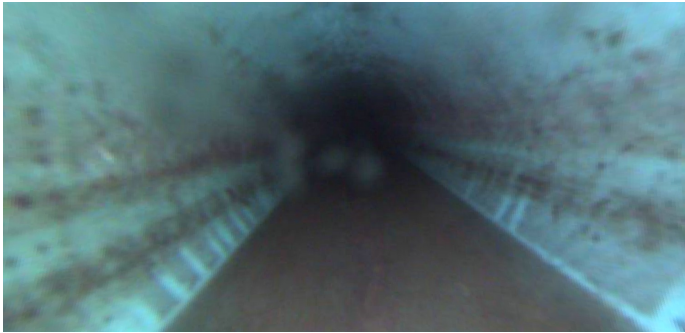
Code:	MWL
Description:	Water Level

Distance (ft):	.0
Structural Grade:	0
O&M Grade:	0
Clock Start/From:	
Clock To:	
1st Value:	
2nd Value:	
Value Percent:	10.000
Continuous Index:	
Within 8" of Joint:	NO
Remarks:

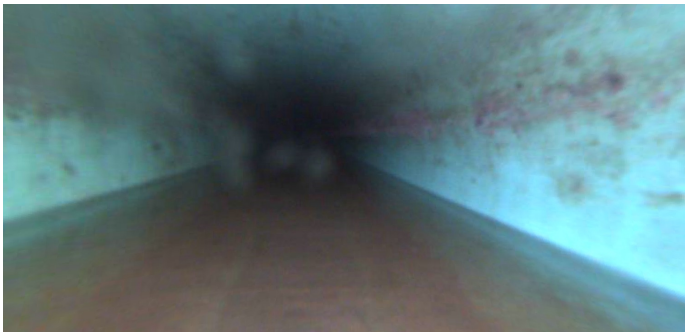
Code:	MWL
Description:	Water Level

Distance (ft):	111.3
Structural Grade:	0
O&M Grade:	0
Clock Start/From:	
Clock To:	
1st Value:	
2nd Value:	
Value Percent:	40.000
Continuous Index:	
Within 8" of Joint:	NO
Remarks:

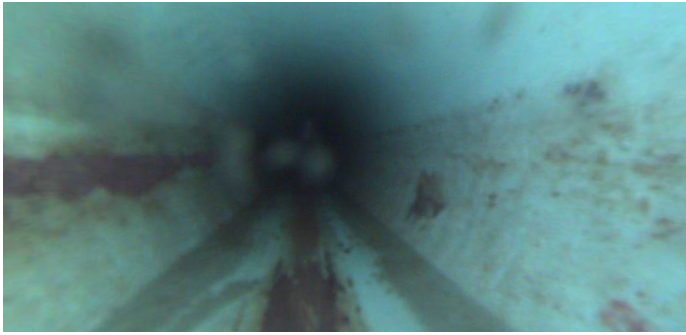
Code: **MWL**
Description: **Water Level**

Distance (ft): **118.2**
Structural Grade: **0**
O&M Grade: **0**
Clock Start/From:
Clock To:
1st Value:
2nd Value:
Value Percent: **5.000**
Continuous Index:
Within 8" of Joint: **NO**
Remarks:

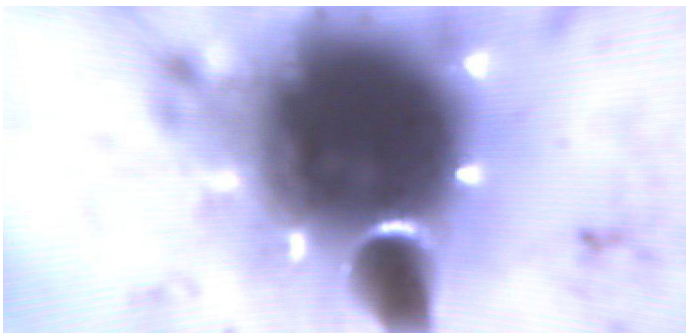
Code: **AEP**
Description: **End of Pipe**

Distance (ft): **237.3**
Structural Grade: **0**
O&M Grade: **0**
Clock Start/From:
Clock To:
1st Value:
2nd Value:
Value Percent:
Continuous Index:
Within 8" of Joint: **NO**
Remarks: **M-903-051; REACHED DS
STRUCTURE**
