## Profile/Photo Observation Report

Street:	<b>37th ave</b>	Flow Control:	<b>Not Controlled</b>
City:	<b>Hobart, IN</b>	Year Renewed:	
Location:	<b>Other</b>	Tape/Media #:	
Purpose:	<b>Not Known</b>	Dia/Height:	<b>10"</b>
Use:	<b>Sanitary</b>	Material:	<b>PVC</b>
Drain Area:	<b>NA</b>	Lining:	
Category:	<b>NA</b>		
Comment:

Location Details:		Direction of Survey:	<b>Upstream</b>
US MH:	<b>M-903-052</b>	DS MH:	<b>M-903-051</b>
		Total Length Surveyed (ft):	<b>197.8</b>

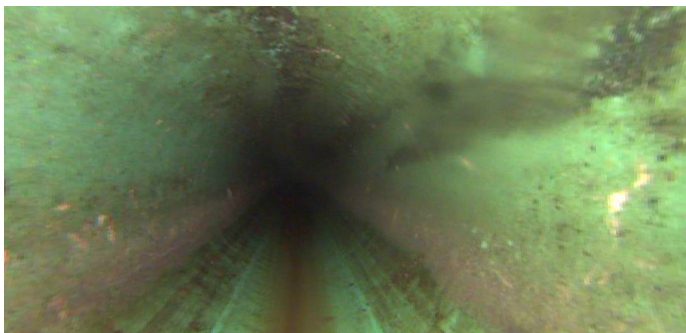
Code: **AMH**  
Description: **Manhole**

Distance (ft): **.0**  
Structural Grade: **0**  
O&M Grade: **0**  
Clock Start/From:  
Clock To:  
1st Value:  
2nd Value:  
Value Percent:  
Continuous Index:  
Within 8" of Joint: **NO**  
Remarks: **M-903-051**

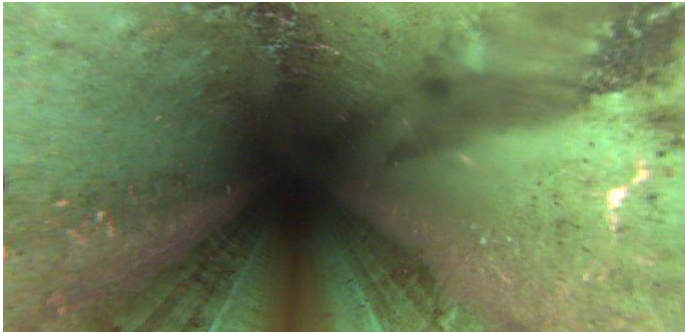
Code:	<b>MWL</b>
Description:	<b>Water Level</b>

Distance (ft):	<b>.0</b>
Structural Grade:	<b>0</b>
O&M Grade:	<b>0</b>
Clock Start/From:	
Clock To:	
1st Value:	
2nd Value:	
Value Percent:	<b>5.000</b>
Continuous Index:	
Within 8" of Joint:	<b>NO</b>
Remarks:

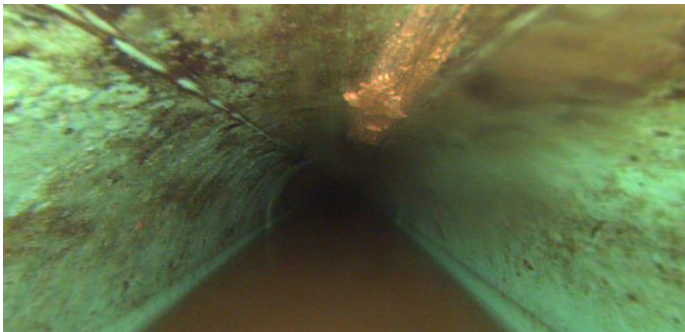
Code:	<b>DAGS</b>
Description:	<b>Deposits Attached Grease</b>

Distance (ft):	<b>60.2</b>
Structural Grade:	<b>0</b>
O&M Grade:	<b>2</b>
Clock Start/From:	<b>12</b>
Clock To:	
1st Value:	
2nd Value:	
Value Percent:	<b>5.000</b>
Continuous Index:	
Within 8" of Joint:	<b>NO</b>
Remarks:

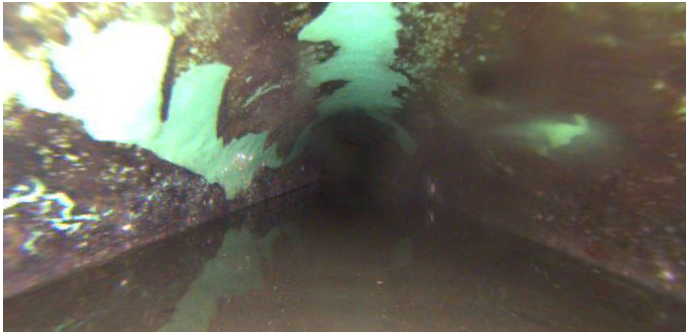
Code: **MWL**  
Description: **Water Level**

Distance (ft): **193.3**  
Structural Grade: **0**  
O&M Grade: **0**  
Clock Start/From:  
Clock To:  
1st Value:  
2nd Value:  
Value Percent: **30.000**  
Continuous Index:  
Within 8" of Joint: **NO**  
Remarks:

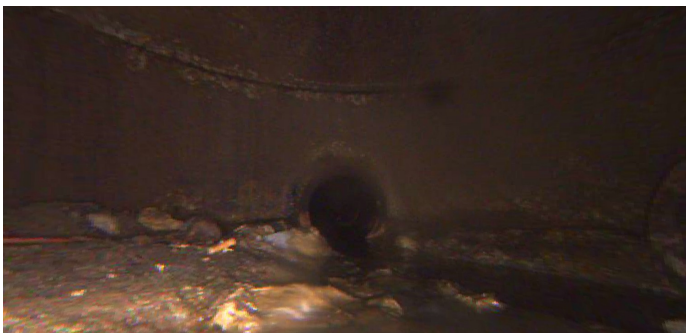
Code: **AMH**  
Description: **Manhole**

Distance (ft): **197.8**  
Structural Grade: **0**  
O&M Grade: **0**  
Clock Start/From:  
Clock To:  
1st Value:  
2nd Value:  
Value Percent:  
Continuous Index:  
Within 8" of Joint: **NO**  
Remarks: **M-903-052**
