Profile/Photo Observation Report

Date:	03/20/2018	Weather:		Coding:	PACP 6.0
Pipe Length (ft):	145.6	Owner:	NA	Pre Clean:	Not Known
P.O.#:		Surveyor:	Justin Gonzales	PSR:	P-903-056-055
Customer:		Clean Date:	01/01/1900	Shape:	C

Street:	OFF N HOBART RD	Flow Control:	Not Controlled
City:	Hobart, IN	Year Renewed:	
Location:	Other	Tape/Media #:	
Purpose:	Not Known	Dia/Height:	10"
Use:	Sanitary	Material:	PVC
Drain Area:	NA	Lining:	
Category:	NA		
Comment:

Location Details:		Direction of Survey:	Upstream
US MH:	M-903-055	DS MH:	M-903-056
		Total Length Surveyed (ft):	138.6

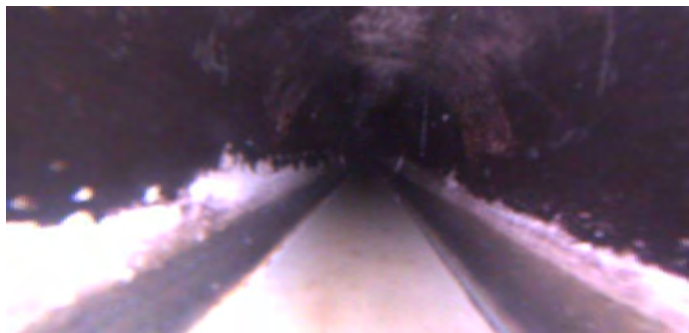
Code: **AMH**
Description: **Manhole**

Distance (ft): **.0**
Structural Grade: **0**
O&M Grade: **0**
Clock Start/From:
Clock To:
1st Value:
2nd Value:
Value Percent:
Continuous Index:
Within 8" of Joint: **NO**
Remarks: **M-903-056**

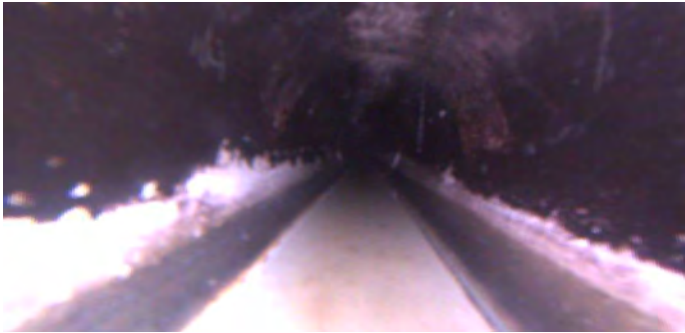
Code:	MWL
Description:	Water Level

Distance (ft):	.0
Structural Grade:	0
O&M Grade:	0
Clock Start/From:	
Clock To:	
1st Value:	
2nd Value:	
Value Percent:	5.000
Continuous Index:	
Within 8" of Joint:	NO
Remarks:

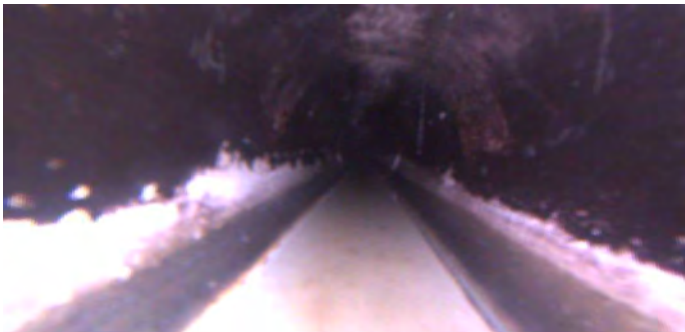
Code:	DAZ
Description:	Deposits Attached Other

Distance (ft):	.0
Structural Grade:	0
O&M Grade:	2
Clock Start/From:	7
Clock To:	5
1st Value:	
2nd Value:	
Value Percent:	5.000
Continuous Index:	S01
Within 8" of Joint:	YES
Remarks:	WANDER

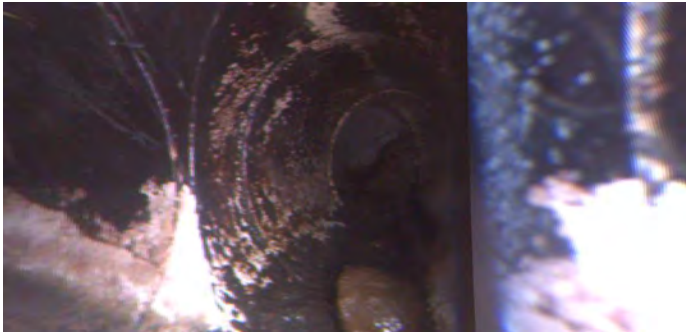
Code: **TF**
Description: **Tap Factory**

Distance (ft): **3.3**
Structural Grade: **0**
O&M Grade: **0**
Clock Start/From: **9**
Clock To:
1st Value: **4.000**
2nd Value:
Value Percent:
Continuous Index:
Within 8" of Joint:
Remarks:

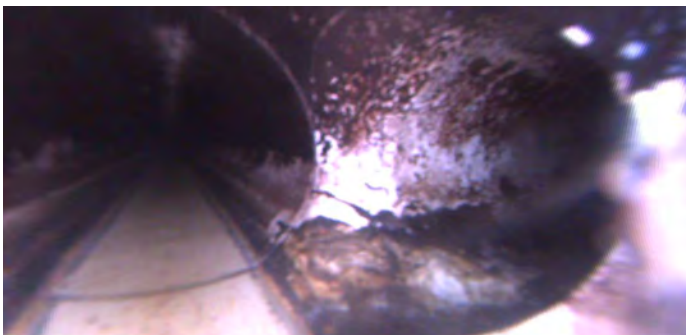
Code: **TF**
Description: **Tap Factory**

Distance (ft): **26.9**
Structural Grade: **0**
O&M Grade: **0**
Clock Start/From: **3**
Clock To:
1st Value: **4.000**
2nd Value:
Value Percent:
Continuous Index:
Within 8" of Joint:
Remarks:

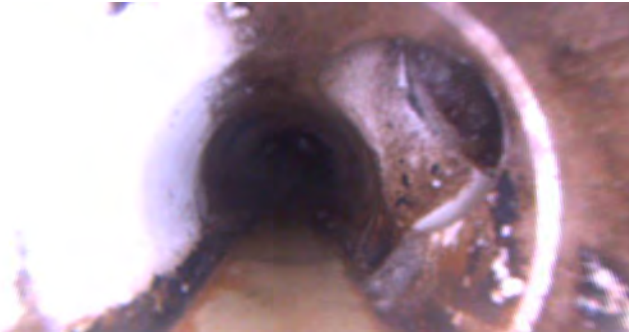
Code: **TF**
Description: **Tap Factory**

Distance (ft): **104.7**
Structural Grade: **0**
O&M Grade: **0**
Clock Start/From: **2**
Clock To:
1st Value: **4.000**
2nd Value:
Value Percent:
Continuous Index:
Within 8" of Joint:
Remarks:

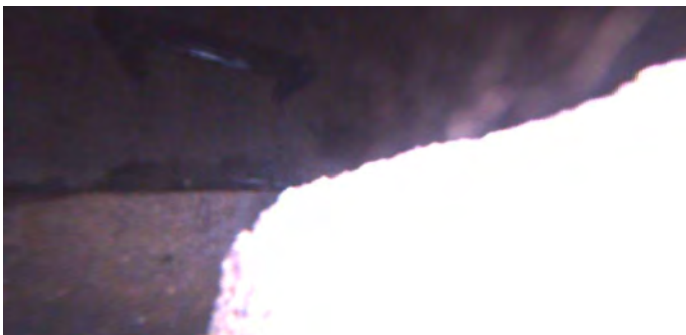
Code: **AMH**
Description: **Manhole**

Distance (ft): **138.6**
Structural Grade: **0**
O&M Grade: **0**
Clock Start/From:
Clock To:
1st Value:
2nd Value:
Value Percent:
Continuous Index:
Within 8" of Joint: **NO**
Remarks: **M-903-055**

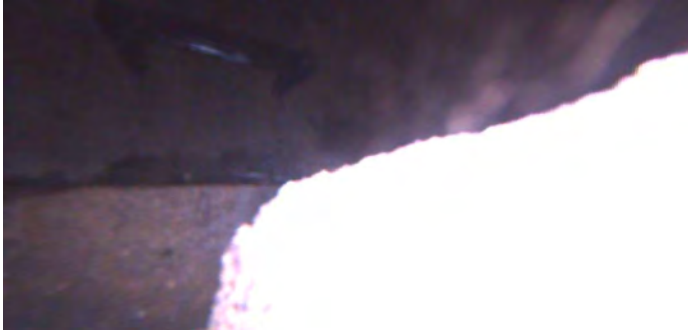
Code:	DAZ
Description:	Deposits Attached Other
Distance (ft):	138.6
Structural Grade:	0
O&M Grade:	2
Clock Start/From:	7
Clock To:	5
1st Value:	
2nd Value:	
Value Percent:	5.000
Continuous Index:	F01
Within 8" of Joint:	YES
Remarks:	WANDER
